RUSTIC ALCOVE **HAFOD** CEREDIGION

ARCHAEOLOGICAL EVALUATION
Project Record No. 32476
MAY 1996

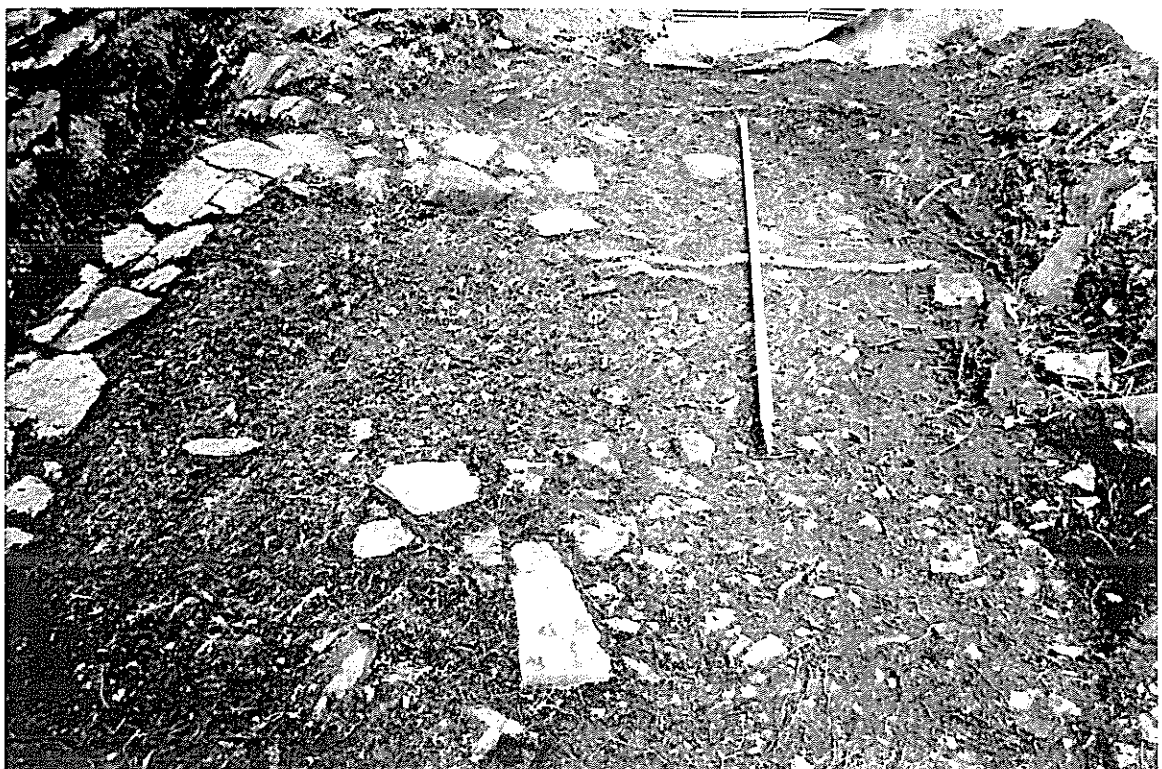
Figure 8

The footpath metalling (16) only remained to any extent at the north eastern end of the excavation area (figures 4 and 8). This consisted of small shale slabs and fragments set on a greyish brown silty clay, lying directly on bedrock (17) and probably over part of the drain capping (10).

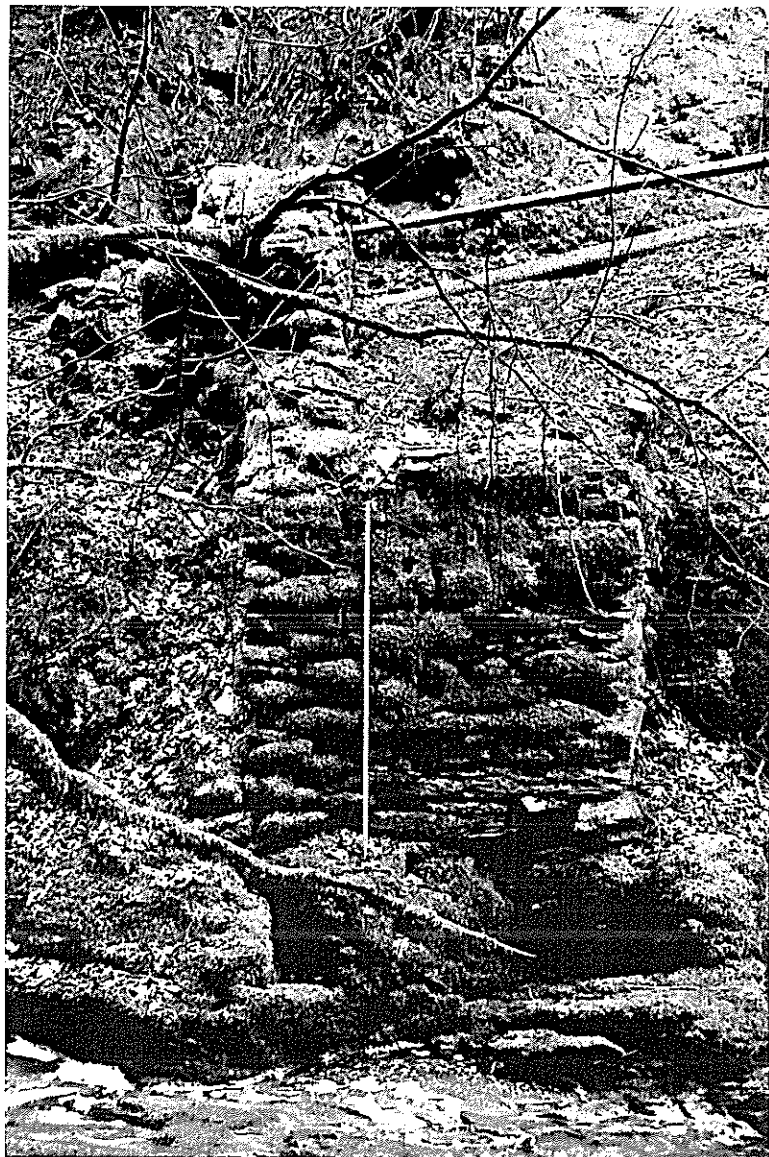
Figure 10

The earliest structure was that of a drystone pier 2.2m wide, 1.8m above the bedrock and projecting at least 1.6m out from the top of the stream bank (figure 10). It was constructed on bedrock which, in the area above the stream, appeared to have been cut to form part of the footings, and also into or on the natural clay bank/hillside material. There was no evidence for timber features in or on the surviving structure (figures 5 and 11). Stone by stone drawings (301-303, figure 6) were made of the elevations; moss cover was left intact where present.

This pier structure, other than a few stones on the northern side, appears to be in reasonable repair. The surface edge stones, however, would be vulnerable to foot damage and some thought should be given to either capping and re-surfacing of the platform of the pier or excluding visitors from this area. Consideration should be given

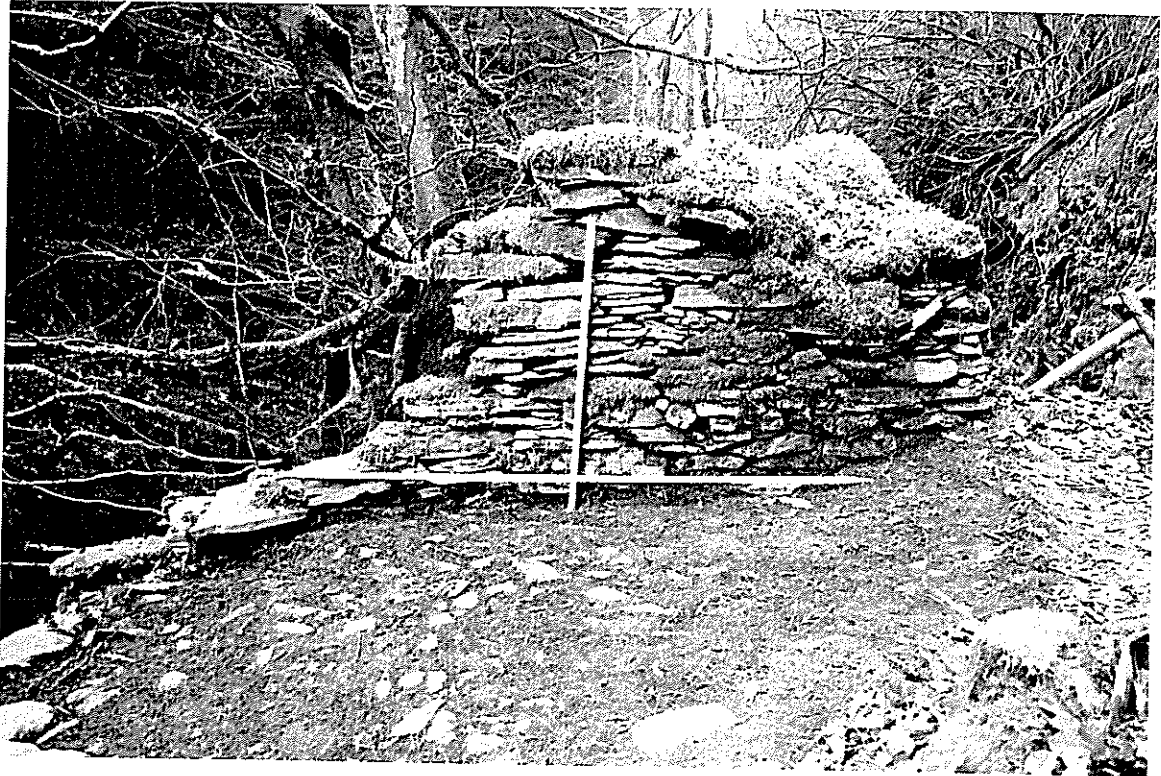
Figure 11

A wall (28) projected above the southern side of this platform and also further to the south on the top of the bank, making a thickened 'L'-shape (figure 5). This again appeared to be all of drystone construction (figure 11). The wall top was thickly covered in moss and almost certainly had been damaged (Phillips 1994). The eastern side of the thickened part had collapsed and this face had been lost. The long arm projecting to the east was evidently much lower than its original height and three stones had been displaced, giving it a false curved appearance. On the higher and thickened part of this wall the southern and western faces had been stepped back by approximately 150mm at 500mm height and the remaining upper part of these faces were slightly battered. The battering of this higher part of the wall could have formed a pillar, possibly to support an arch; however, there was no discernible physical evidence for any structure on the opposite side of the path, and the apparent drystone construction of this pillar is unlikely to have taken any great amount of thrust. It is possible that it was simply decorative or supported a timber structure.

The 'L'-shaped wall and pillar above are in worse condition. The consolidation of drystone walls in poor repair is a problem. There is insufficient evidence of the original structure for a satisfactory reconstruction and furthermore the bank has fallen away below part of the wall. This walling should either be left as it is and its condition monitored, or substantial consolidation (probably with internal bonding) should be undertaken with prior recording, but still leaving an impression of a drystone moss-covered ruin.

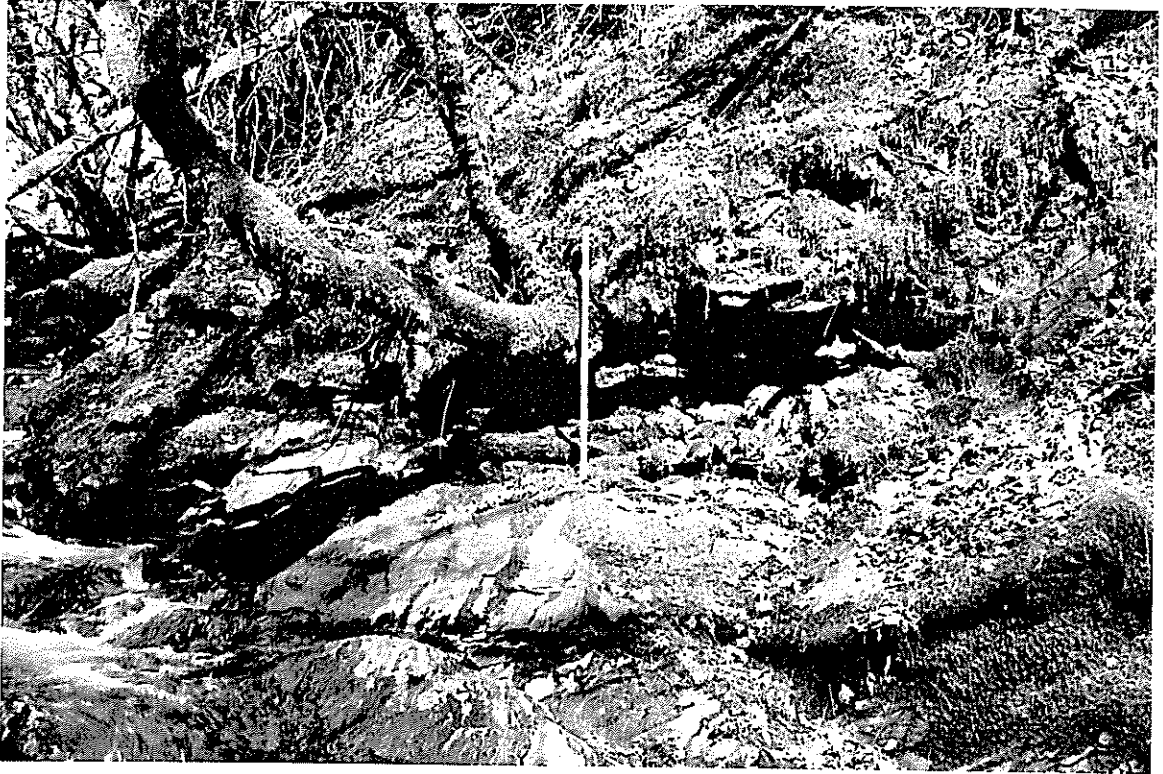
Figure 13

Wall 101: The remains of what was probably a corresponding bridge pier could be seen opposite that of Site 2 (101, figures 1 and 2). However access was poor and it was in a very ruinous condition (figure 13).

This structure was built on bedrock which slopes towards the stream. In the area where the south western corner and southern face of the pier were probably located the slope was approximately 45°, which may have been a factor in its collapse. However, part of the face remained, adjacent to the stream. Here, partly below the fallen remains of a dead tree, there was a face three courses wide by 5 courses high (approximately 0.5m). There was also a considerable amount of core work and some of the southern face may have survived further up the slope. The core work was at least 1.7m wide. It appeared that these remains possibly ran up the hillside to join the remnants of a footpath, and seemed to have been of similar height to those of the pier on Site 2.

On wall 101 the three dead trees and the one conifer at the top area should be cut down with care and the stumps left to rot in place.
