A PRELIMINARY SURVEY
OF
HAFOD ICEHOUSE
RECORD NO. 26535

REPORT NO. 35948

June 1998

HAFOD ICEHOUSE (Hafod Archaeological Database No. 26535) A PRELIMINARY SURVEY

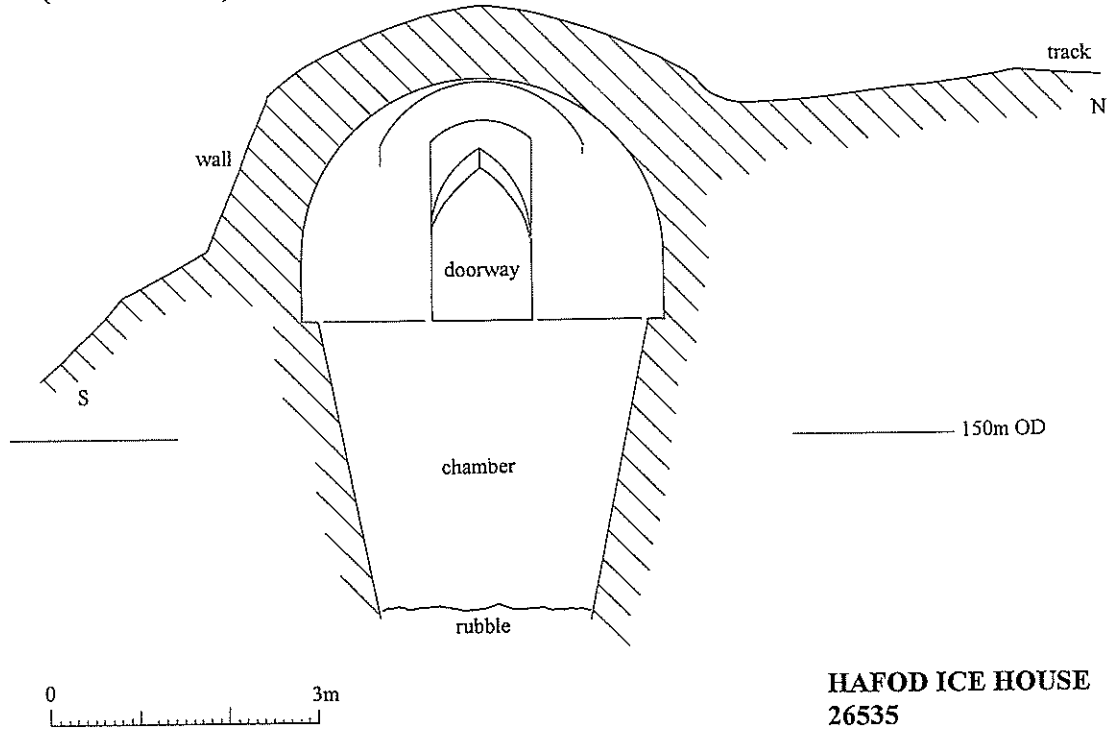
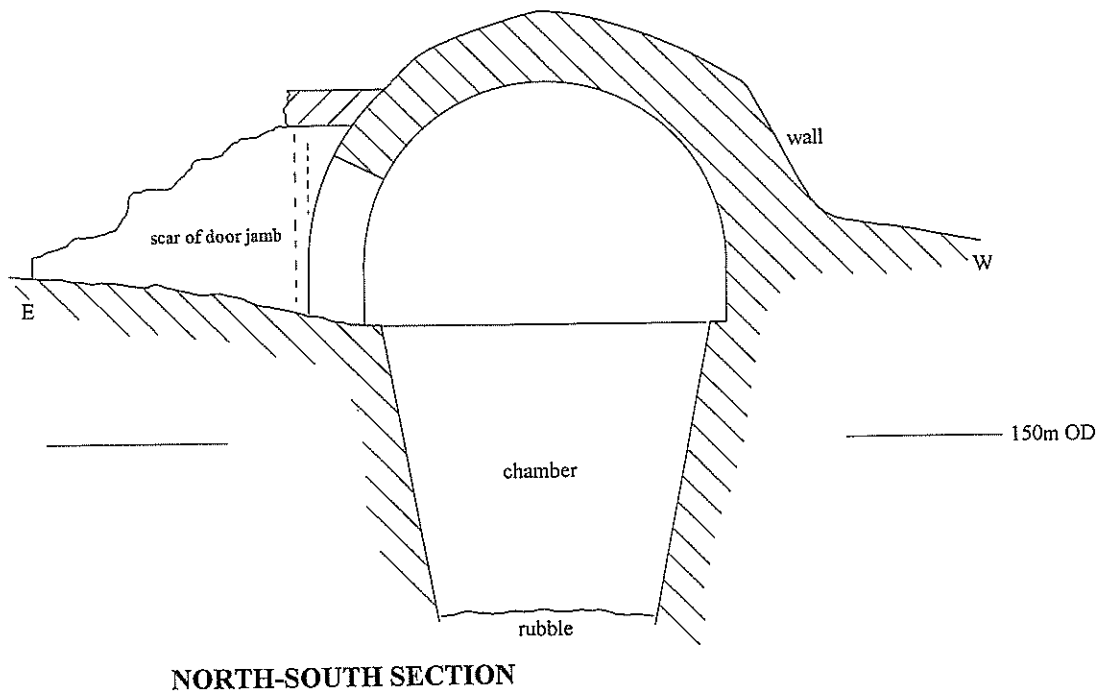
Figure 2. Sections of Hafod icehouse.

The interior of the chamber and dome of the icehouse is in very good condition. There is no evidence of root penetration from the shrubs growing above. It is built of coursed rubble. The chamber is cone-shaped, 3.35m diameter at the top narrowing down to c. 2.15m at the lowest visible point. Its depth down to rubble which fills its lower levels is 3.3m. This rubble is of unknown depth and presumably fills a sump and drain. The dome is 3.7m across at its base and is estimated to be semi-hemispherical in shape (it was not possible to conduct detailed measurements). Despite the step at the junction of the chamber and dome, there is no reason to suspect that they were not of one build.

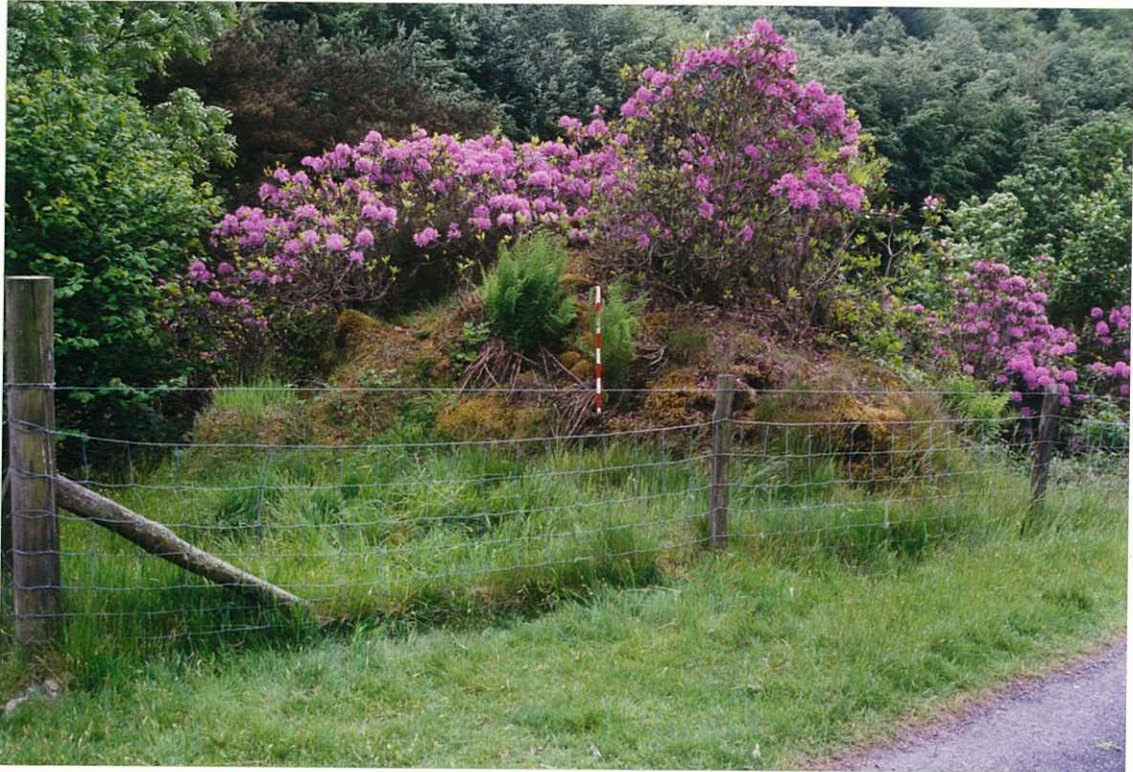
Photo 1. Icehouse from the north-east.

Immediate action: the rhododendron and hazel scrub growing on and near the dome of the icehouse should be removed and killed to prevent future growth. Also a band of ground stretching *c.* 5m either side of the icehouse should be cleared of rhododendrons and the ash tree down to the river, as roots may eventually begin to penetrate through to the icehouse chamber in the made-up ground. This ground should be returned to grazing land.

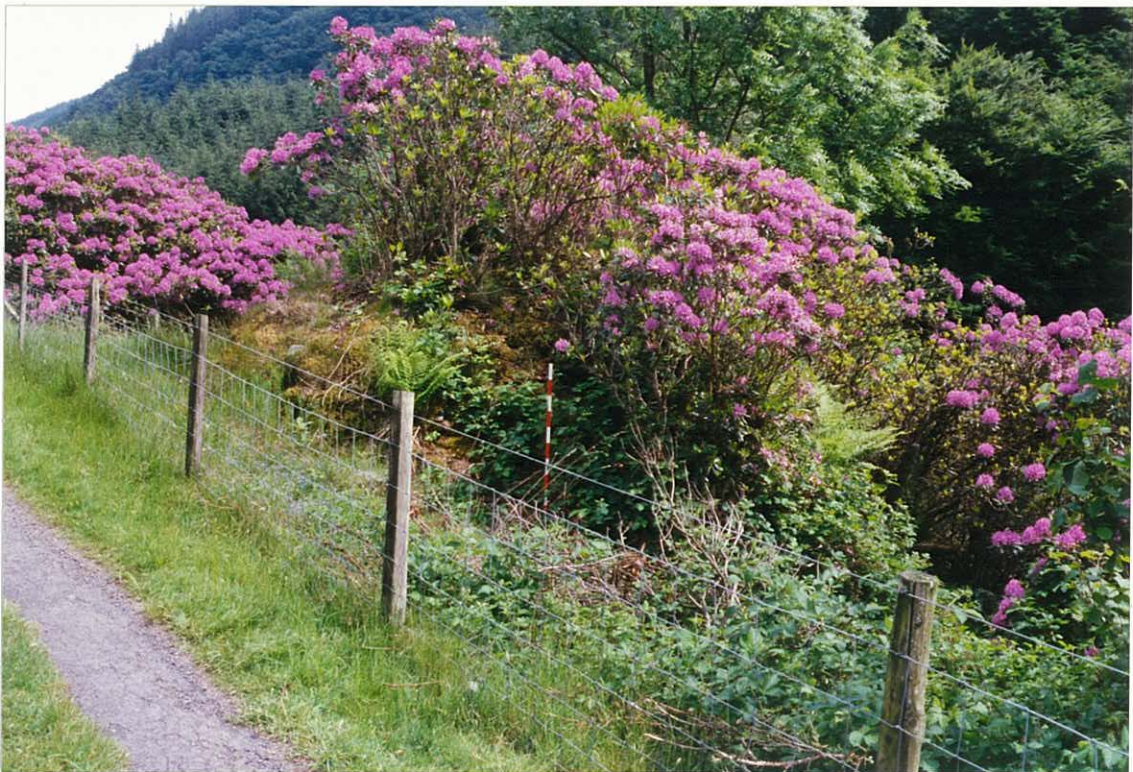
Photo 2. Icehouse from the north-west.

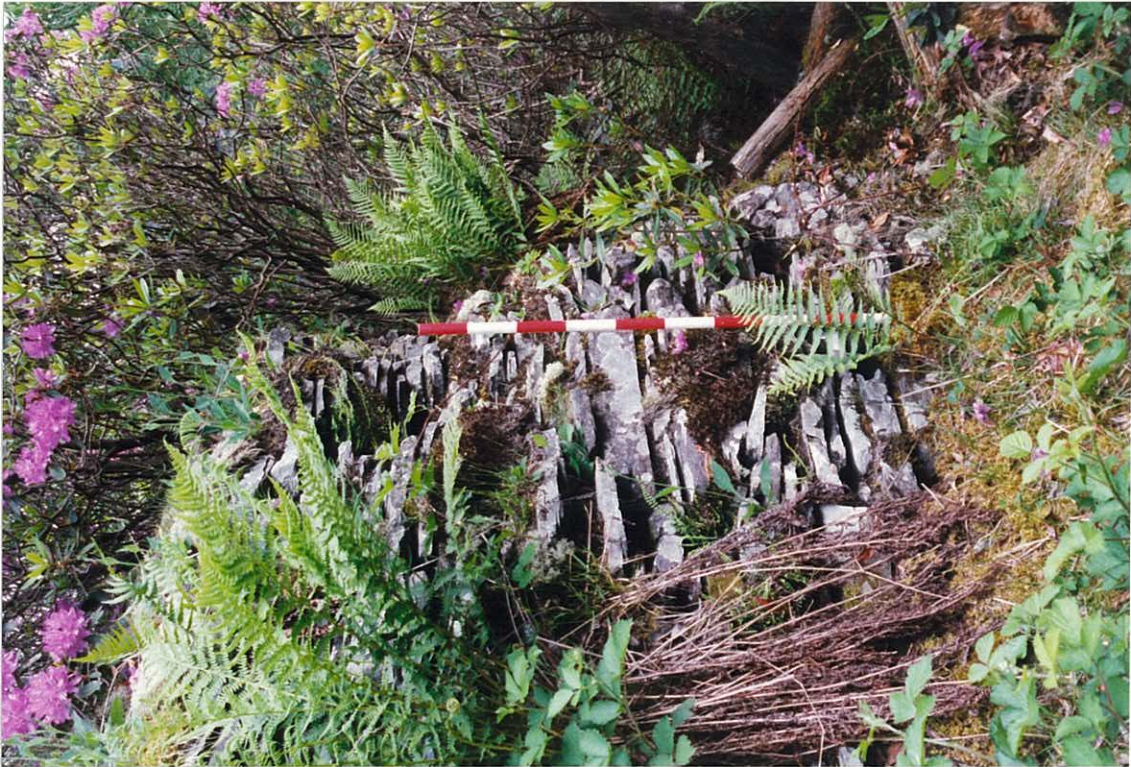
Photo 3. External wall on south-west side.

Medium term: Although the interior of the icehouse appears in good condition, the state of most of the external masonry is not known due to vegetation cover. An area of vegetation and accumulated soil should be removed using archaeological techniques from part of the icehouse mound to examine the condition of the masonry. The amount of any restoration work would depend on the condition of the uncovered masonry.

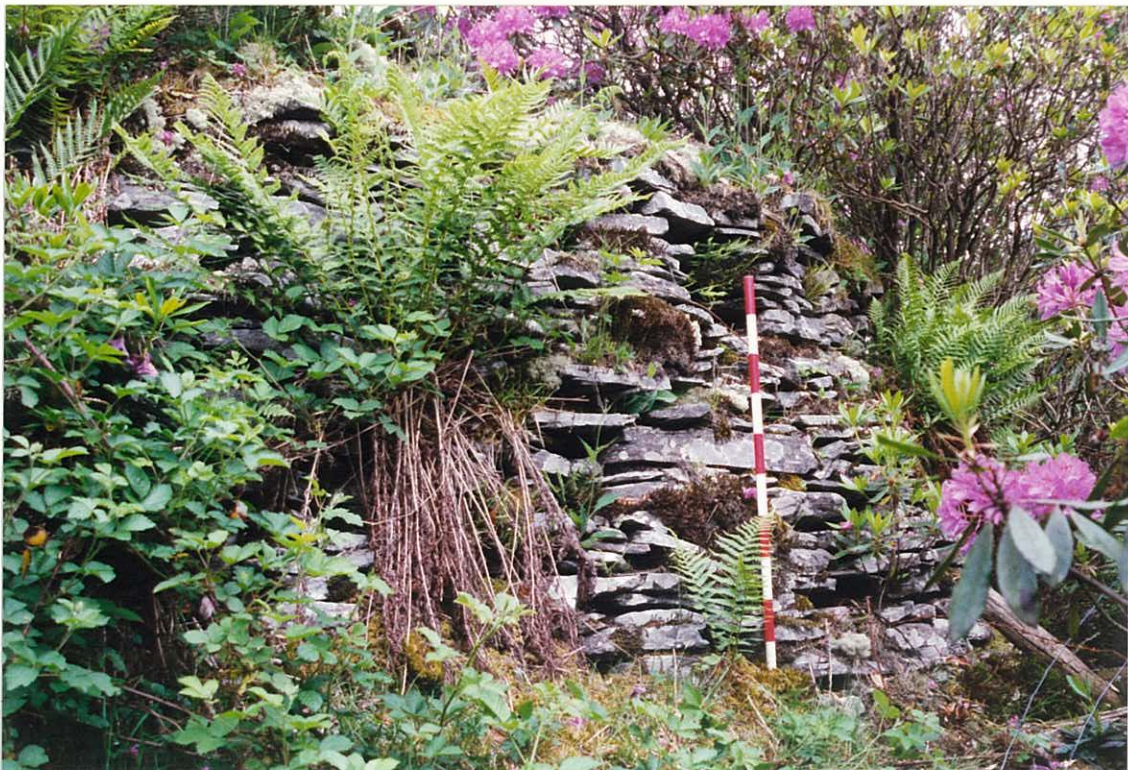
Photo 4. External wall on south side.

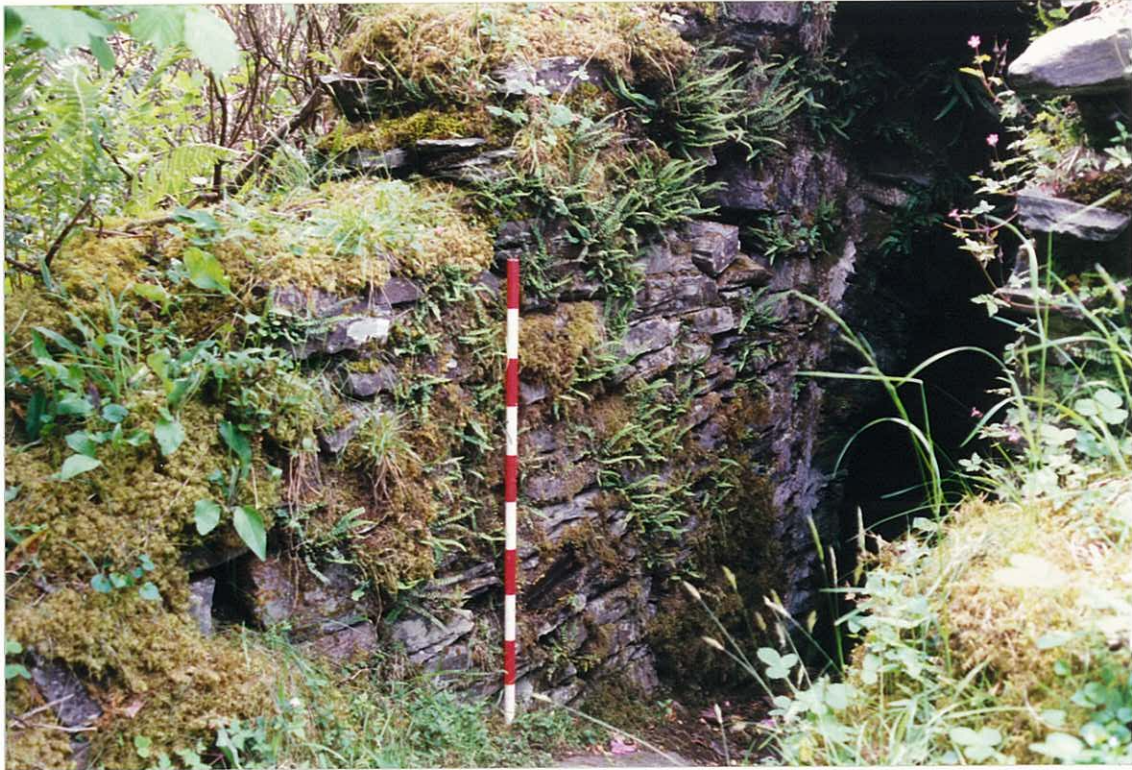
The icehouse entrance passageway is in a very poor state of repair: the stone vaulting has collapsed apart from a c. 1m section adjoining the icehouse's dome, much dilapidation has occurred to the stone-built side walls (the north wall in particular) and rubble has accumulated in the passageway. Nevertheless, it is possible to detect the original plan. The passageway was 3.9m long, 1.1m wide, 1.9m high and built of coursed rubble. A mortar scar of a removed door jamb is visible adjoining the chamber. The walls of the passageway are butt-joined onto the masonry of the chamber, but this is probably a reflection of the building technique employed rather than of chronological significance.

Photo 5. South passageway wall.

Short term: to prevent further decay to the passageway, repointing of the side walls is required.

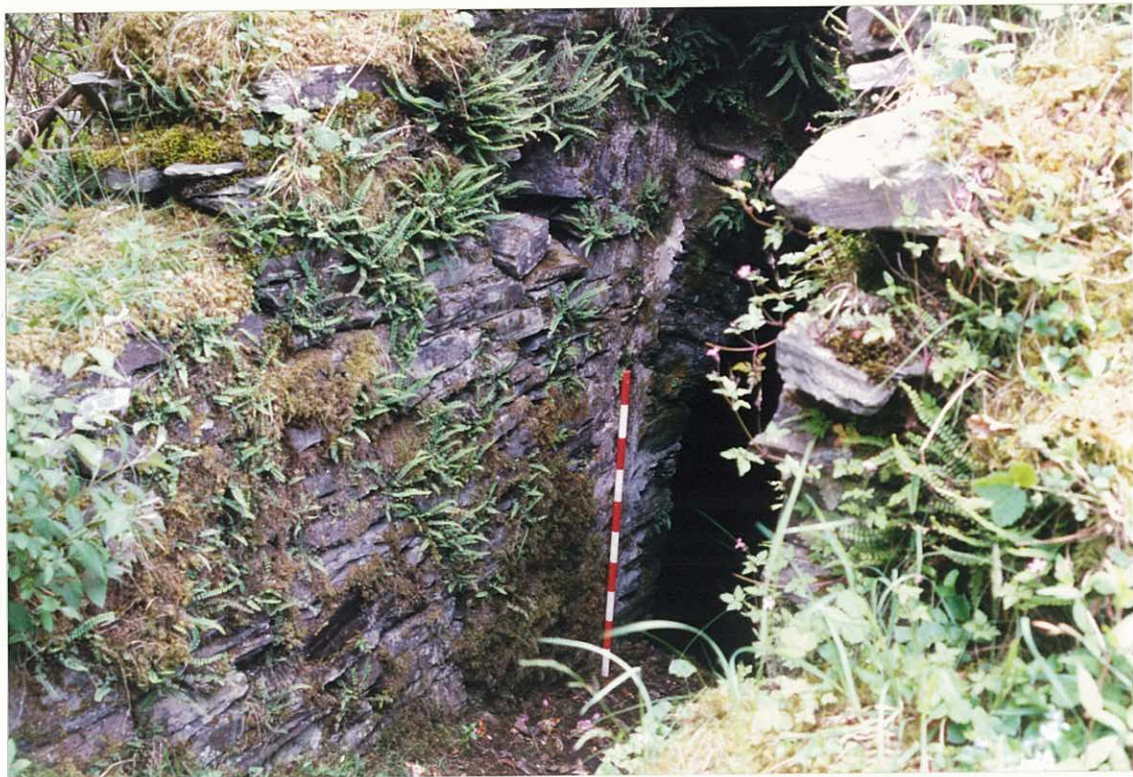
Photo 6. South passageway wall.

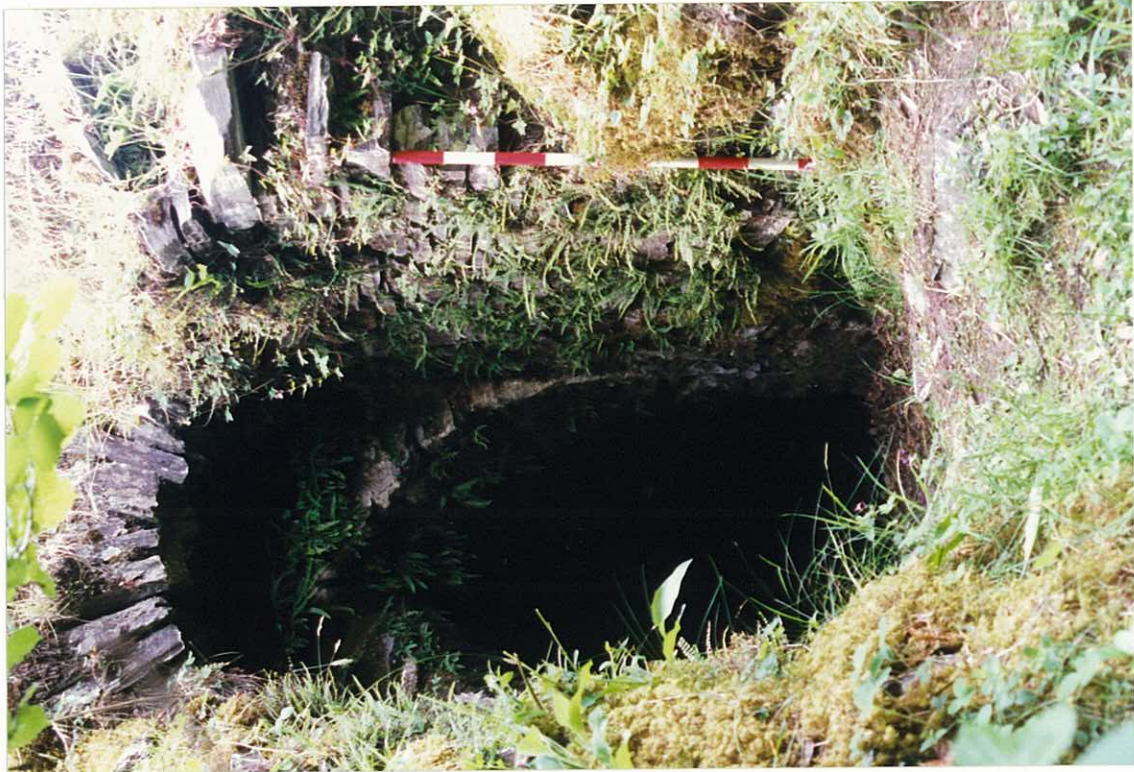
Photo 7. Entrance.

Replacement of icehouse door: two designs have been suggested: a solid door with 'letter box' for bat access and an open grill. Archaeologically there is little to choose between the two. However, a solid door will not allow visitors to view the icehouse's interior and will impede ventilation. The latter may lead to the build-up of toxic gases, particularly if there is vegetation matter mixed with the rubble in the base of the chamber.

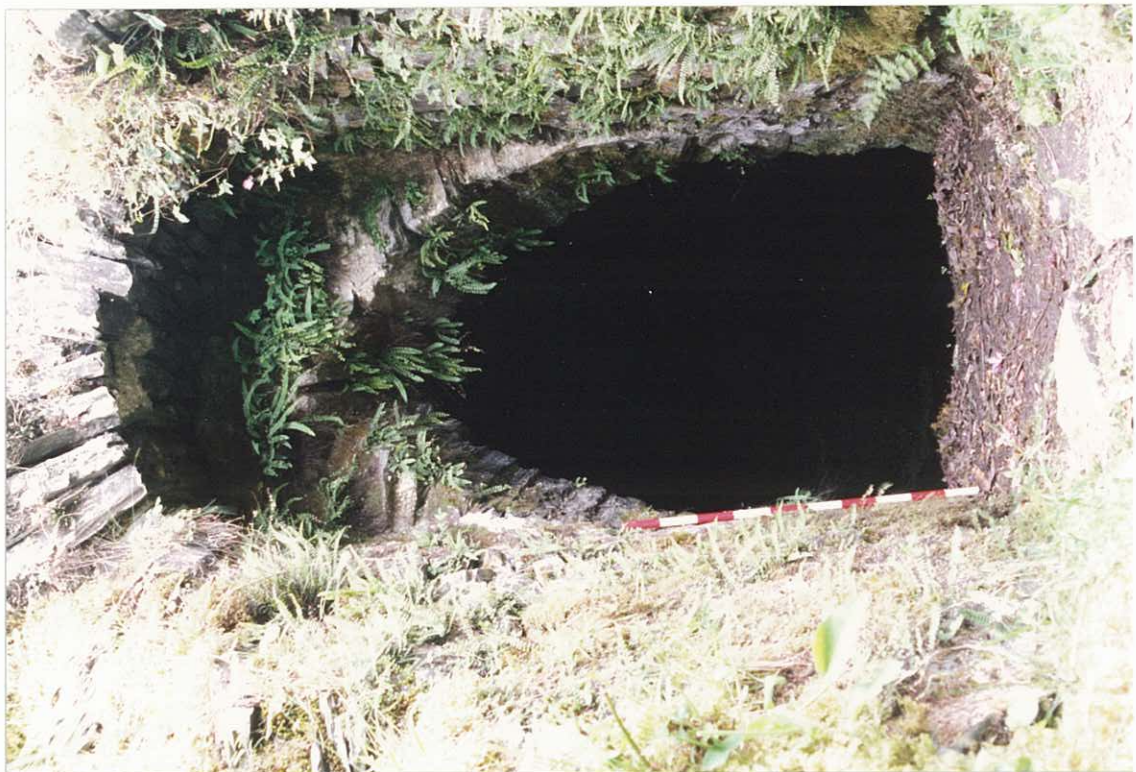
Photo 8. Entrance.

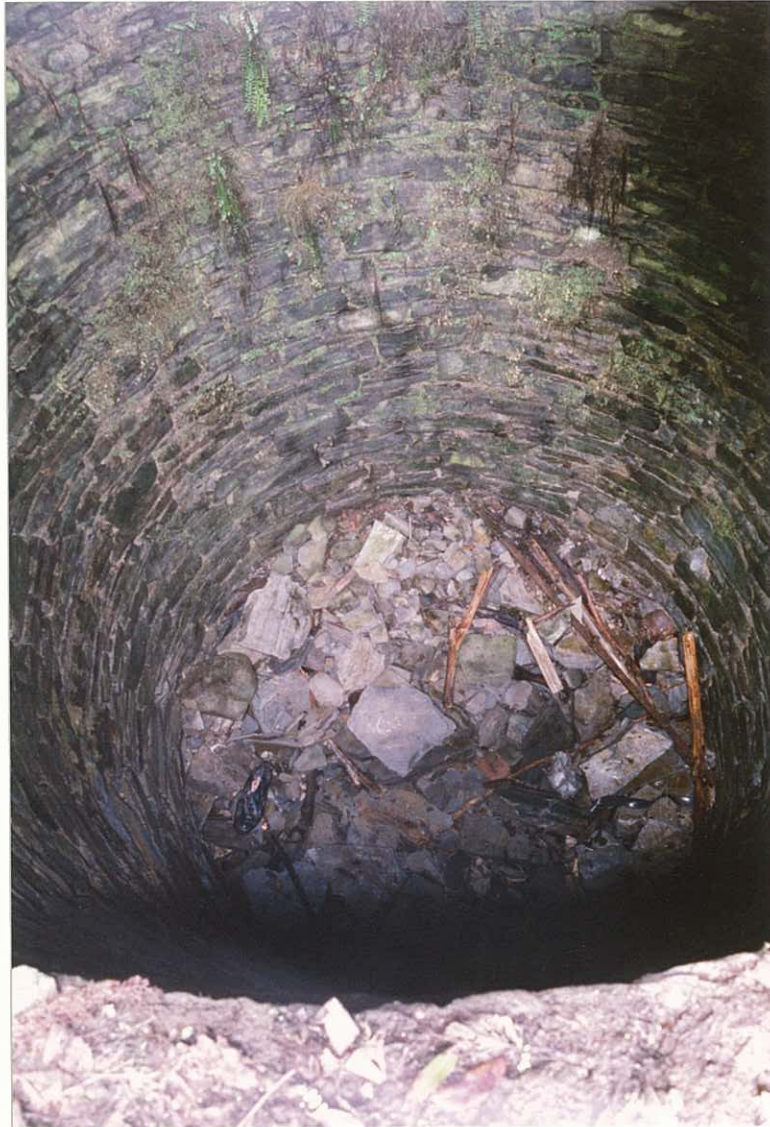
Photo 9. Interior of the icehouse
