SURVEY OF ALPINE BRIDGE, HAFOD, CARDIGANSHIRE

Commissioned by Welsh Historic Gardens Trust  
from Dyfed Archaeological Trust

## HAFOD: ALPINE BRIDGE

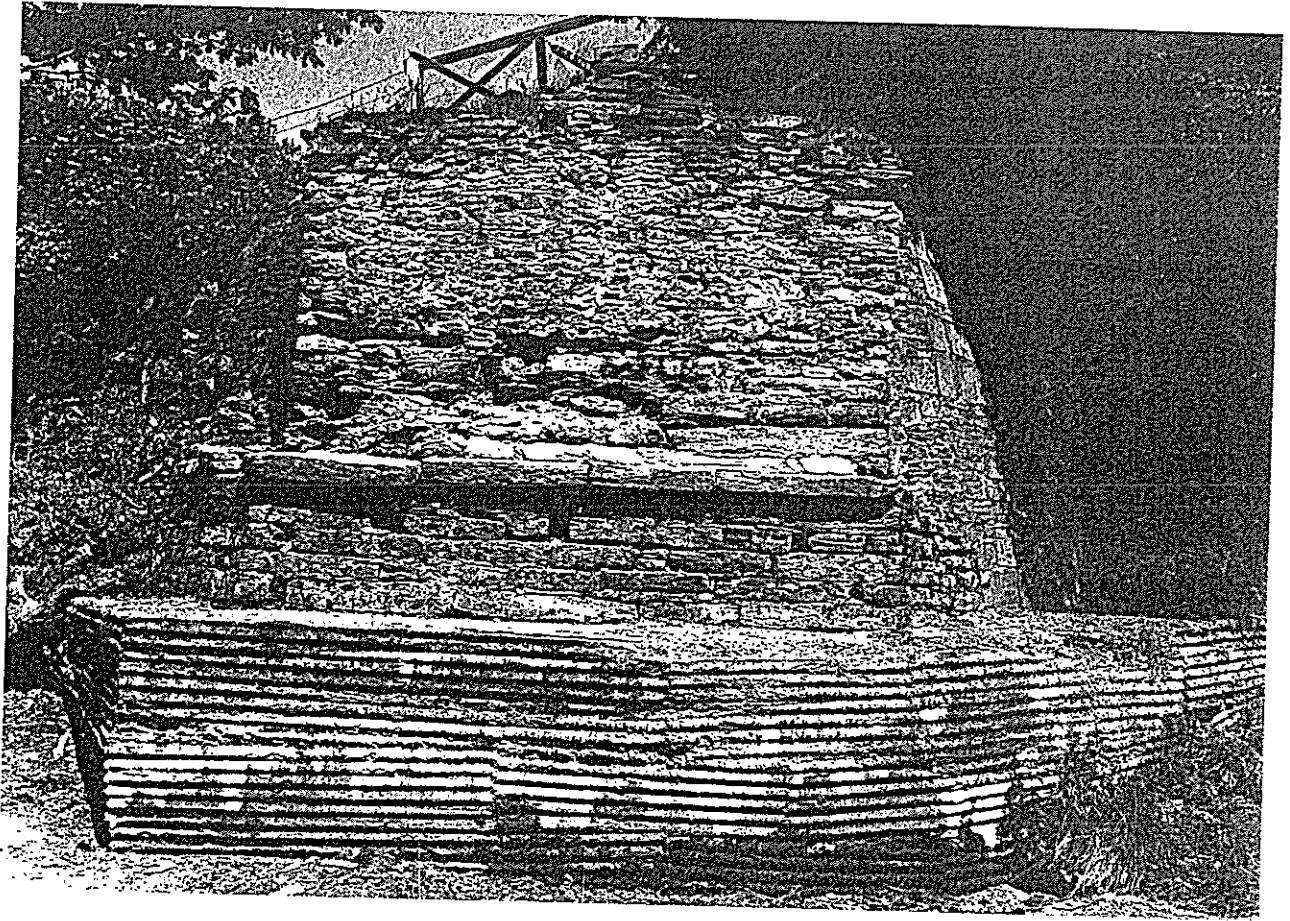
1

The upper 0.5m of masonry is loose due to rainwater percolation. There is some very loose stonework on the western side - this needs repointing.

1. North abutment, south face. Lower portion of abutment encased in concrete. Note the poor condition of the stonework on the western end of the battered face and the different character of the masonry above the batter.

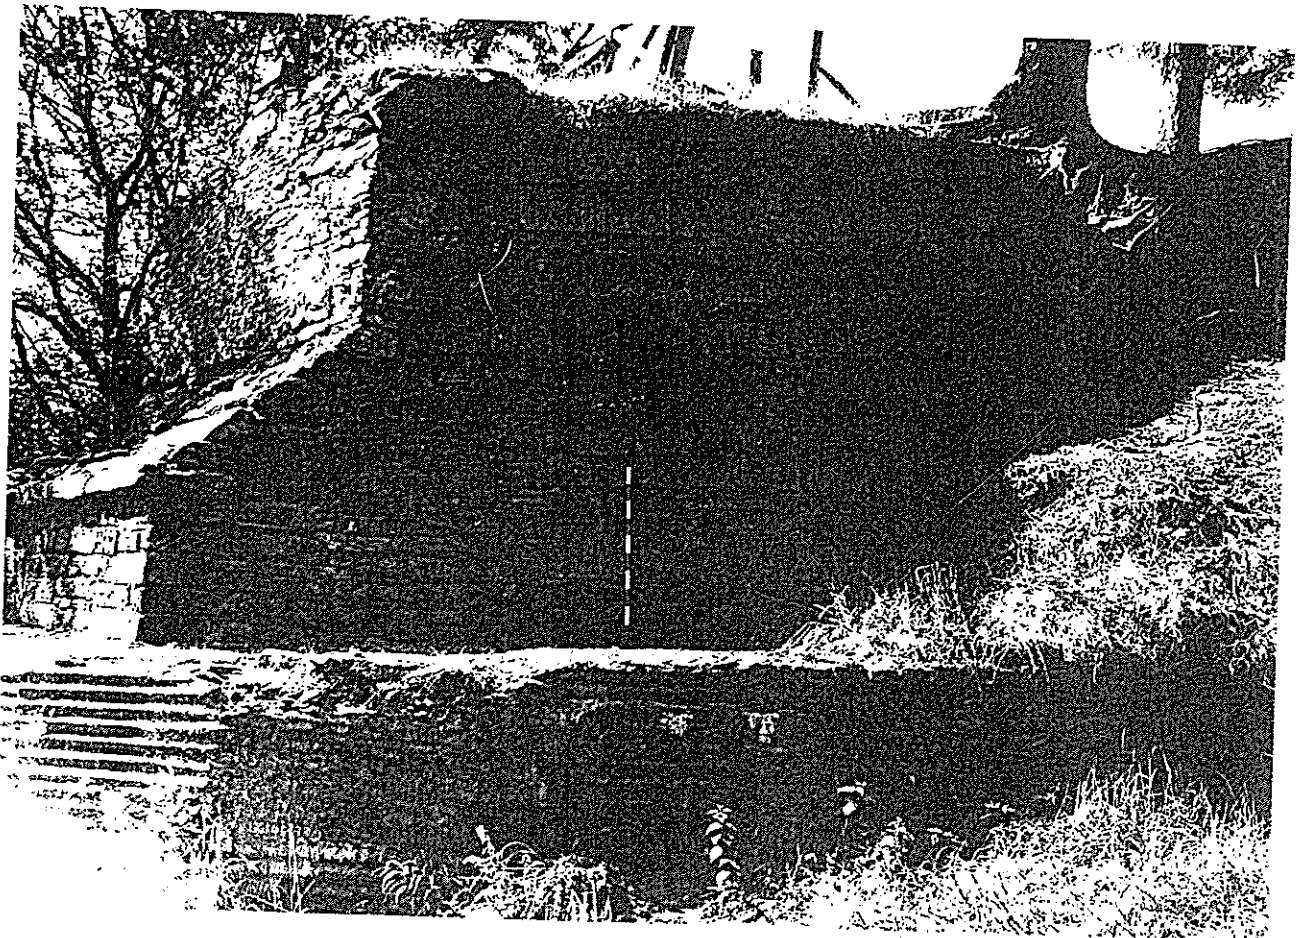
2

2. North abutment, east elevation. The steeply sloping wall of reused stone rests on the concrete plinth.

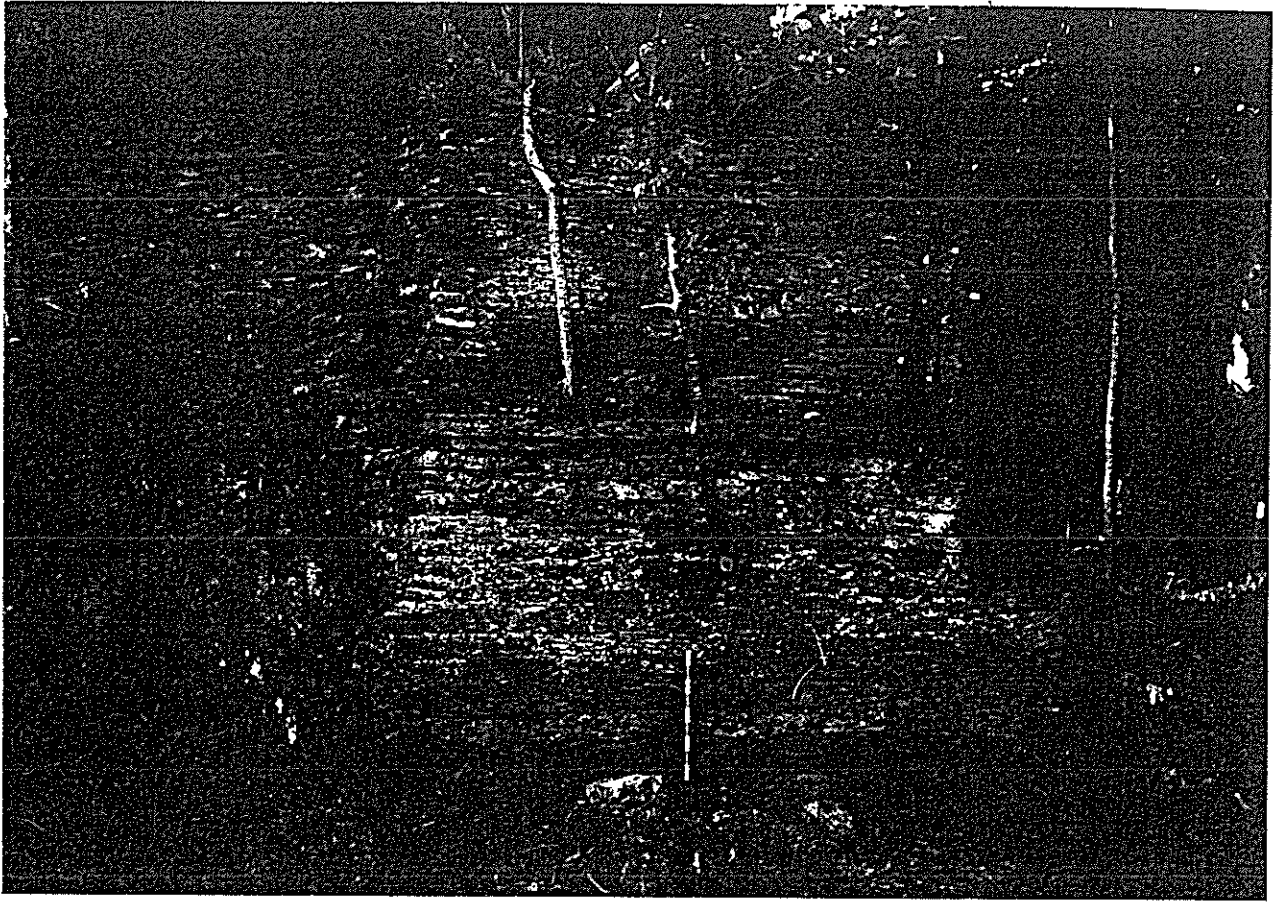
3

This abutment is in good condition apart from several saplings which have taken root in it and the upper 0.5m of masonry which is loose due to rainwater percolation.

3. South abutment, north face. Note the poor condition of the stonework on the battered face and the different character of the masonry above.

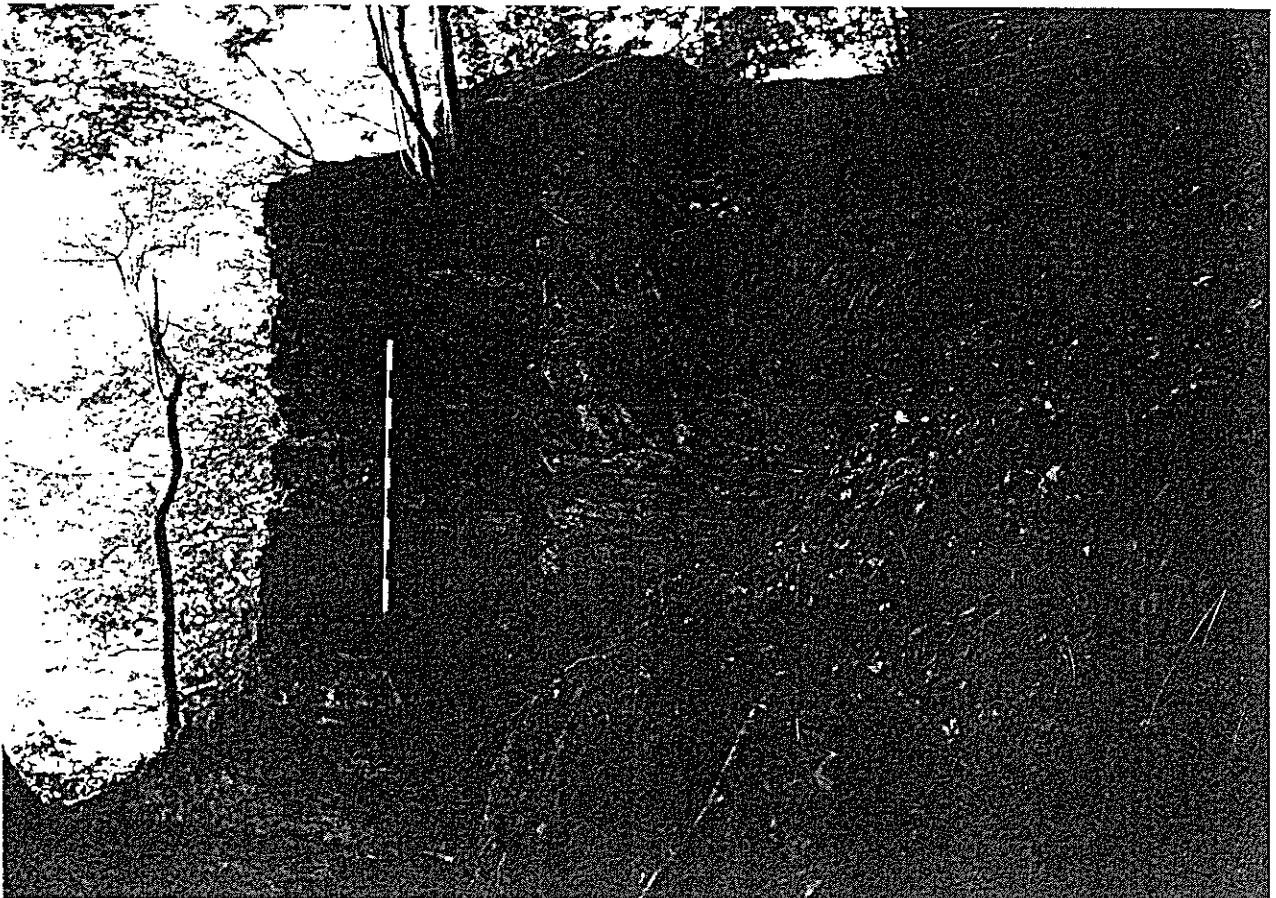
4

4. South abutment, west elevation. Note the character of stonework on the battered face in contrast to the wall above. Also the un-mortared masonry behind this wall.

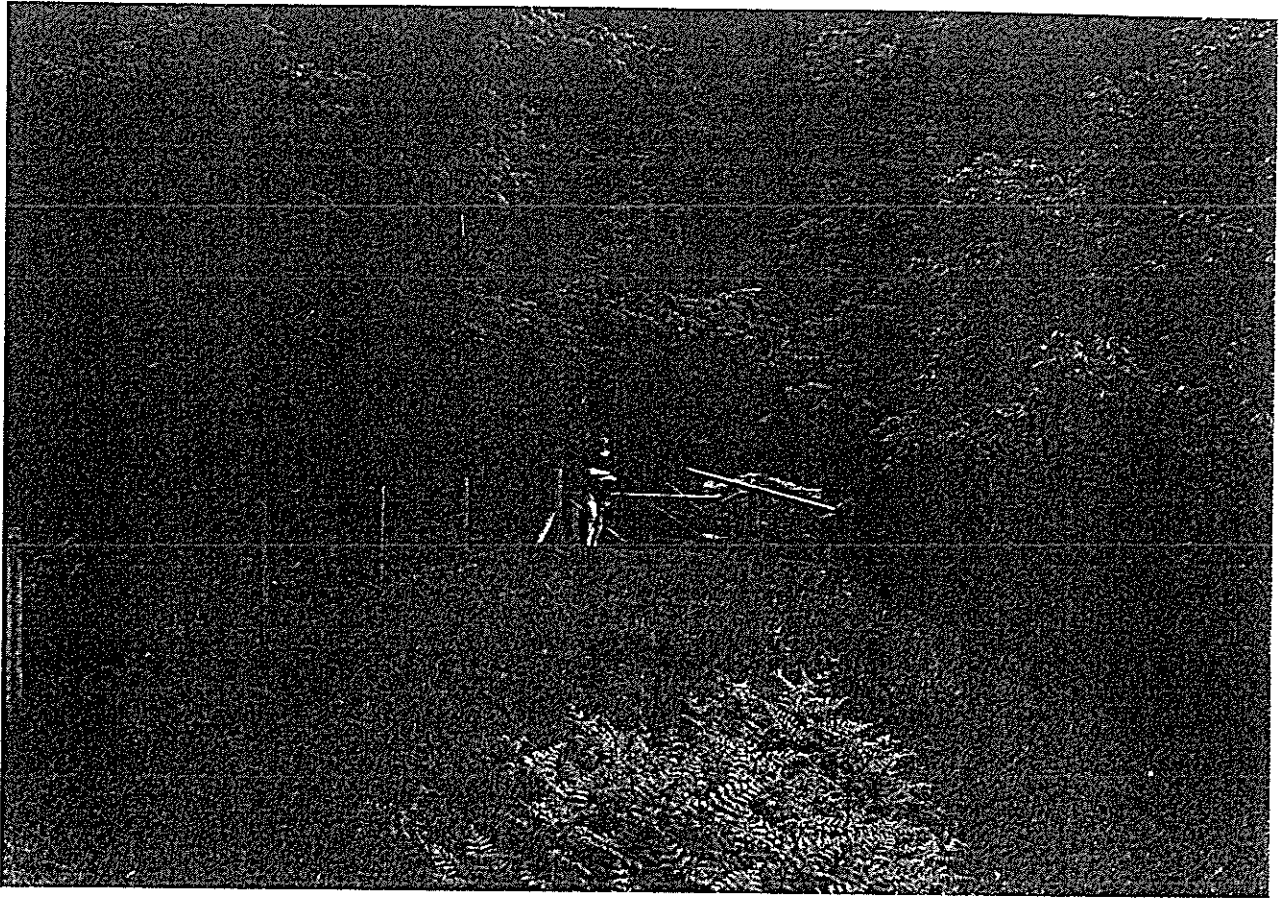
5

5. The approach track to the northern side of the bridge.

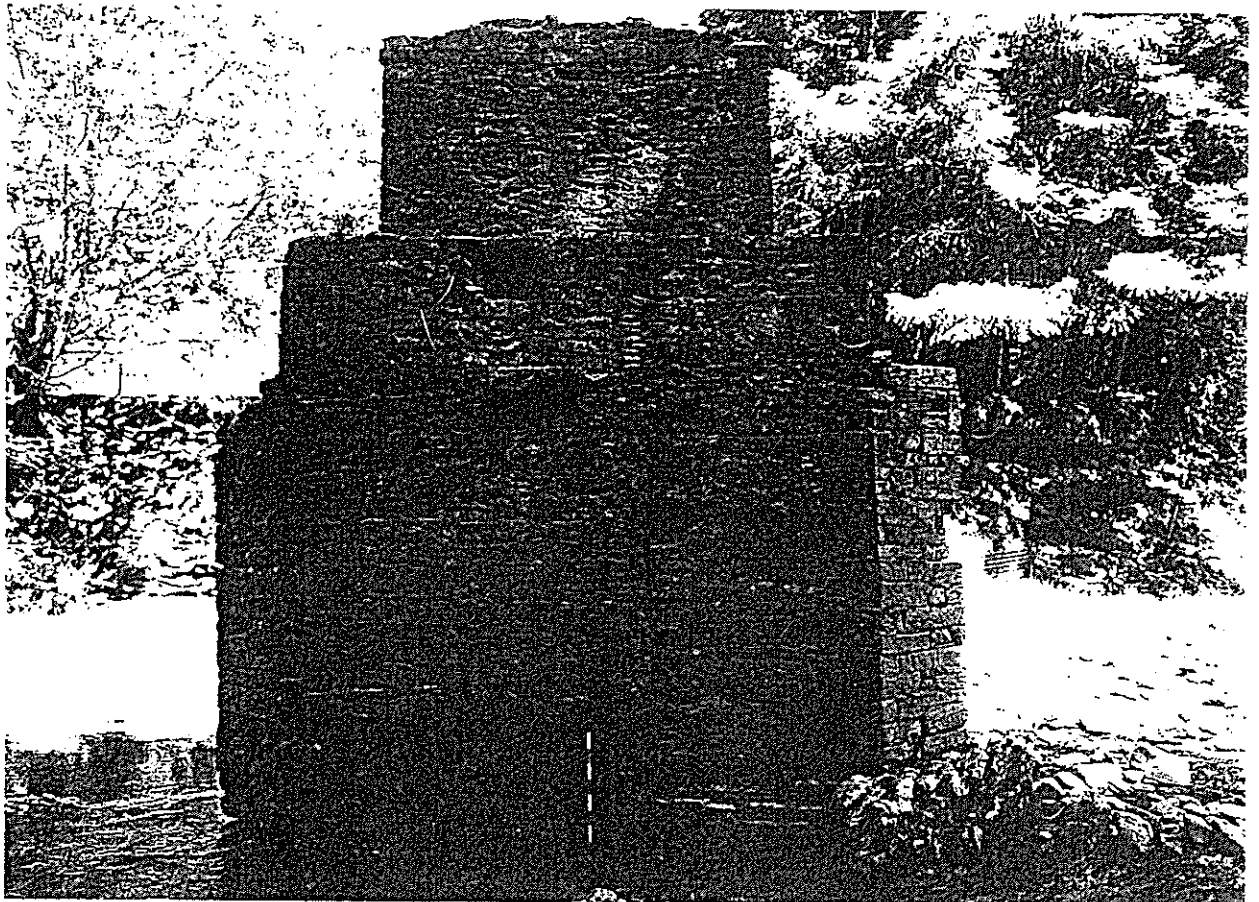
6

There has been some subsidence of the western part of this structure causing large cracks to open up at the junction of the phase one/phase two piers. On the south side the crack continues above the height of the phase one pier where it has been filled with water-worn stones. On the north side the crack has been partly filled with cement.

6. Central pier, south elevation.

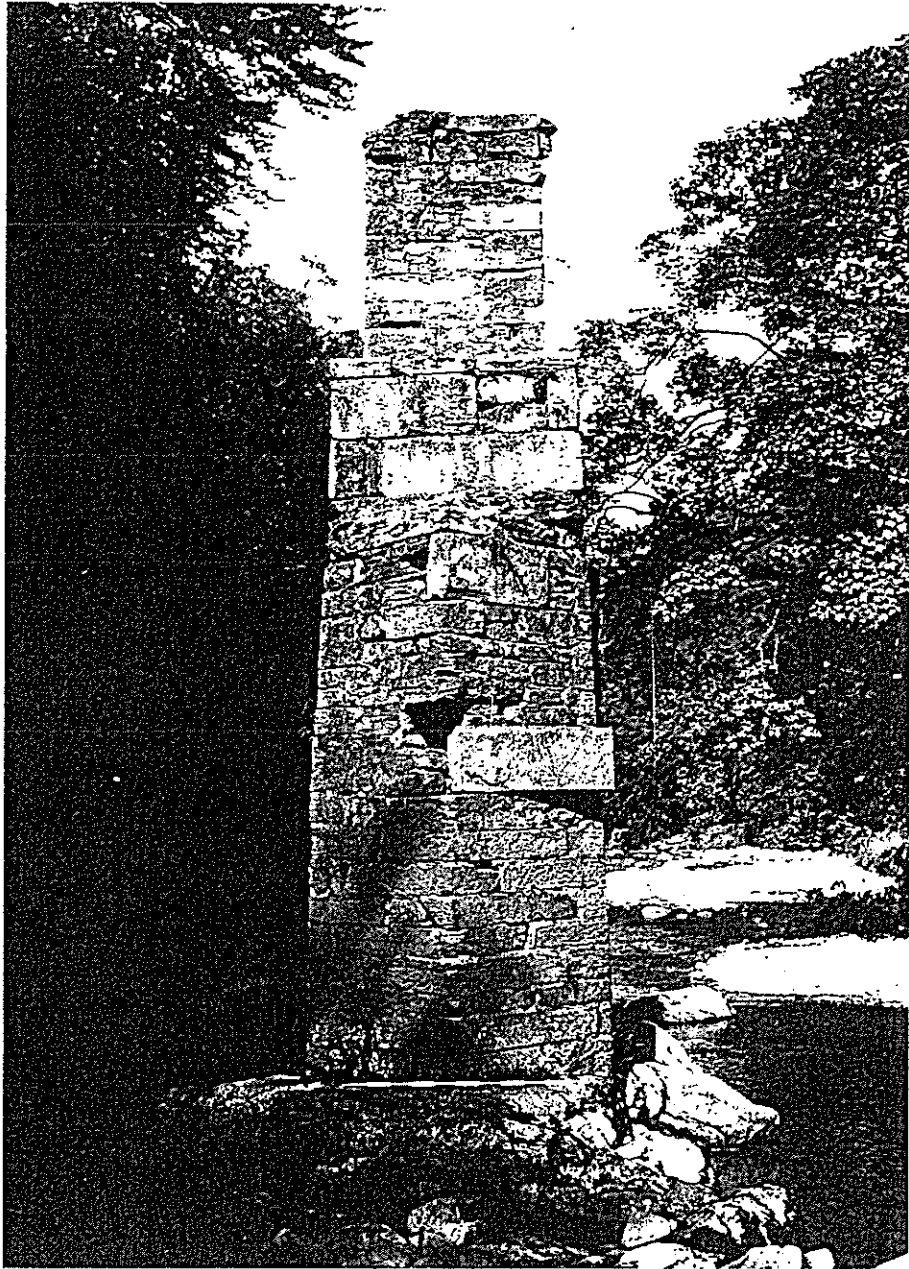
7. Central pier, upstream cutwater.

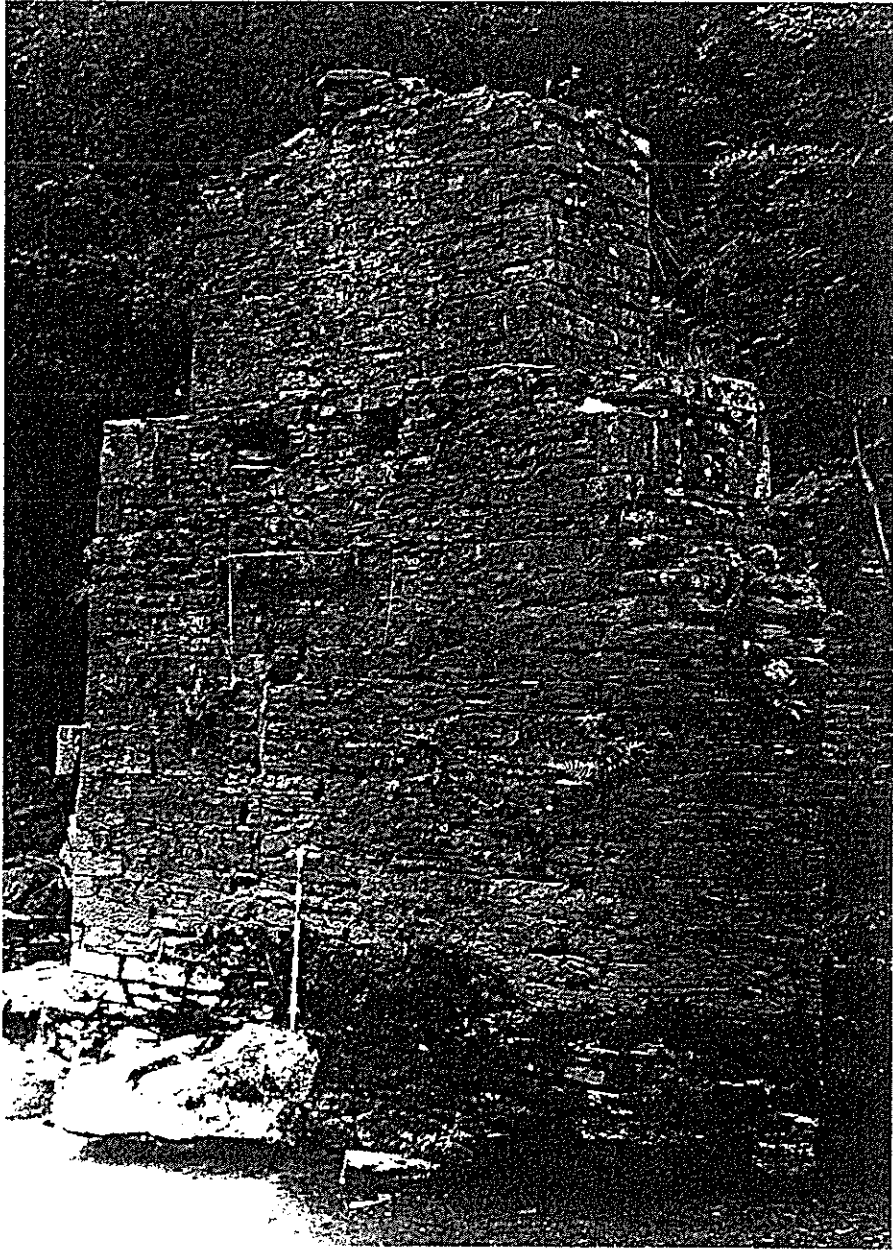
8. Central pier, north elevation and downstream cutwater.
