**APPENDIX II: ST. ISHMAEL, CARMARTHENSHIRE,  
DESERTED MEDIEVAL VILLAGE (SN 2891 2086)**

**ARCHAEOLOGICAL INVESTIGATION**

*As part of the Arfordir Project, a small scale archaeological investigation was undertaken of the deserted medieval settlement at St Ishmael, Carmarthenshire (NGR SN 2891 2086). The site was first identified following an episode of coastal erosion in the late 19<sup>th</sup> century and has subsequently been noted and monitored on an intermittent basis, which has highlighted how the site has been eroded over many years. Although it lies at the very edge of the strand line of the highest spring tides, and is mostly effected during stormy weather, considerable portion of the site has already been lost, and it is anticipated that with climate change and the predicted sea level rises the site will be subject to more frequent erosion and eventual destruction.*

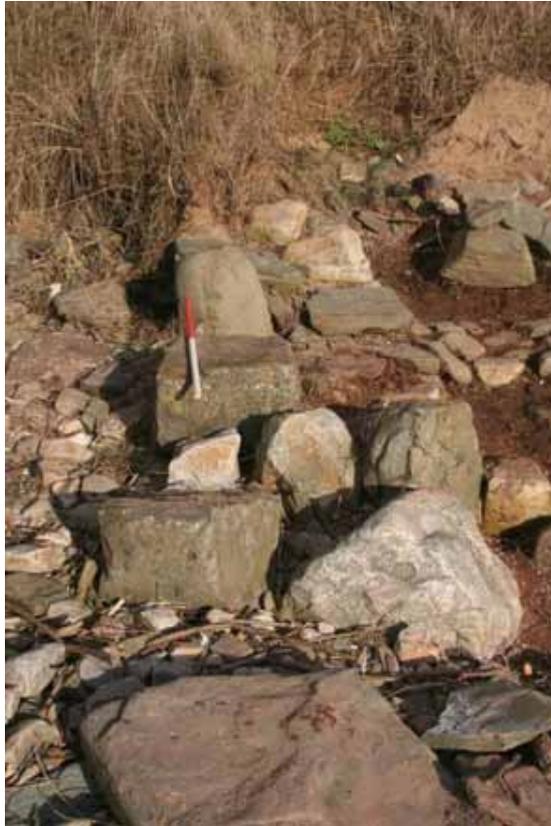
The northern most wall of (102) was aligned southwest to northeast and was partially concealed beneath beach stone further into the sand dunes. It comprised semi-dressed laid stone blocks, some of substantial size (0.4 x 0.4 x 0.3m), and measured 3.16m in exposed length, 0.94m in width and survived to a maximum height of 0.75m. The wall was neatly faced, with a rubble core. Erosion had removed most of the rubble core of the wall, and some smaller facing stones. Patches of clay visible where the wall entered the sand dunes suggest the wall had been clay bonded. One upright water worn stone within the wall, which may have been eroded in-situ by tidal action.

Photo 2: Wall (102) facing southeast

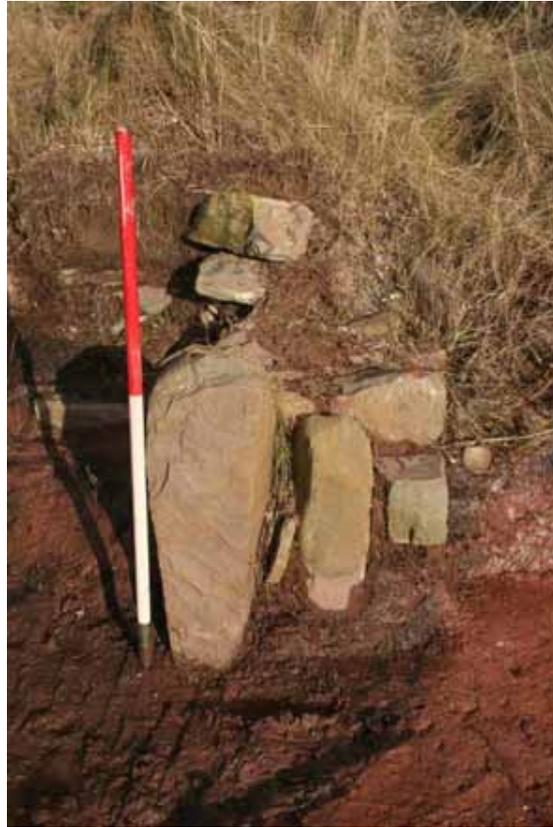
A 1.1m length of a second northwest to southeast aligned wall (103) was clearly visible 5.3m to the south of (102). Together, these walls appeared to define the area of a room. Wall (103) was narrower, measuring 0.59m in width. It comprised roughly dressed stone blocks on the outer faces, with a rubble core. It

was laid directly onto the natural clays and was either drystone or clay bonded. A number of stones laid on end at its western end of the wall perhaps marking one side of a door way.

Photo 3: Wall (103) showing upright stones at the northwestern end of the wall, facing southeast (Pit [109] visible beneath)

Two other features which pre-dated Building 1 also recorded. The first (cut 110) was a large circular pit measured 1.6m x 0.9m in width, situated underneath wall (103) (Photo 3). The fill of the pit (109), was very waterlogged and consisted of lenses of clay alternating with layers of very dark organic matter containing fragments of wood, charcoal and small twigs. The pit had been previously identified and partially excavated by Owen Harris, and two sherds of pottery dated to the 14<sup>th</sup> century were recovered from it. Although the depth of the pit was not ascertained, it must have been at least 0.5m depth, as it was visible directly below the floor level (108) within the structure, and cut through natural clay beneath. The pit had been partially eroded away with tidal action, visible in the clay natural sloping steeply to the west.

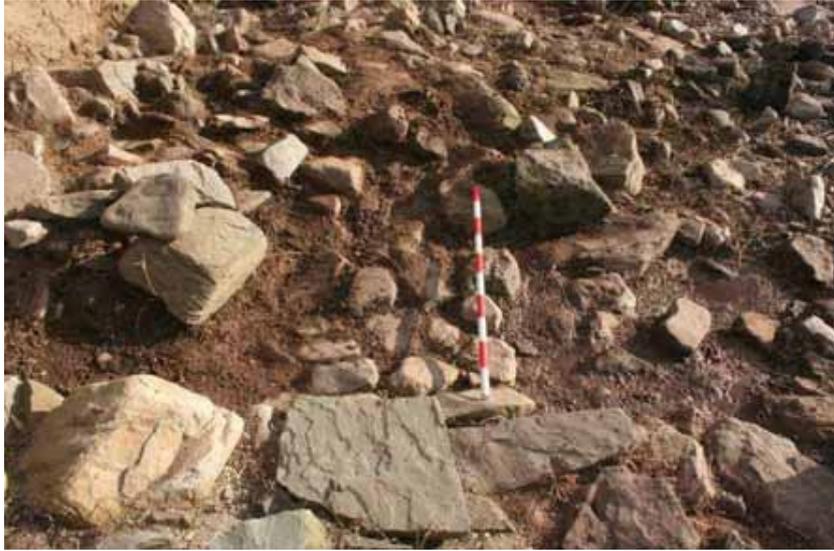
Two possible areas of flooring were present between wall (102) and (103). These included a cobbled surface adjacent to (103), comprising a number of similar sized cobbles laid to form a relatively flat surface (107). Only an area of approximately 2m x 1.4m in size could be clearly defined, although the floor may have been present sealed under a collapse of rubble and sand dune material. The second floor (108) was located closer to wall (102) and was less substantial and well formed than (107), probably due to erosion. The floor area survived to approximately 1.6m x 0.9m in size. Both floors were set into the natural underlying clays, and evidence for small pebbles being packed between the gaps was noted.

Photo 4: Area of cobbled flooring (107) facing southeast

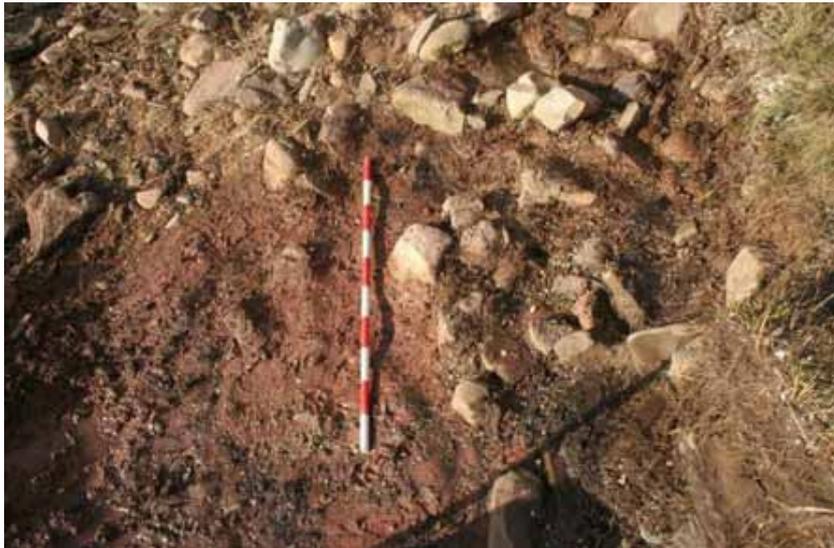
Photo 5: Area of possible flooring (108) facing northwest

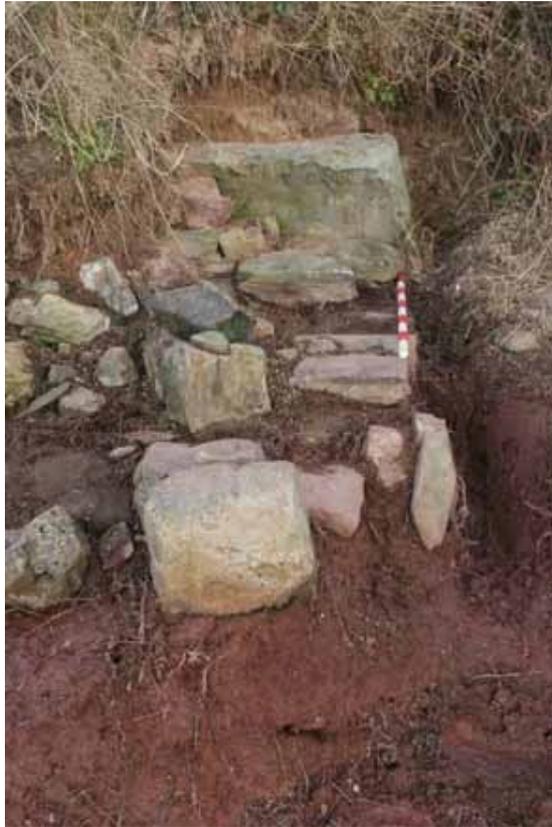
9.03m to the south of wall (103), a 2m length of Wall (104) forming the south wall of Building 1 was visible protruding from the base of the dune. The wall measured 0.60m in width. As with wall 103 it comprised larger roughly dressed facing stones, with smaller packing and rubble between and was either drystone or clay bonded.

Photo 6: Wall (104) facing northwest

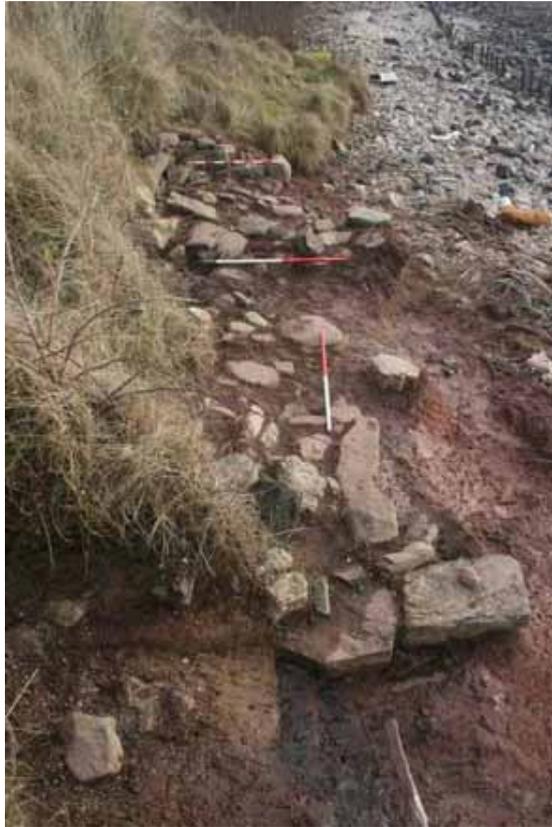
Two possible floor surfaces were located within the second room of the building. The most northerly (111), measured approximately 1.2m x 0.23m and was visible as a layer of fairly large and flat stones set into the natural clays. The majority of the floor appeared to consist of disturbed cobbles. A straight edge formed by larger flatter blocks was clearly visible in the northern part of the room. This edge, an apparent break in the floor, may suggest the presence of a drain, or may be the surviving base of a wall dividing the room into two parts. There was no evidence for any floor in the northern part of this room.

The second floor (112) is likely to have been the same as (111), but was no longer physically connected due to later disturbance and erosion. This floor was made of rough cobbles set into the natural clays, measuring roughly 1.01m x 0.35m, but heavily disturbed.

Photo 7: Showing edge of floor (111). The remainder of the room is visible to the rear, with floor (112). South wall (104) is located adjacent to the far scale

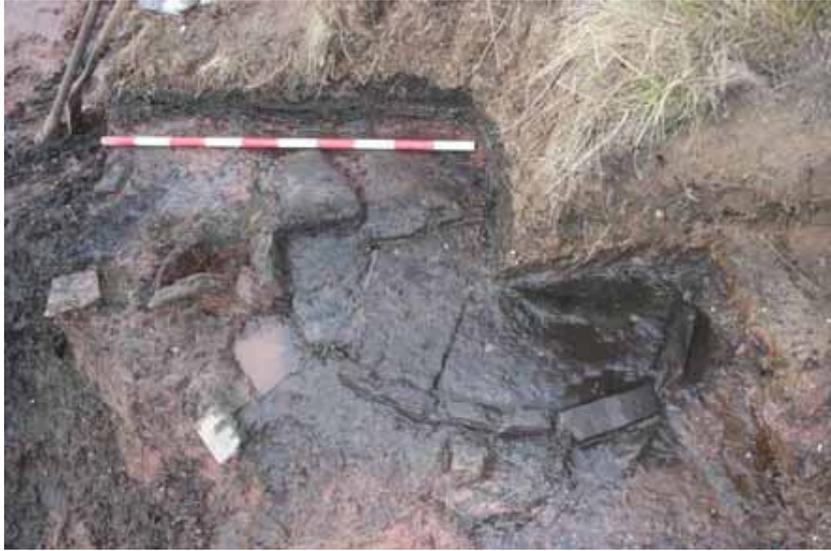
Further investigation to the south of wall (102) and floor (111) revealed a an oval hearth made neatly cut and fitted flat stone slabs (117), edged by smaller stones set on end (118). The hearth measured approximately 1.05m along its longest length (northwest to southeast), and with a visible width of 0.7m. The hearth was located at a very similar level to the floor (111), but there was no physical connection between this or any other visible floor surface. The hearth had evidently been subjected to heat and directly above it was a compacted burnt layer (119/123) around 2cm in depth and containing charcoal and fragments of shells. To the west of the hearth two stones had been placed edge-on, forming a triangle, with the pointed end pointing away from the hearth. They had evidently been specifically placed, but their function is unclear. Perhaps with others on other side of the hearth (not excavated), they may have held a wooden or metal post from which skillets could be suspended.

Photo 8: Hearth within Building 1, flat slabs (117) and edge stones (118).

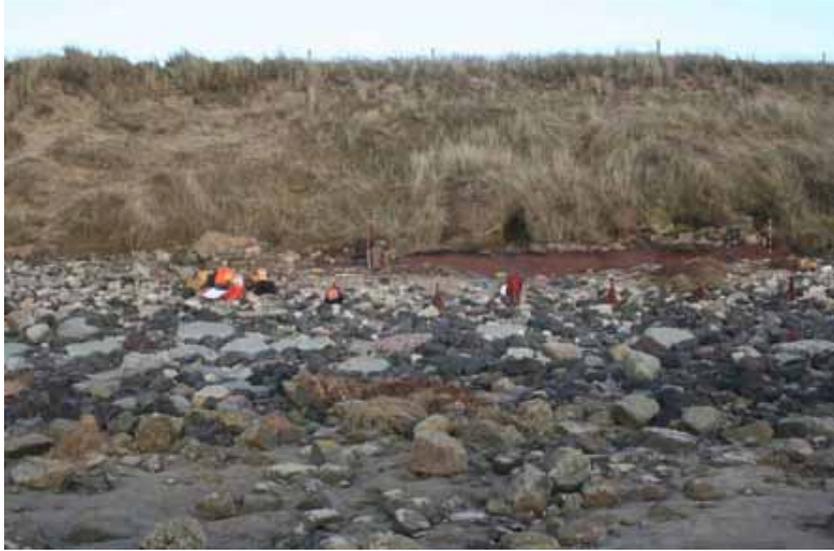
Due to the natural ground levels and patterns of erosion, the majority of the northern room of Building 1 was at a similar level to the surrounding beach level. Far more small stones were present on the beach to the north covering the underlying clay natural geology. Moving south along the building, the height of exposed clay at the base of the sand dune increases. All of the archaeological remains seen within the site were set upon, or cut into this clay (Photos 9 & 10).

Photo 9: View east of Building 1 showing increase in depth of exposed clay natural at base of sand dune, walls (1002), (103) and (104) are marked with vertical ranging rods.

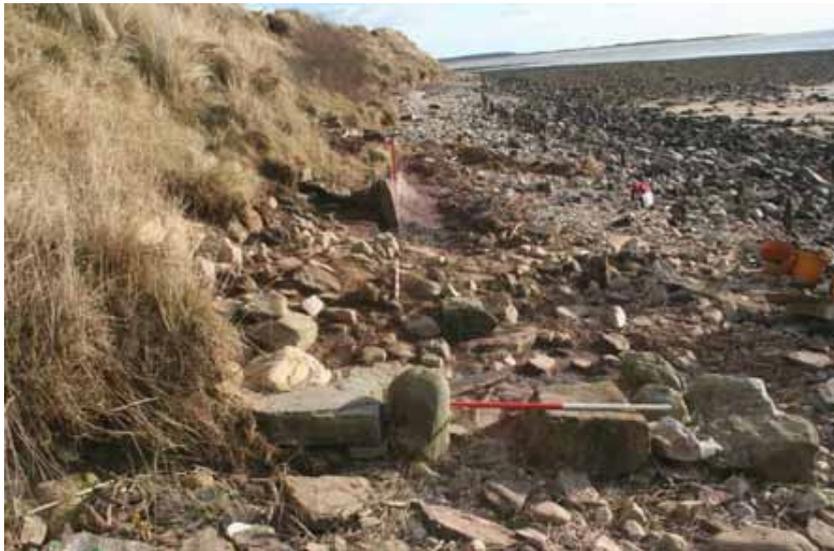
Photo 10: Overview of Building 1, with wall (102) in foreground, wall (103) by next scale bar and wall (104) beyond

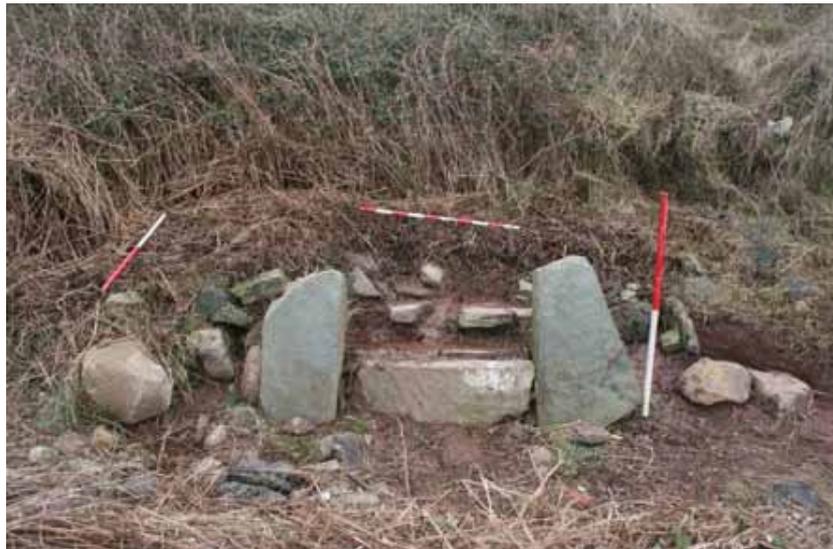
The most obvious feature at the northern end of the building comprised two upright stones spaced 0.83m apart, with a flat stone lying between them. This arrangement (201) seemingly forms a doorway into the building (photo 11 & 12).

Photo 11: Wall (200) to left, with doorway (201) visible in centre of photo

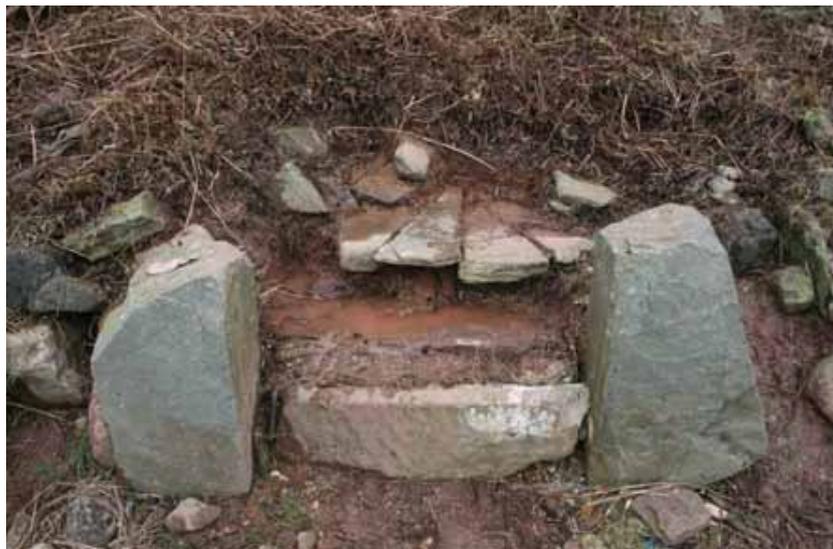
The level of the threshold stone corresponded with a flat stone lying behind it and presumably within the building. Behind this was a step up to four flat stones that had been laid to form a rectangular surface (one stone had been removed in the past, but could be fitted back into the missing location easily; photo 12).

Photo 12: View of doorway (201), with missing stone of second step replaced.

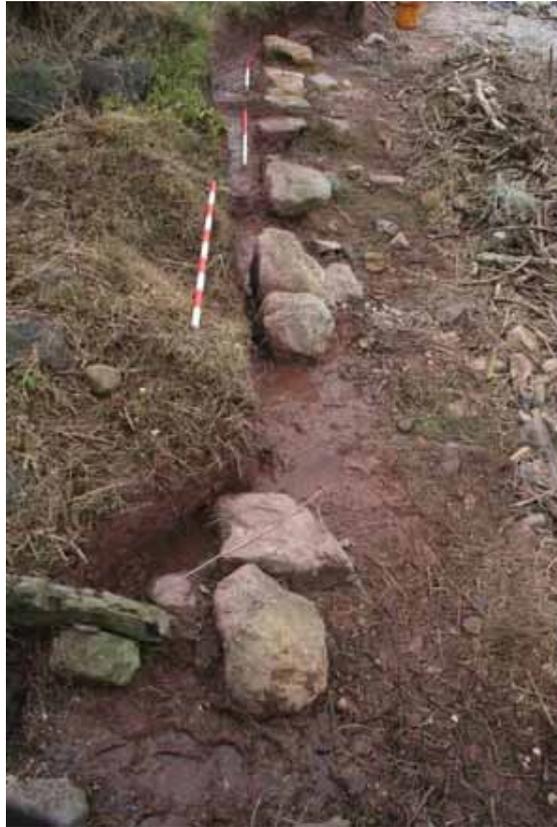
Photo 13: Wall (205)

Doorway (201) was apparently located on the western side of the building, set within wall (205). This wall survived south of the doorway, for a length of 6.8m. It comprised a single length of medium sized stone blocks set into the natural clay (photo 13). It would appear that only the internal facing stones of the wall survived, a single course in height, with all bonding stones, rubble core and outer facing stones having been previously eroded away. At the southern end of the wall all evidence of the relationship between this and the two southern walls of the building have been lost to erosion.

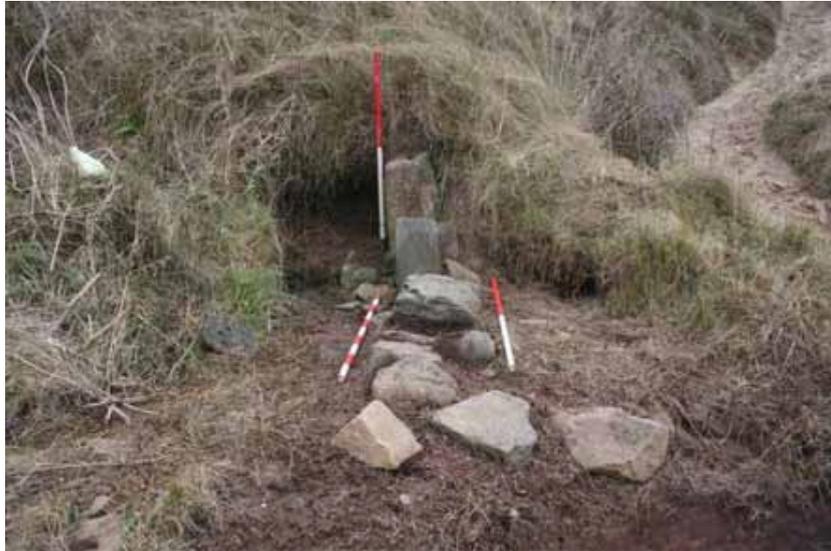
Wall (202) protruded from the sand dunes 9.65m to the south of wall (200). It measured 2.5m in exposed length, with a width of 0.6m. The wall was badly eroded at the western end, but some large upright blocks were present nearer the sand dune (photo 14). The wall was either drystone or clay bonded, comprising larger blocks, roughly dressed on the outer faces, with a rubble core. A number of large water worn stones were also present in the wall.

Photo 14: Wall (202)

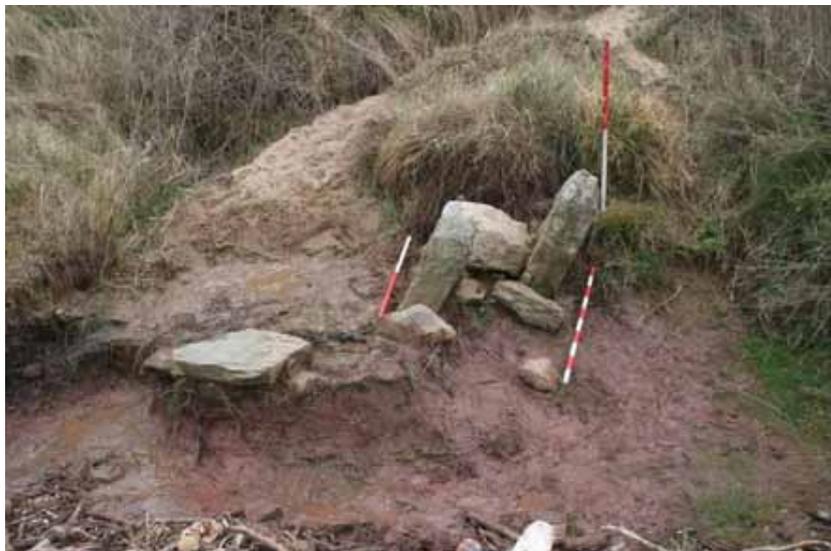
The southernmost wall of the building was (203), consisting of a 1.55m length of wall protruding from the dunes, of around 0.65m width (photo 15). The wall lay 3.7m to the south of (202, and was similar in construction as it comprised a number of large upright blocks on the outer faces of the wall. The upright stones were noticeably leaning over towards the south, presumably as a result of pressure from movement within the sand dunes (an area of sand slip is evident directly adjacent to the wall).

Photo 15: Wall (203), showing outward lean of stones

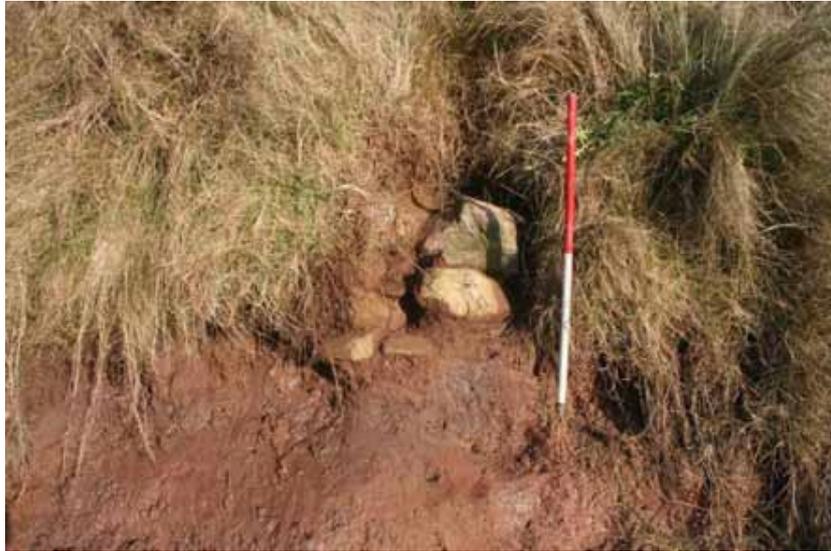
The probable northern wall of the building (300) was comprised of medium sized stones, roughly coursed, surviving to a height of 0.55m. The wall was around 0.5m in width. The stones included angular blocks and water worn stones. No bonding material could be discerned.

Photo 16: Wall (300)

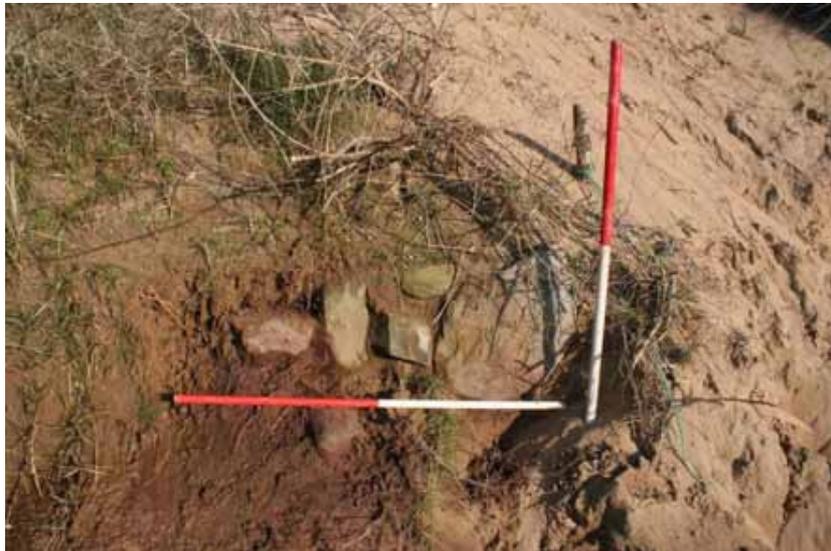
This building is the only one where a standing stretch of an eastern wall has been revealed. The side walls of the structure (400) and (401) comprised roughly coursed angular blocks of medium and small sizes. The eastern wall of the structure, comprising medium and large stones was also roughly coursed using the varying sized blocks. Again the walls were set upon or into the underlying natural clay. This building was narrow, c.3m wide and only survived to a length of 1m into the dunes. No floor surface was revealed in the building, although it is possible that the floor was directly upon the underlying natural clays.

Photo 18: Wall (400) and adjacent collapse of sand dune

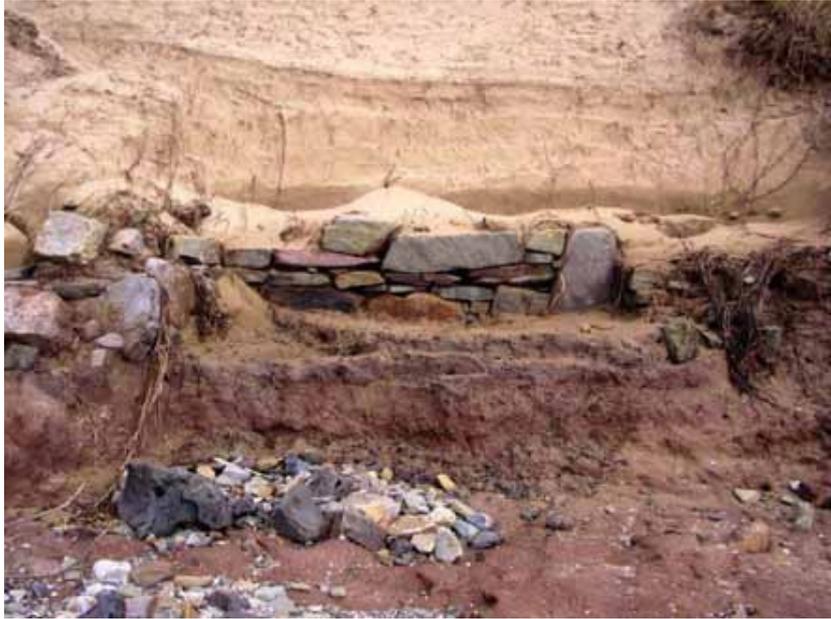
Photo 19: Previous photograph of area, with wall (400) to left, wall (401) to right (hidden by vegetation) and wall (402) to rear. (Owen Harris photograph)

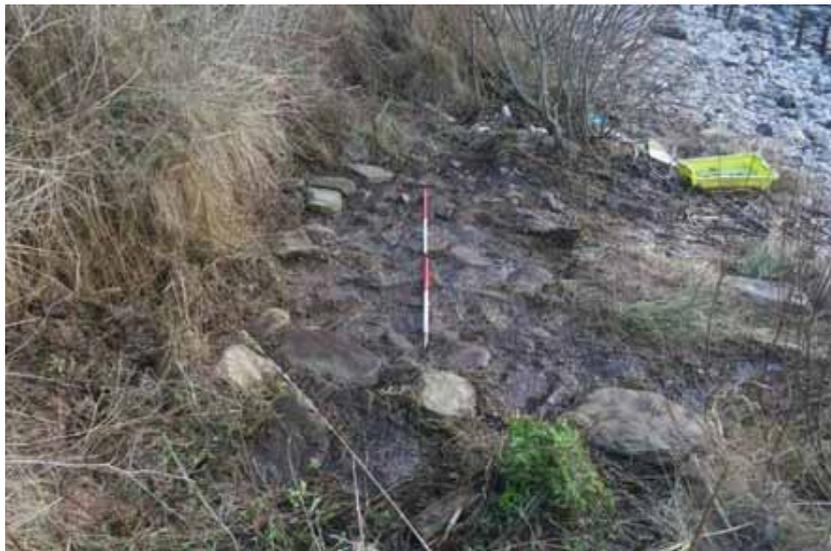
The areas visible between Buildings 1 and 2 and between Buildings 3 and 4 are considered to represent yards, as there is no evidence of walls around them. The first yard area lies around 10m to the south of Building 1 (photo 20). It comprises a number of flat sandstone slabs laid on the natural clay to form a rough surface. An area of the surface approximately 3.5m x 1.6m is exposed, with more likely to be buried beneath the dunes to the north, south and east.

Photo 20: Yard surface between buildings 1 and 2

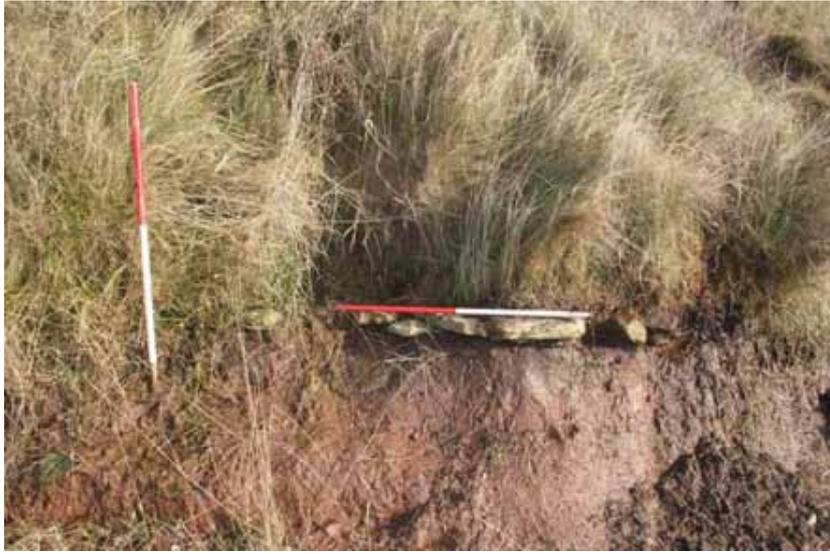
The second yard area lies 4m to the south of Building 3, visible as a small stretch of stones 2m in length sitting on top of the clay within the sand dune face. The top of the surface was only partially exposed. The stones in the floor were smaller (most around 0.15m square), and well laid to form a fairly level surface. The surface had been visible on previous visits, when a possible feature was also noted underneath cutting through the clay in the exposed section. This feature was not clearly identified during these investigations and not yet been recorded further.

Photo 21: Yard surface between Buildings 3 and 4

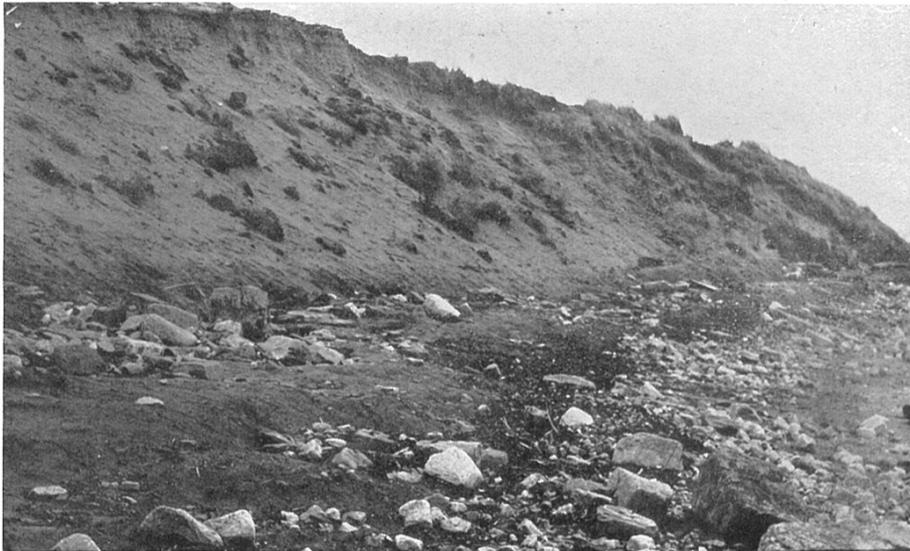
The RCAHMW survey of 1912 includes a description based on the earlier account as well as two photos of the site (photos 22 and 23). These show the dunes, with stone work exposed at the base on top of the same clay natural as was seen during the recent investigations. What is most evident in the two photos is the extent of clay natural exposed (possibly around a 3 or 4m band), with the sand dune set much further back in relative terms to how it lies at present. Vegetation is only just growing back on the edge of the dunes in the photos, indicating that a substantial part of the sand dune must have been stripped away in 1896.

Photo 22: RCAHMW photograph from 1912 visit to the site (RCAHMW 1917)

Although no clear remains are visible in the first photograph, the extent of stone work at the bottom of the dune is indicative of former structures. In the second photograph a substantial part of a building is visible exposed on top of the clay natural. The building appears to be short-end-on to the sand dune (similar to Building 4 of these excavations) with a substantial part of the southern and eastern walls exposed. The coastline has changed considerably since this time, and certainly the building in photo 23 has been completely eroded by now. Both photographs were taken over 10 years after the removal of the 40 to 50 cart loads of stone, and subsequent episodes of erosion over those years. The relative lack of stone across the clays in photo 20 may be indicative of this stone removal and erosion. The implication is that the stone of the building in photo 21 would have been removed if it had been exposed in 1896.

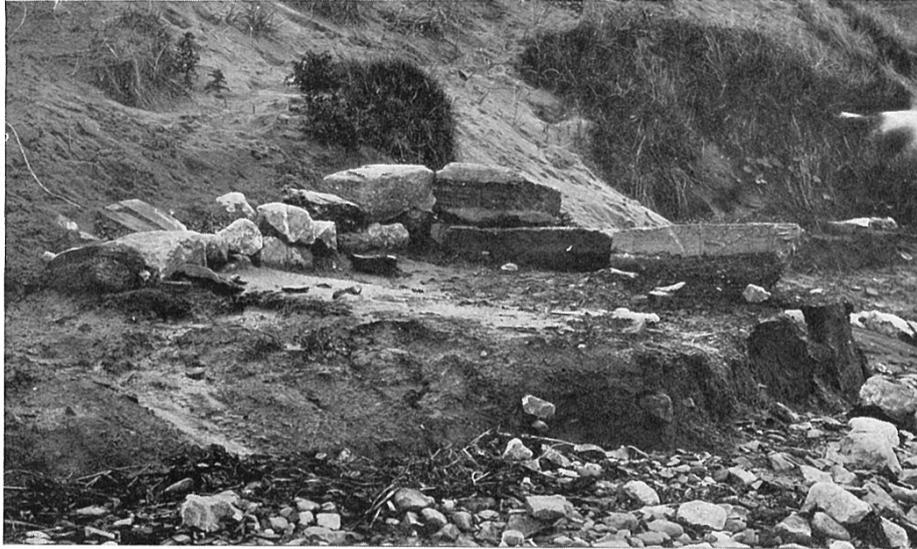
Photo 23: RCAHMW photograph from 1912 visit to the site (RCAHMW 1917)

Other drawings in the collection are labelled as "*the corner of a building*" and "*an erect dressed stone with hole*". The corner of the building may well be that seen in photo 23. The dressed stone with a hole appeared to have been over 1m in height and presumably the hole would have once housed a door or gate hinge. Such a stone is visible in 2010 lying below the high tide mark. The final sketch is of a stone well head described as being sand filled, but unfortunately this was inadequately located and has not subsequently come to light (although local residents do claim to have seen something similar quite far out on the adjacent scar). It is thought that all of the remains seen in 1912 have now eroded away, so it is possible that a number of the larger seemingly dressed sandstones that lie below the high tide line may be some of those recorded in 1912.

Looking at the 1912 photographs it is evident that the natural clay layers exposed beneath the dunes have since eroded away, and it is estimated that this would be about a 4m wide strip (based on the size of the exposed stones and height of the sand dune). This estimate may be quite conservative, as it assumes that the base of the dunes has not retreated back any further.

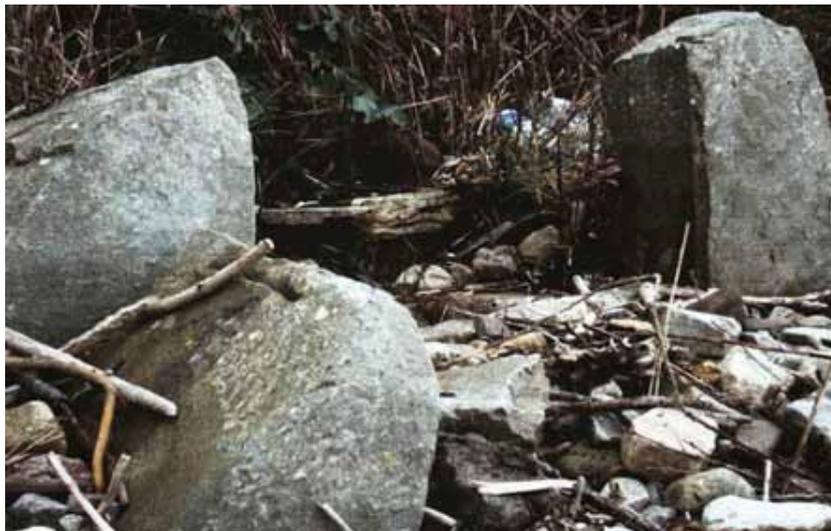
Obvious changes to the site have taken place in the last few years. This has included the recovering of Building 4 by the sand dune following its exposure during a storm in 2007, as noted above. The threshold of the doorway into Building 2 has evidently been exposed in the last few years and is likely to be dislodged in the near future. The entire length of the western wall of Building 2 has already been eroded, such that only a few of the larger stones on the inside face of the wall survive, but these will not last for very much longer.

Photo 24: Doorway into Building 2 in October 2007. Note that there is a large stone in front of the door which is no longer present, and that the ground level corresponds with the top of the threshold stone. (Owen Harris)

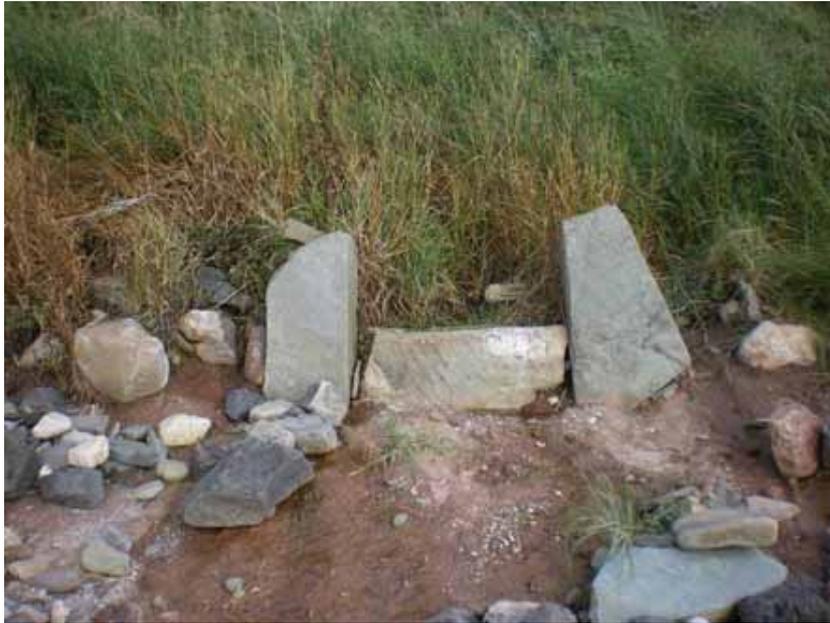
Photo 25: Doorway into Building 2 in September 2008, note that the threshold stone and adjacent uprights are completely exposed to their base (Owen Harris)

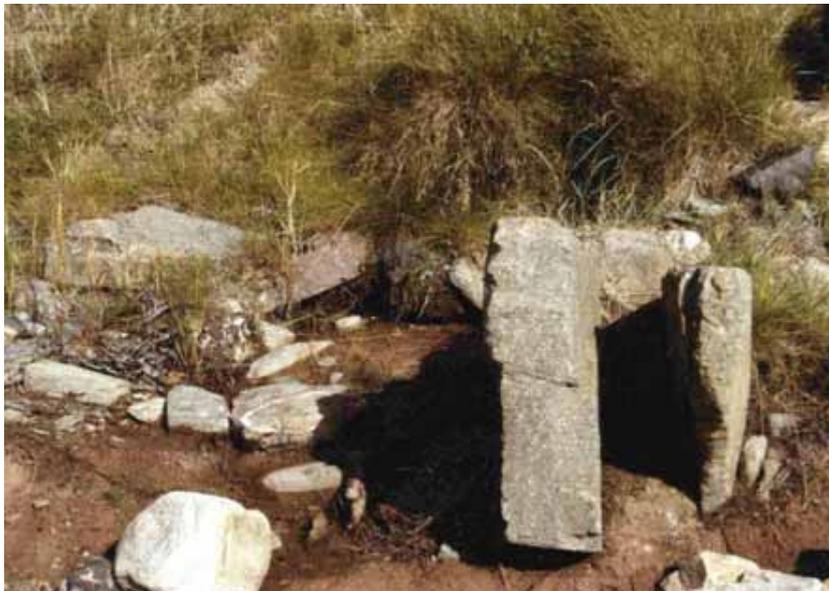
In 2007 one of the walls within Building 1 had two large upright stones at its western end. Neither of the stones now survive, but they may be present on the beach in front. It is unclear which wall these stones were associated with, or whether they were actually part of a western wall that has since been eroded.

Photo 26: Upright stones seen in 2007 within Building 1 (Owen Harris)
