**HAFOD
THE LADIES' WALK
ALPINE MEADOW SECTION**

ARCHAEOLOGICAL INVESTIGATION

FEBRUARY 1996

PROJECT RECORD No. 32112

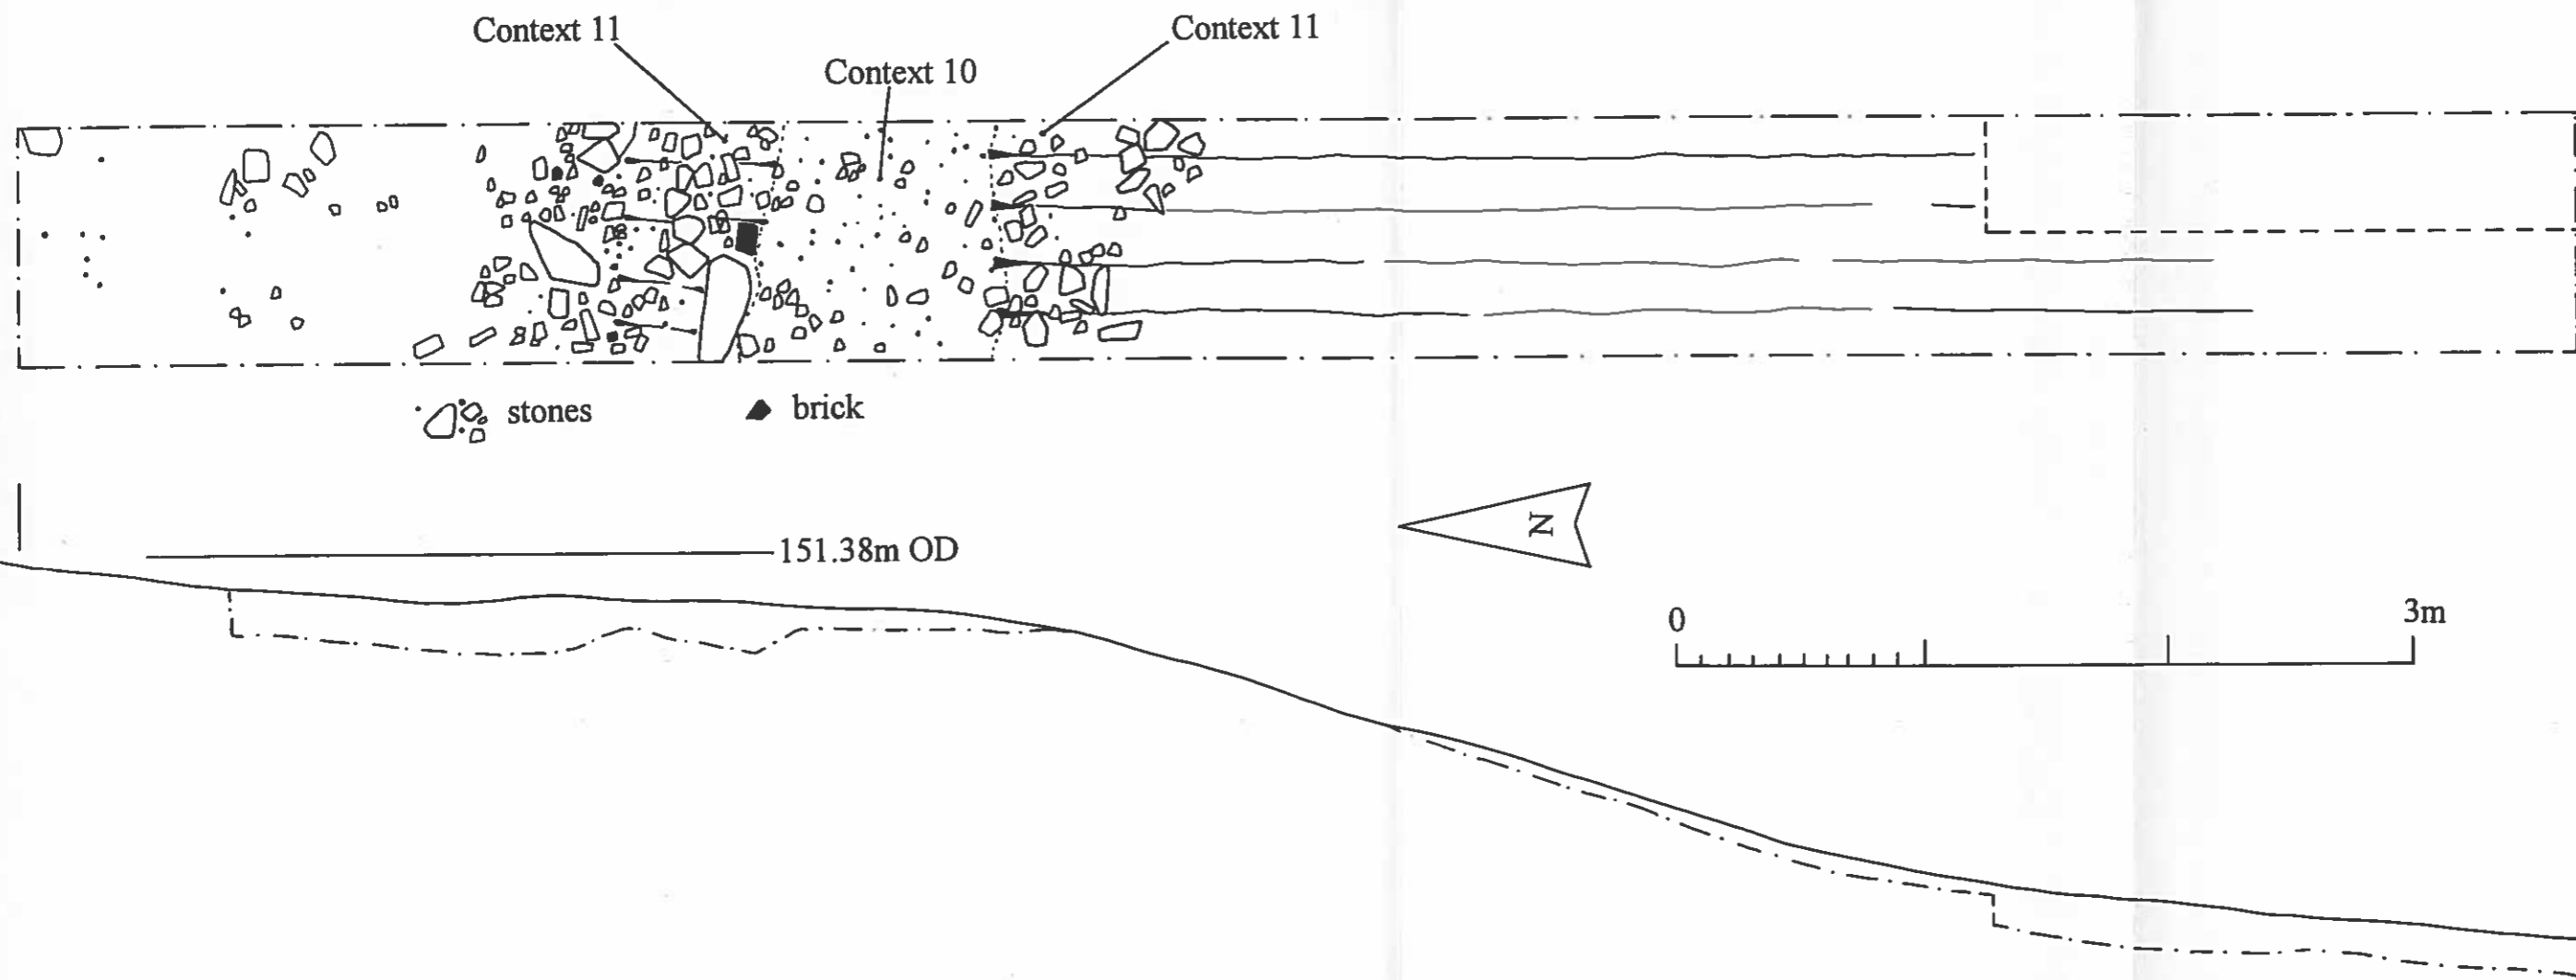
Figure 7. Trench 2: plan and west-facing section

HAFOD · LADIES' WALK · THE ALPINE MEADOW
TRENCH 2 PLAN AND WEST-FACING SECTION

Trench 2. Figure 7 (SN 7641 7304)

Excavated across the terrace cut into the valley side at the western end of the Alpine Meadow at the point where the terrace begins to slope down to the meadow, this trench measured 10.5m by 1m. Only topsoil and superficial layers were removed during the excavation.

On the terrace, 0.10-0.20m below leaf mould and soil accumulation, a well-defined band of stone was apparent. It was possible to divide this feature into two distinct though intermixed contexts:

Context 10. The upper surface consisted of angular stones and shale fragments on average between 40-70mm with a scattering of smaller angular stones and some brick fragments, set in compact silty-clay soil matrix. Roots had disturbed

Context 11. Below 10. A layer approximately 2.4m wide with well-defined edges, particularly on its northern side. It comprised 70-80% stones set in a silty-clay soil matrix. These stones consisted of rounded cobbles 60-100mm, slabs up to 130-150mm, smaller shale fragments, sub-rounded small stones, occasional small stones and some small fragments of brick. This layer seems to have been laid to form a slight camber. A strong east-west linear depression or rut lay towards its northern side.

The evidence from Trench 2 is conclusive: the terrace at the western end of the Alpine Meadow is the route of a path/track. A very rough metalled surface, possibly of two phases, had been laid over the artificially created terrace in order to provide a firm surface. The substantial nature of the metalling coupled with possible rutting suggests that this path/track may have been designed and used by wheeled traffic as well as pedestrians. All the materials for the metalling could have been collected in the near vicinity of Trench 2, with, as Palmer (1996) suggests, the brick and oolitic limestone gathered from the site of the Cold Bath, a few hundred metres to the west. This may indicate that waste stone chips and brick fragments from the construction of the Cold Bath were used in the make-up of Johnes' path or that the path was repaired at a later date using materials from the disused and dilapidated bath. It seems likely that these path surfaces were not vigorously maintained; a surface of soil was allowed to accumulate over them.

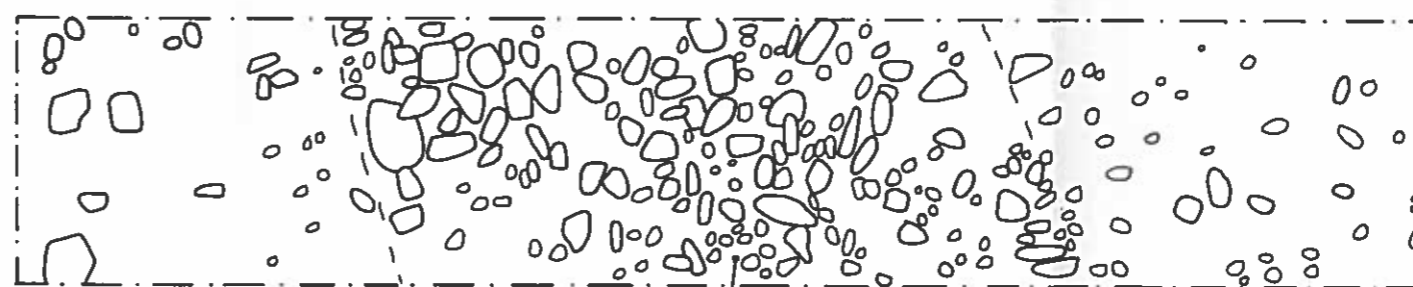
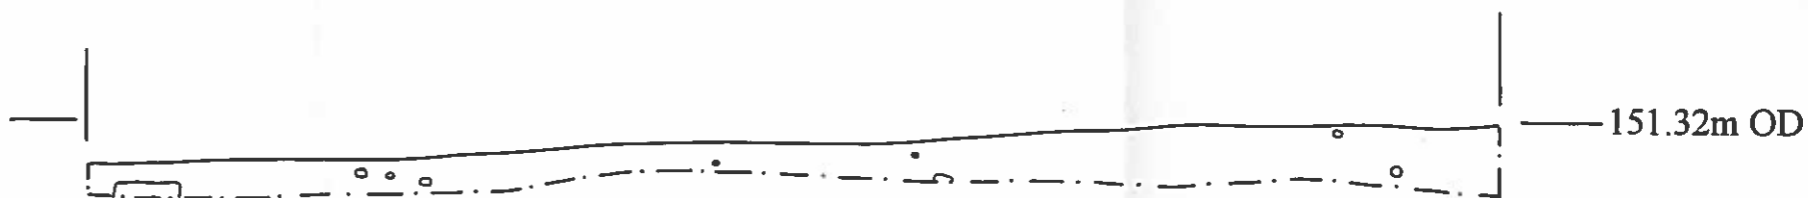
Figure 8. Trench 1: plan and west-facing section.
Trench 3: plan and east-facing section

TRENCH 1 PLAN AND WEST-FACING SECTION

TRENCH 3 PLAN AND EAST-FACING SECTION

Context 16

Trench 1. Figures 8 and 9 (SN 7647 7304)

An east-west band of stones (Context 4) 2.0 - 2.4m wide lay directly beneath the topsoil at an average depth of about 0.10m; some stones were directly below the turf. The band was very well-defined on its northern side; less well so on its southern side. The stones of this layer consisted of rounded cobbles, 150-250mm, and a few angular slabs, 100-250mm. The angular slabs were concentrated towards the edges of the stone band. The stones were set in a compacted silty-clay soil matrix. No other stones apart from those mentioned above were present in Context 4. Soil was removed down to subsoil level on the northern side of Context 4. The band of rested on silt; the upper surface of the fluvio-glacial deposits (Context 5).

All the evidence indicates that the band of stones is make-up for a path. There is no evidence of disturbance; it is therefore assumed that there was never a top dressing of smaller stones. The construction technique seems to be as follows: a band of

topsoil was stripped from the intended line of the path; cobbles were then laid to a level flush with the ground surface and packed in position with soil. Cobbles of similar size and shape to those used in Context 4 can be found in the underlying geological deposits (Context 5).

Trench 3. Figures 8 and 10 (SN 7654 7305)

A band of stones (16) approximately 2.3m wide ran obliquely across the trench south-west to north-east. This feature was identical to Context 4 in Trench 1; a deposit of cobbles with some angular slabs set in a compact soil matrix.

The oblique angle of the band of stones across the trench indicates that the path followed a course close to the foot of the valley side from Trench 1 to Trench 3, and, if the line of the path is projected, to the east of Trench 3.
