**HAFOD**  
**An archaeological investigation of**  
**THE LADY'S WALK S4**  
**and**  
**THE COLD BATH**  
Report no. 35903

May-June 1988

Commissioned by: Hafod Trust

Report by: K Murphy BA MIFA  
Archaeoleg Cambria Archaeology  
The Shire Hall  
Carmarthen Street  
Llandeilo  
Carmarthenshire  
SA19 6AF  
01558 823121

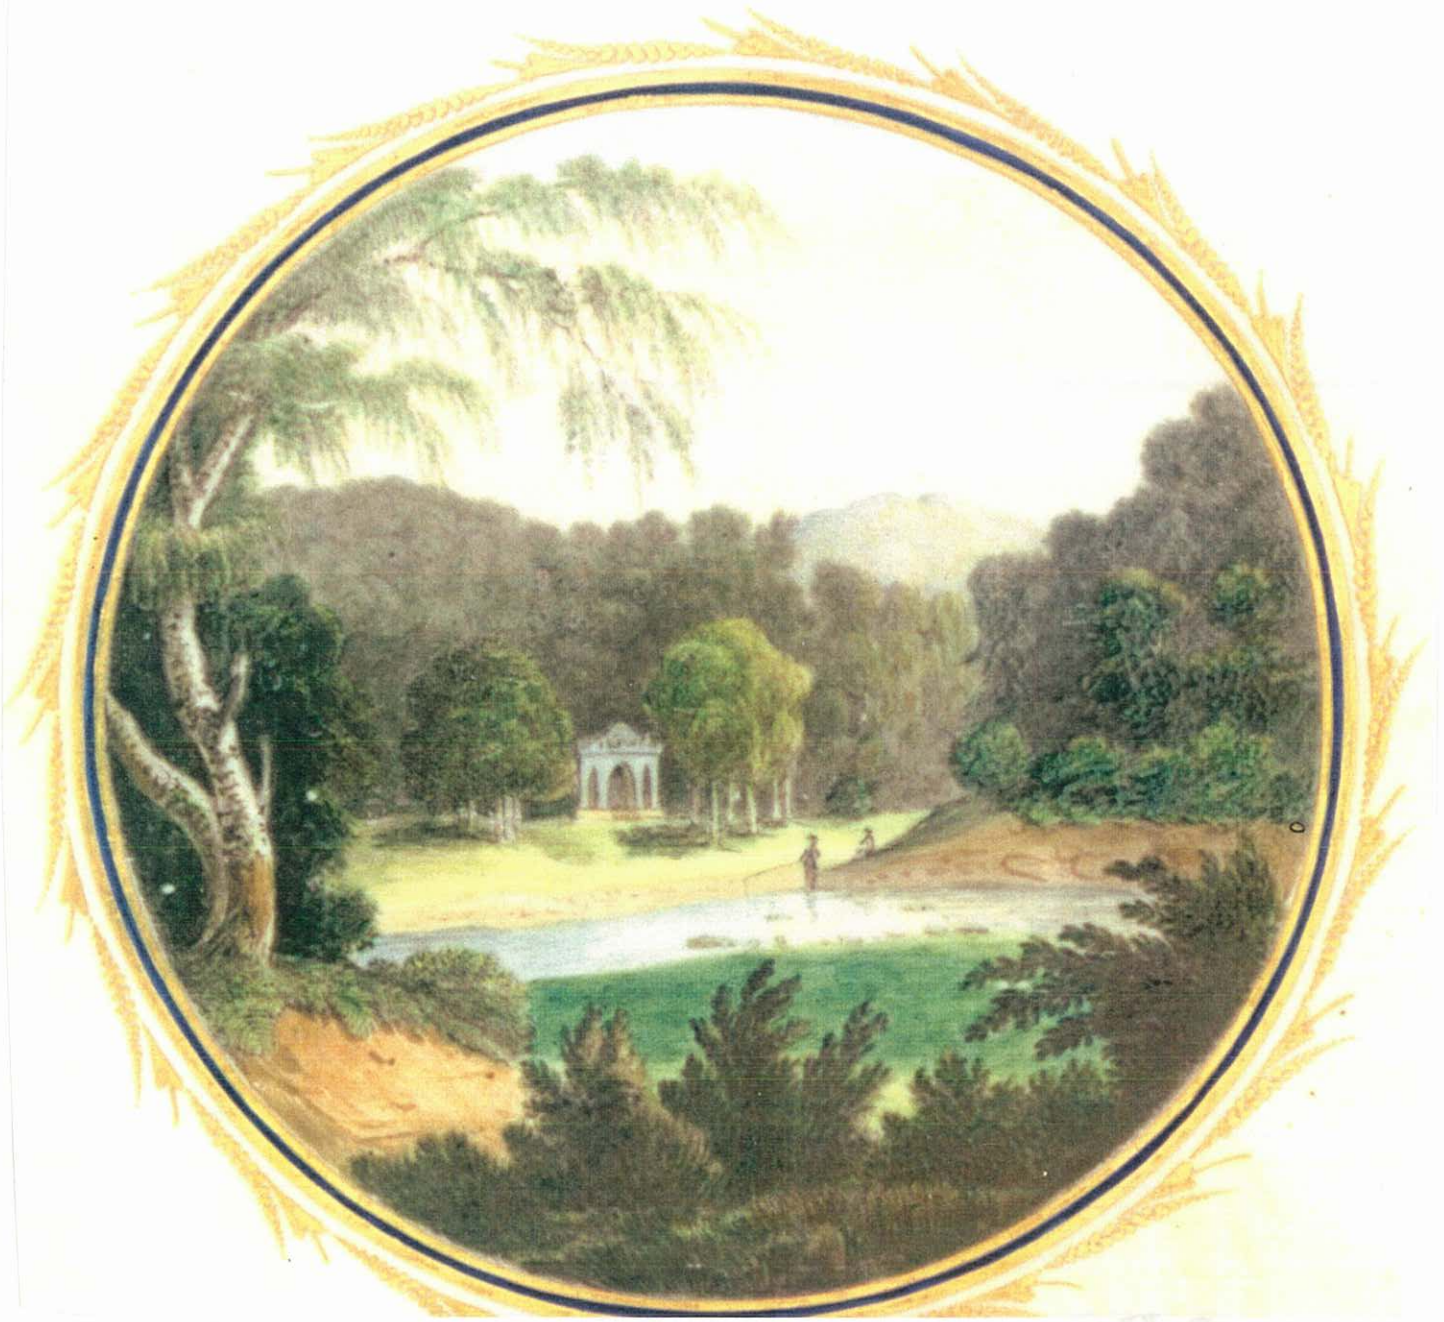
*Illustration 2. 'Cold Bath Hafod', on a square dish of the Hafod Service, 1788.  
Photograph copyright J. Watkin. Reproduced by permission of the Friends of Hafod.*

The Cold Bath was constructed within a south-facing open basin in which a small spring rises and flows down to the south towards the Ystwyth. Prior to excavation, several locations for the Cold Bath had been proposed. The most likely was represented by a spread of building rubble (Fig. 2) located on a slight earthwork platform. This site has been partially, but inconclusively, investigated by Phillips in 1994. The presence of an outflow of a small stone culvert (33099) to the south-west of this rubble spread strengthened the likelihood of this being the site of the bath, though given its position this culvert could drain from one of several locations. Slight indications which seemed to be of a small rectangular building on aerial photographs (Cambridge University Collection QI-38-42) indicated a second possible site. However, only photocopies of these photographs were originally available for inspection. On receipt of good prints it was clear that this putative structure lay on an impossibly steep slope. A third possible site lay where the terrace of the Lady's Walk opened out as it entered the basin across a slightly boggy area created by the spring. The map accompanying Cumberland's description (1796), however, shows the Cold Bath in none of the above locations, but on the northern edge of a path that runs down the steep valley side from the north-west. It has been assumed that this path is coterminous with the modern track, and as the valley side rises steeply from the northern side of this track it was considered that the map was incorrect as this would seem an impossible location for a building.

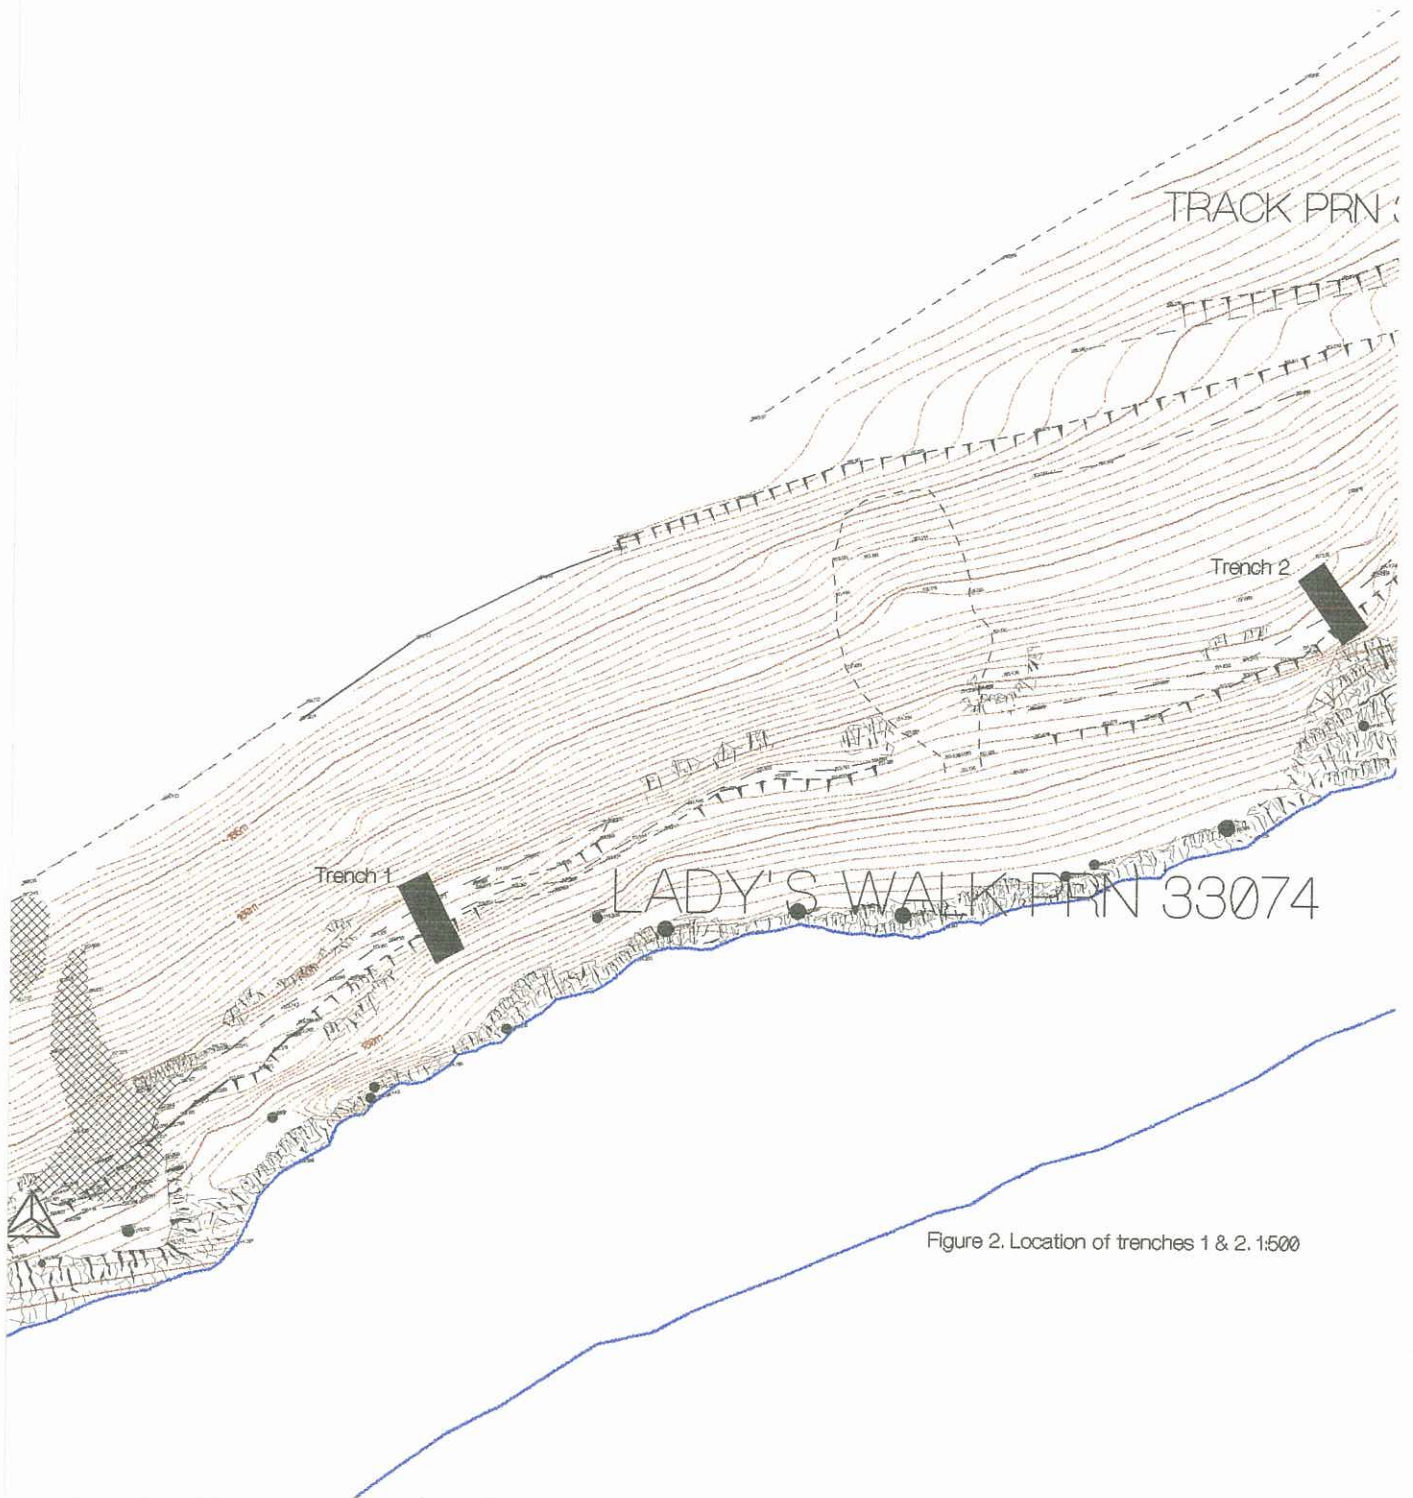
Figure 2. Location of trenches 1 & 2. 1:500

Figure 2. Location map of trenches 1 and 2.

(Figs. 2, 3 and 4; Colour photos. 1-6)

(Figs. 2, 5 & 6; Colour photos. 7-10)

(Figs. 2, 12 & 13; Colour photos. 23-29)

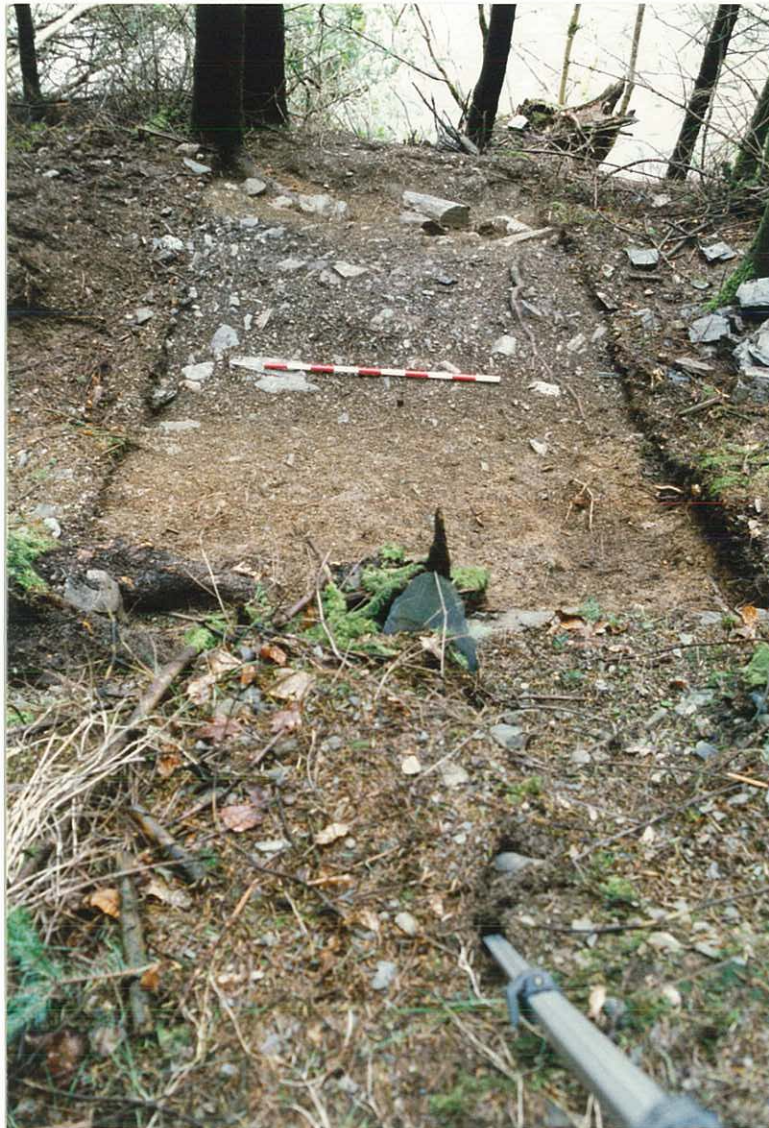
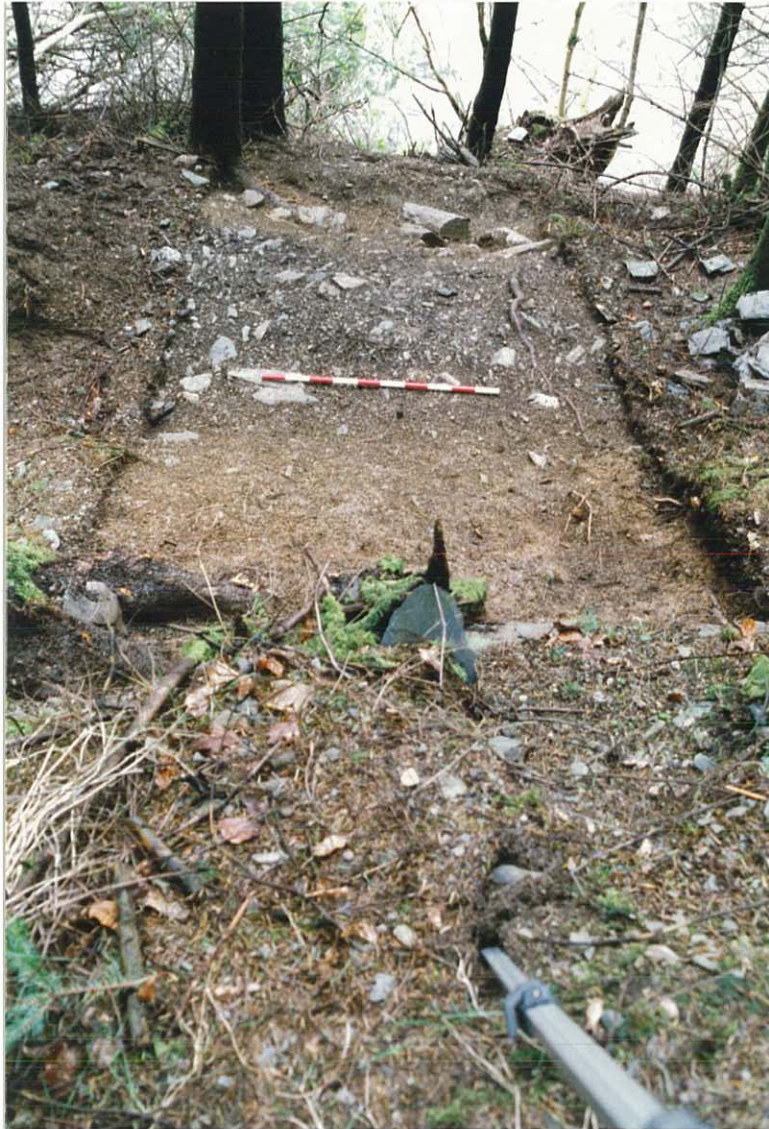
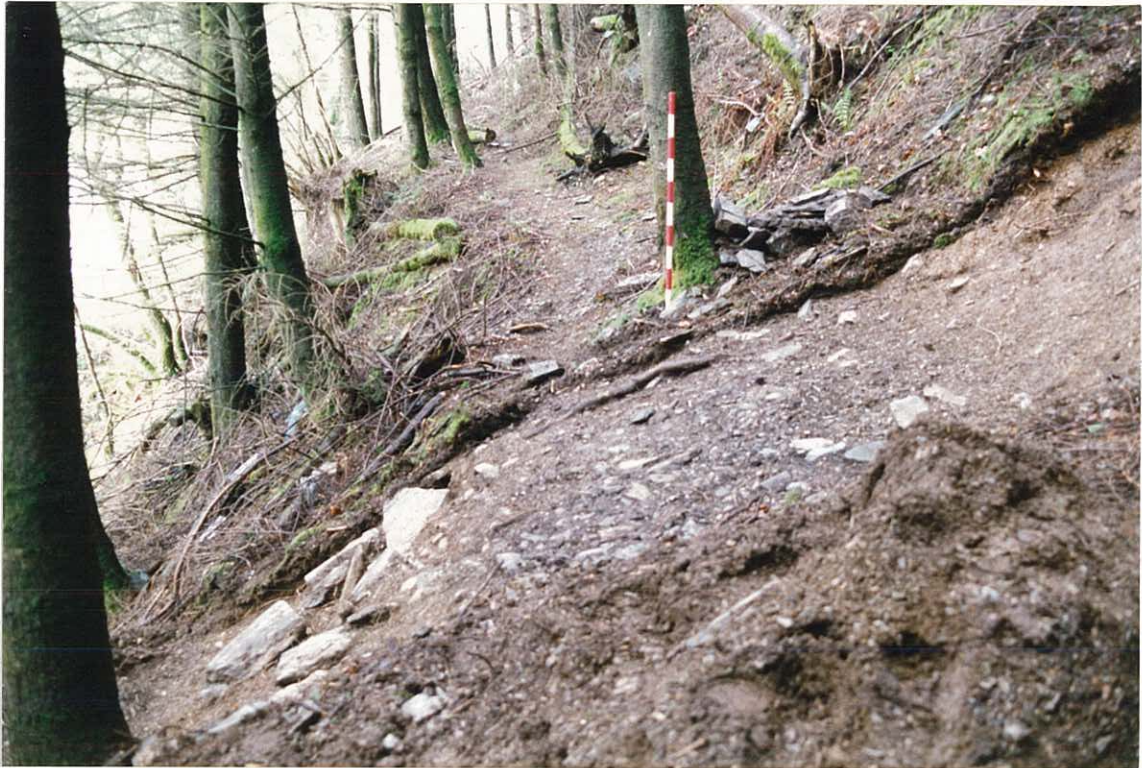
*1. Trench 1 after removal of topsoil.*

*2. Trench 1 after removal of topsoil.*

*3. Trench 1 after removal of topsoil.*

Following the removal of a very thin (5-15cm) topsoil, vegetation mat and pine needle debris (context 1), the surface of the walk terrace was revealed. This consisted of a deposit of dark brown - black loose loamy soil containing 60-70% small- (up to 2cm) and medium-sized (2cm - 5cm), rounded, platy stones. It initially appeared that these stones formed a surface to the layer, but on excavation it was discovered that they were evenly distributed throughout it. Small sherds of a wine bottle(s) of late 19th-century date were found on the surface and incorporated in this layer.

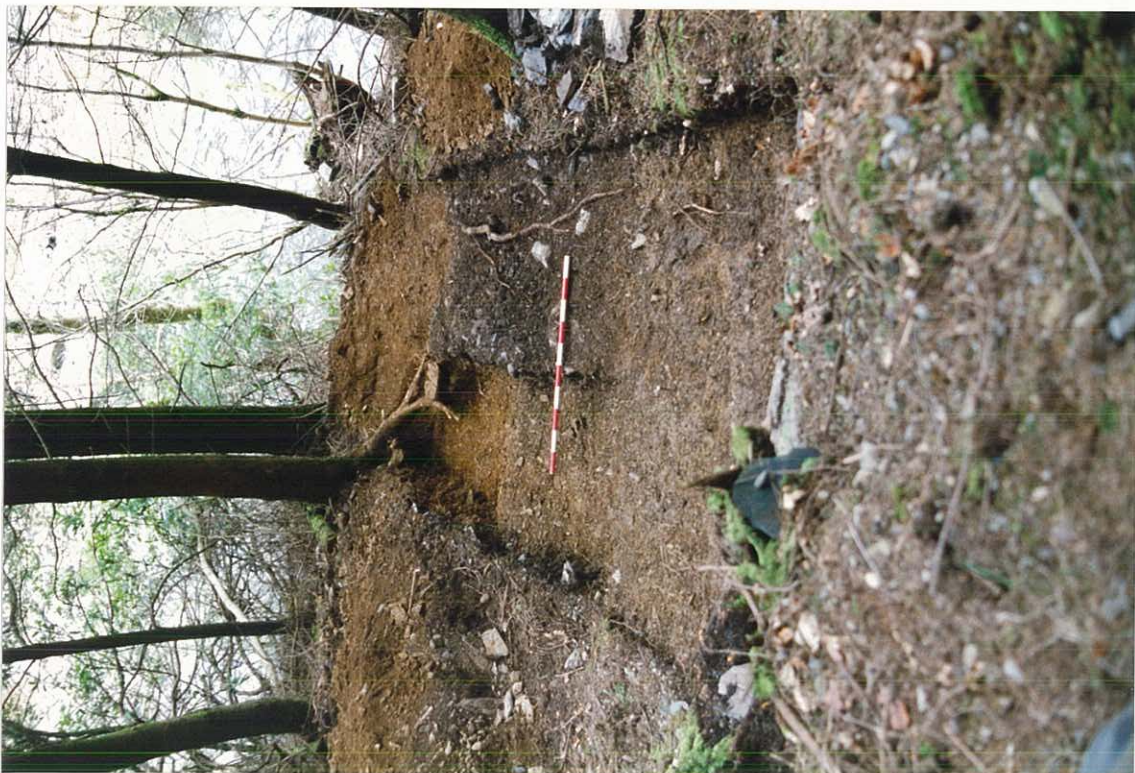
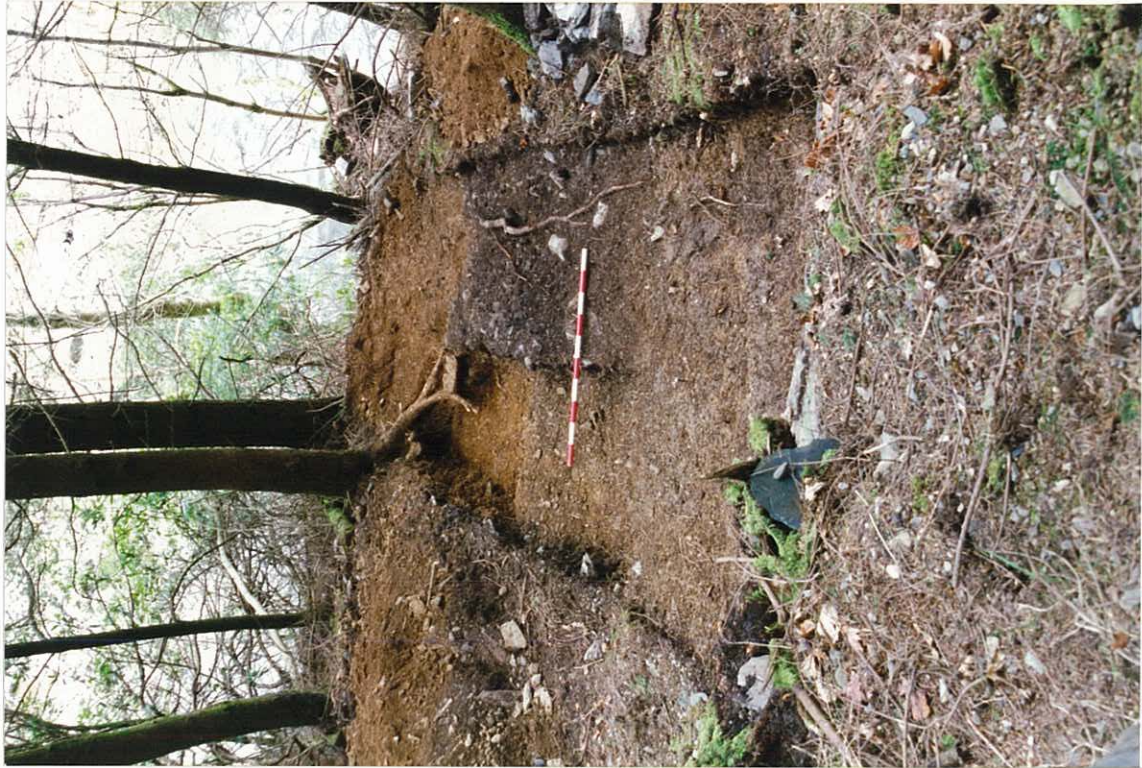
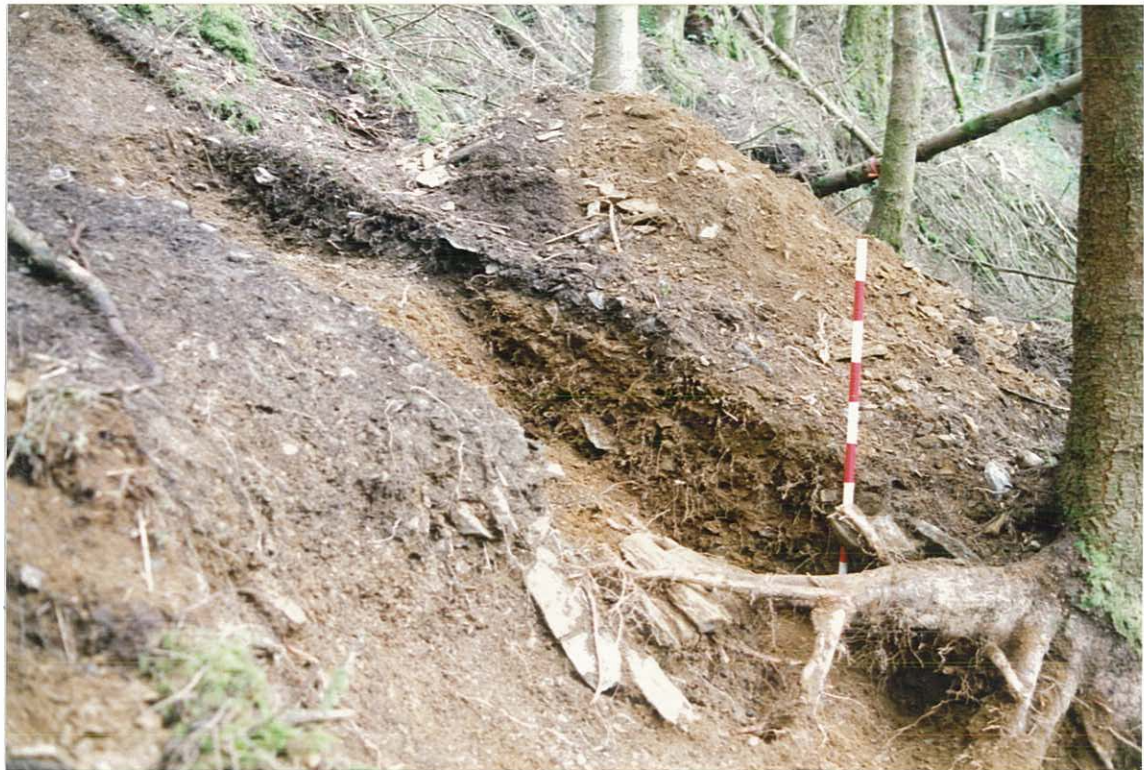
*4. Trench 1 after excavation.*

*5. Trench 1 after excavation.*

*6. Trench 1 after excavation showing west-facing section.*

The interpretation of this trench is quite straight-forward. A terrace was excavated along the valley and the spoil deposited on the down-slope side. Very large stones from the excavation were sorted and used to revet the spoil. A top dressing of small- and medium- sized stones that had been sorted or sieved from the excavated subsoil may then have been scattered over the surface of the created terrace. The walk would have originally been between 2.2 and 2.5m wide. Subsequent to construction, hill-

wash accumulated on the terrace, became mixed and trampled with upper layers of the walk and was formed into layer 2. At an unknown period the revetment wall failed; this caused slippage leading to the consequent narrowing of the walk to its present width.

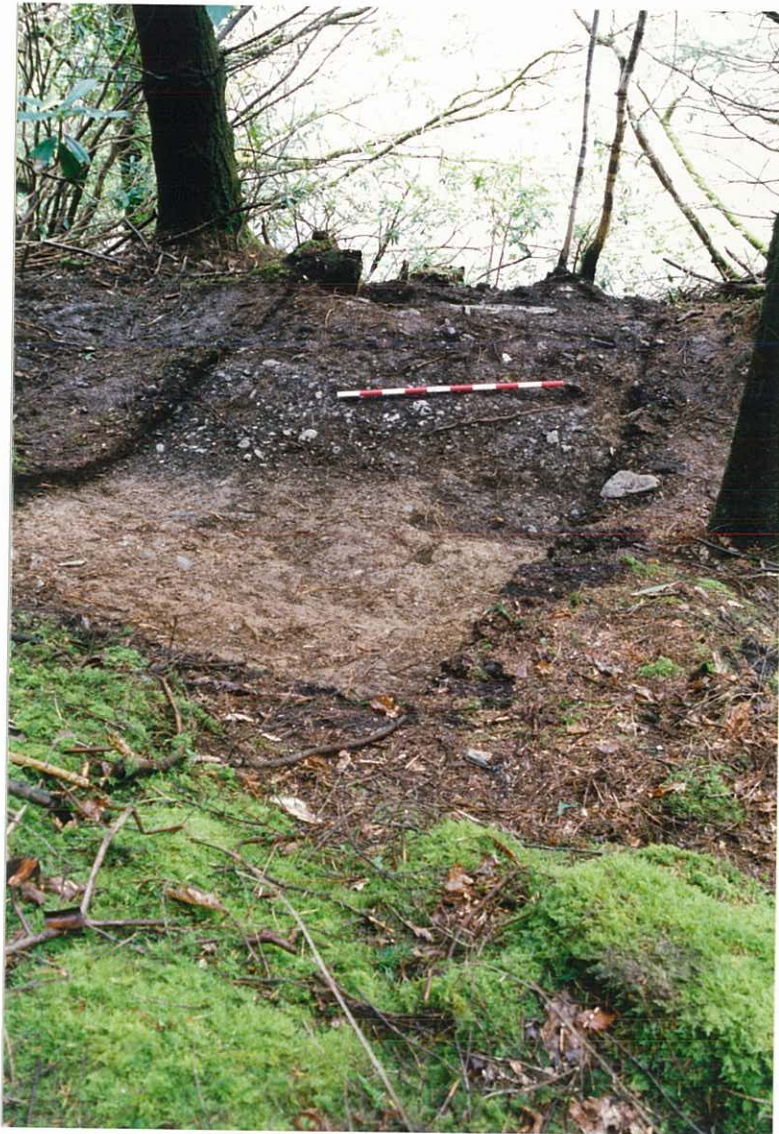
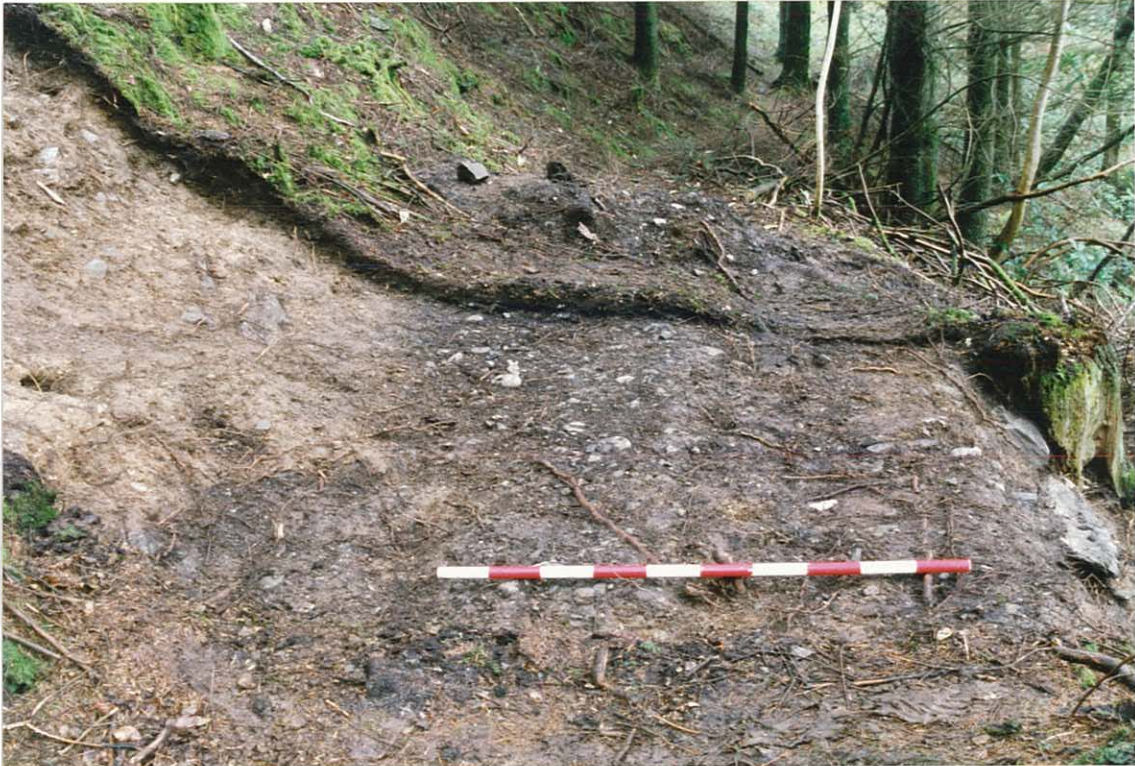
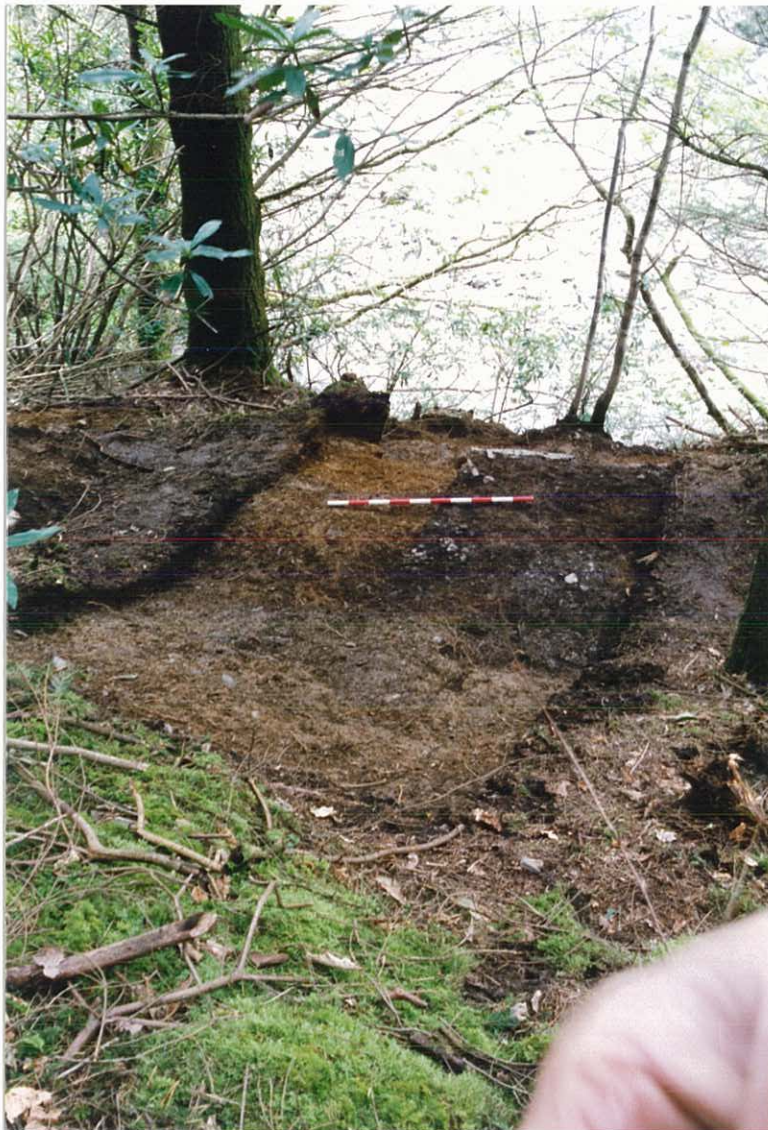
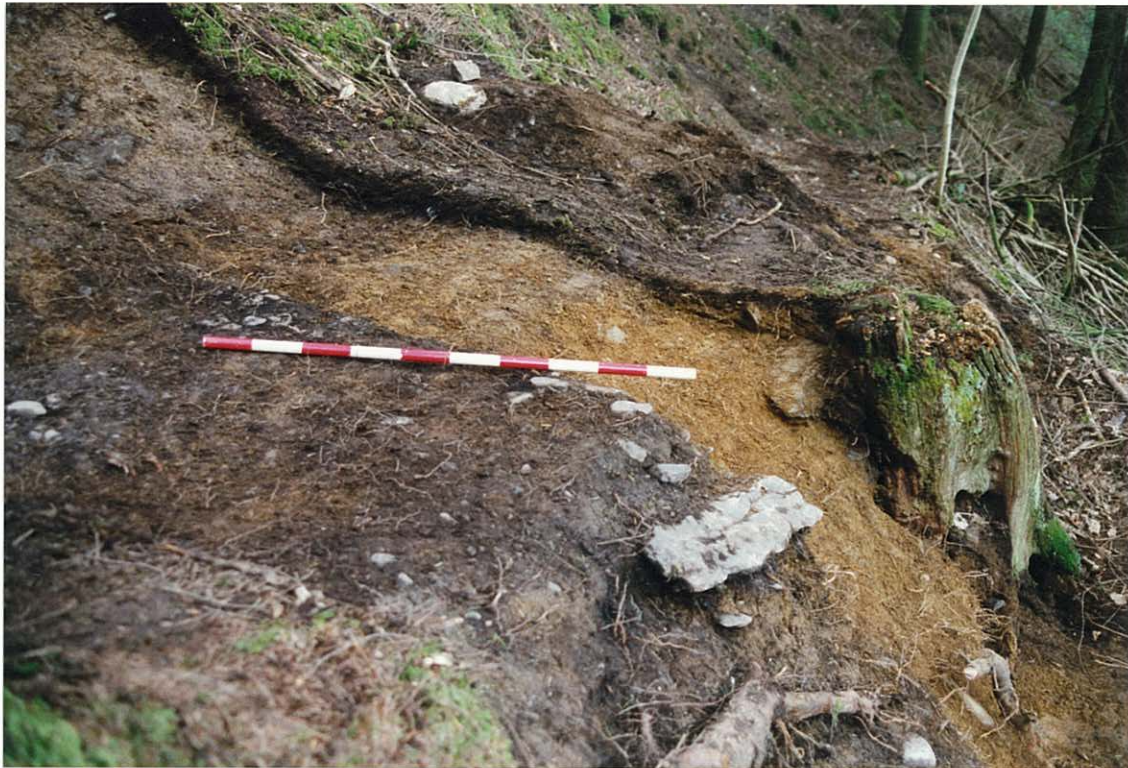
*7. Trench 2 after removal of topsoil.*

*8. Trench 2 after removal of topsoil.*

*9. Trench 2 after excavation.*

*10. Trench 2 after excavation showing west-facing section.*

Removal of topsoil, vegetation mat and pine needle debris (7) revealed layer 8, a dark-brown - black, loose, silty-loam containing 60-70% small- and medium-sized rounded, platy, stones randomly scattered and layer 9, an orangy-brown silty-loam with 40-50% content of gravel and small- to large-sized, rounded, platy stones evenly scattered throughout. On excavation layer 8 was found to be just a 1-2cm thick and lay on a horizontally cut terrace (11). Layer 9 was similarly very thin - 3-5cm - and had been deposited on a terrace cut at slightly lower level and was revetted by the remains (two courses survived against the west-facing section) of a dry-stone wall (10). Clearly this slightly lower terrace had been excavated to accommodate this revetment wall. The subsoil (12) through which the terrace (11) had been excavated was similar to that encountered in Trench 1 except that bedrock was present just below the cut of the terrace. Original path width would have been *c.* 1.8m.

The construction technique used in this section of path is similar to that employed in Trench 1. However, the terracing into the valley side is here more substantial and the extension of the width of the walk shelf by depositing and revetting subsoil less substantial. This has resulted in a far more stable walk terrace than that revealed in Trench 1. Consequently the light engineering techniques have not failed so dramatically, although the revetment has largely disappeared, and the path retains its original width. The thin topsoil and vegetation debris and the absence of wash deposits over layer 8 indicates that the course of the walk has been kept free of accumulating material, but it is uncertain whether this was by maintenance or the result of the passage of feet.

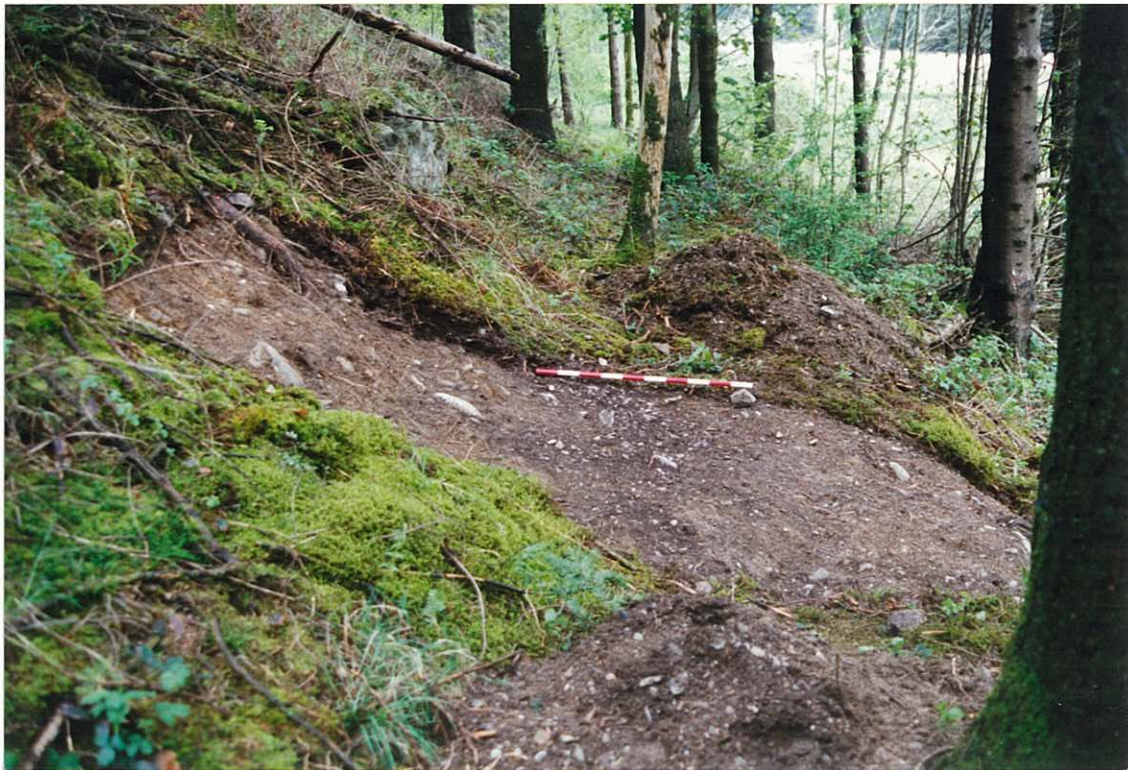
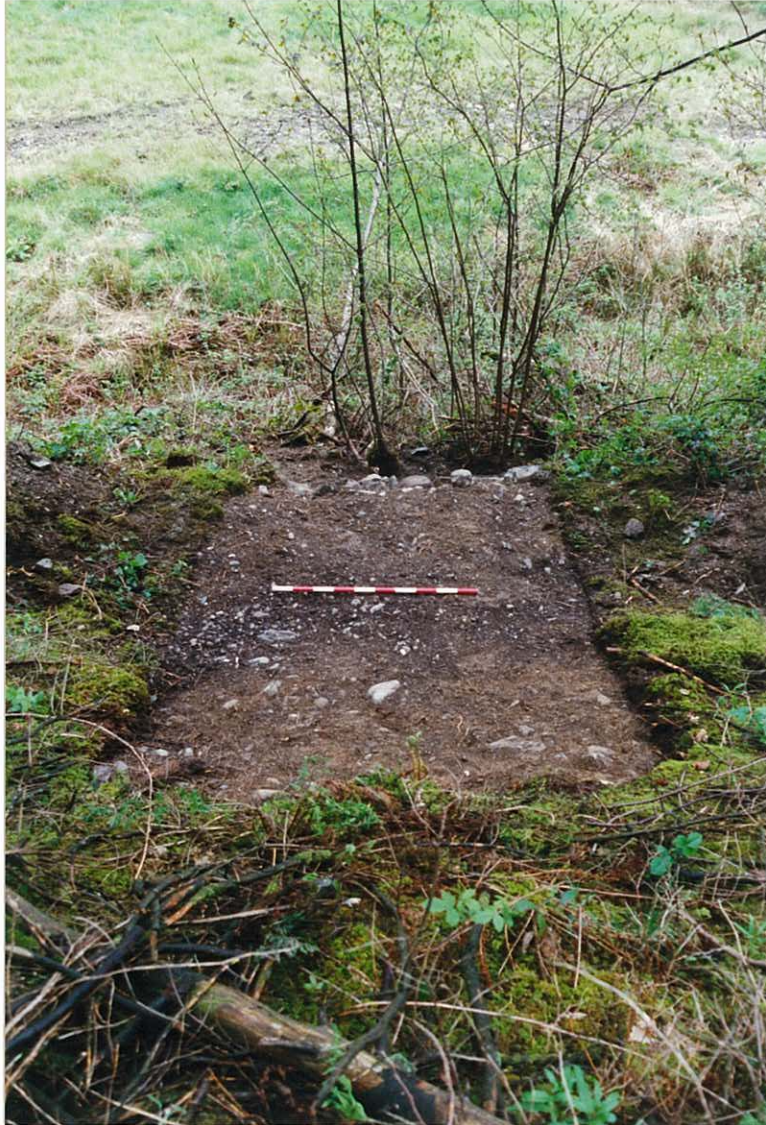
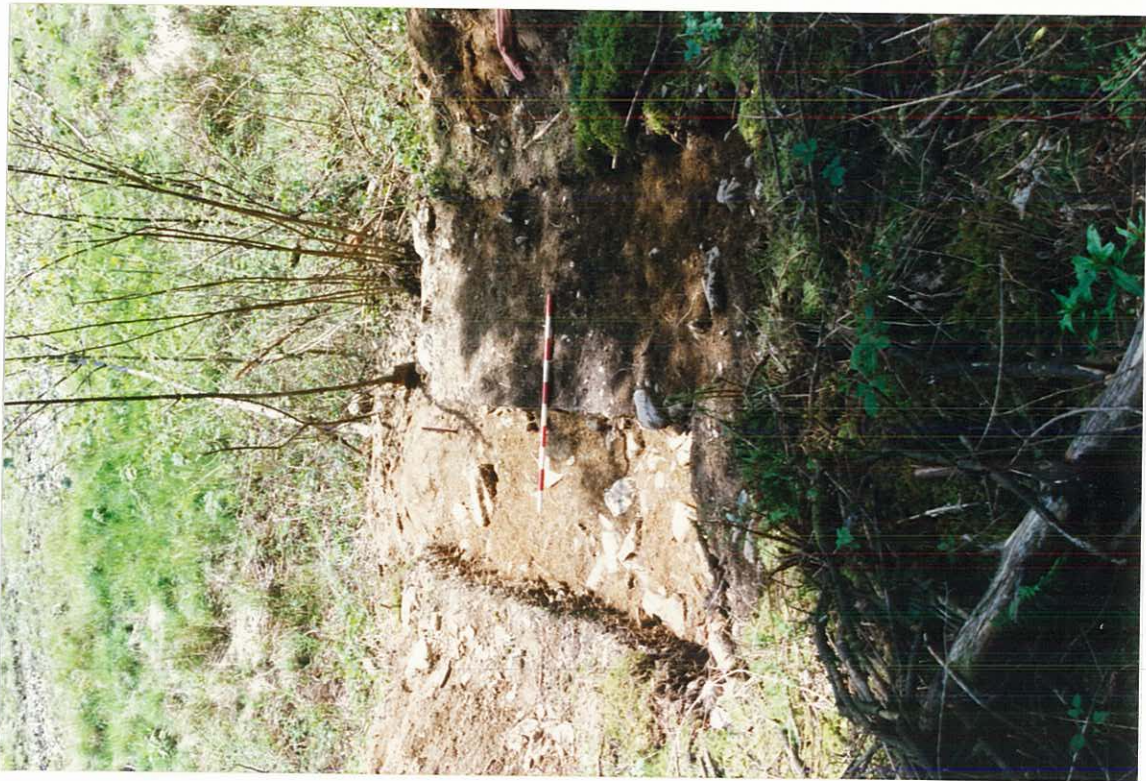
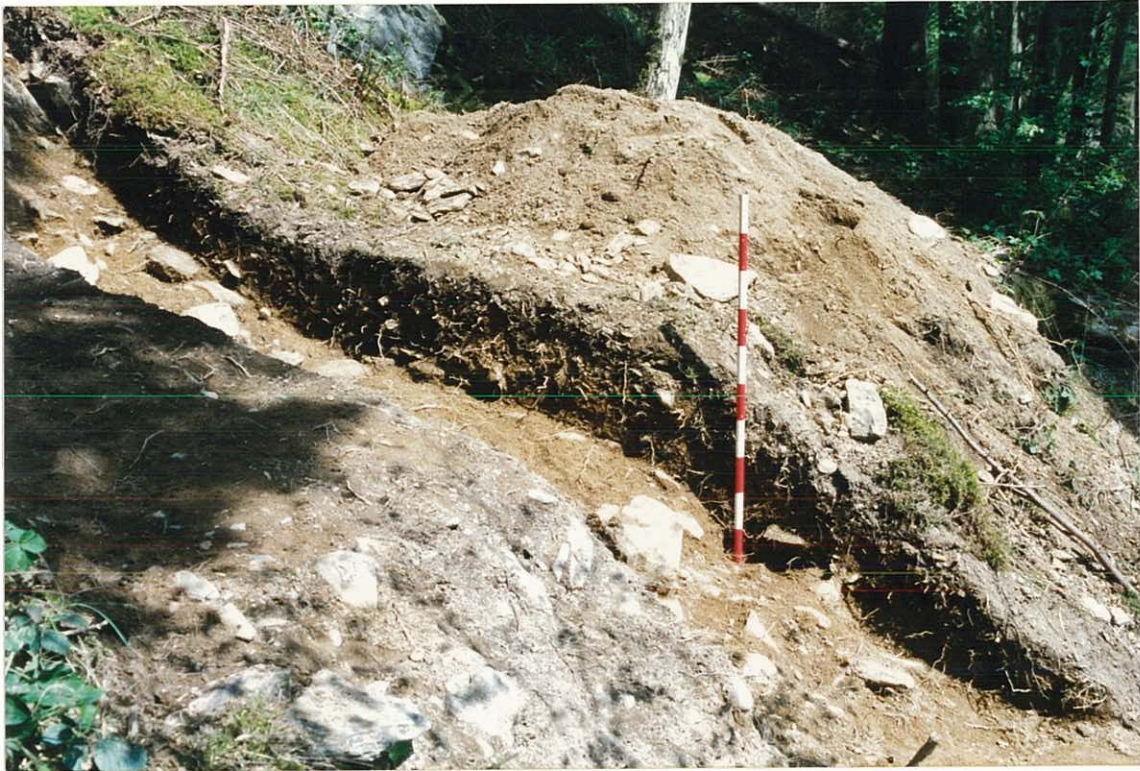
*11. Trench 3 after removal of topsoil.*

*12. Trench 3 after removal of topsoil.*

*Trench 3 after excavation.*

*15. Trench 3 after excavation showing west-facing section.*

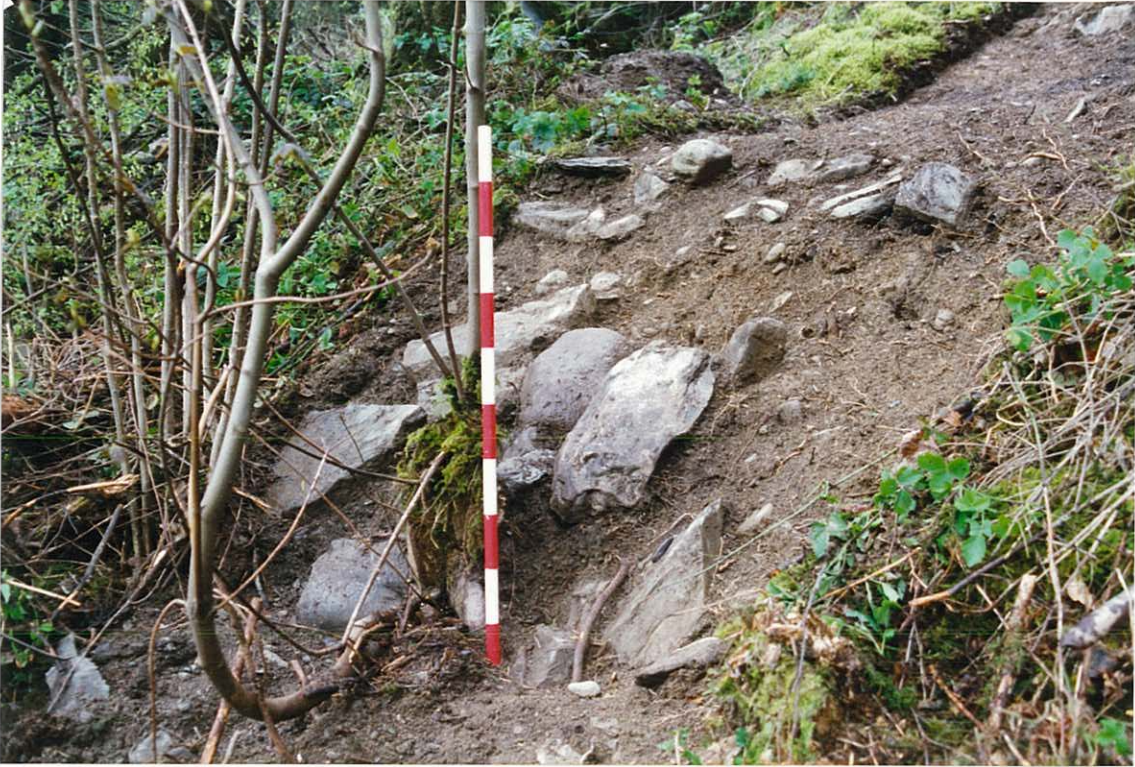
*13. Trench 3 showing collapsed revetment.*

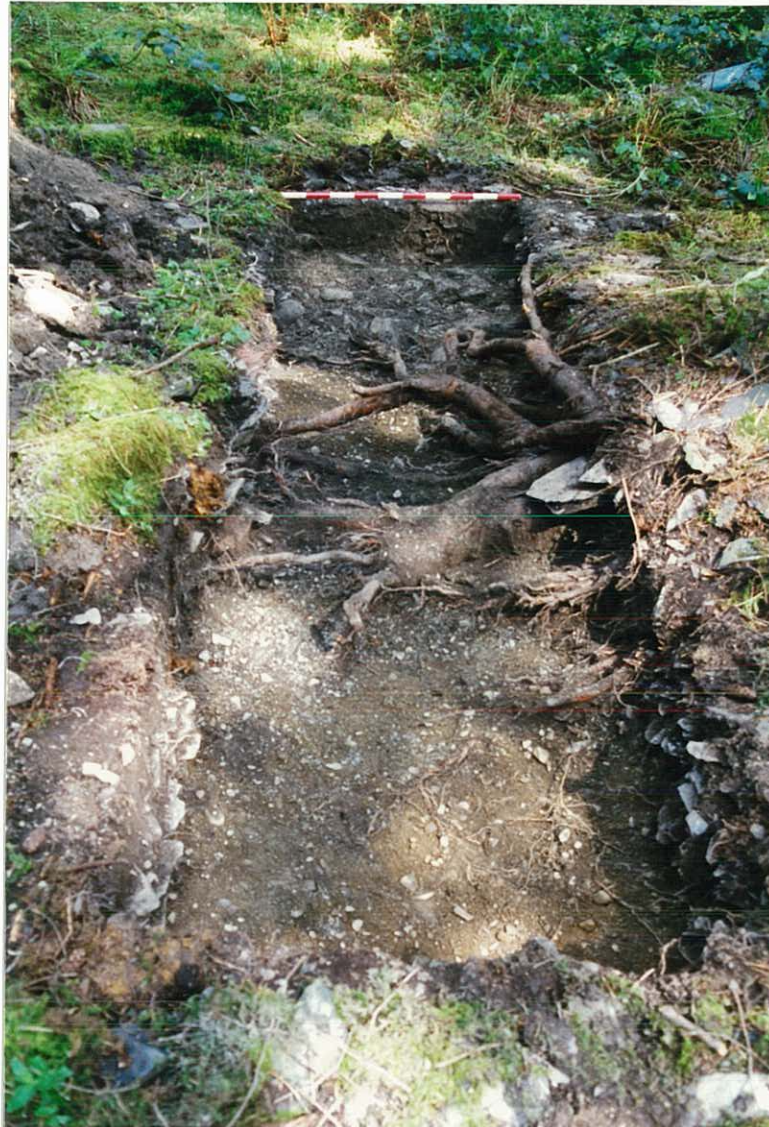
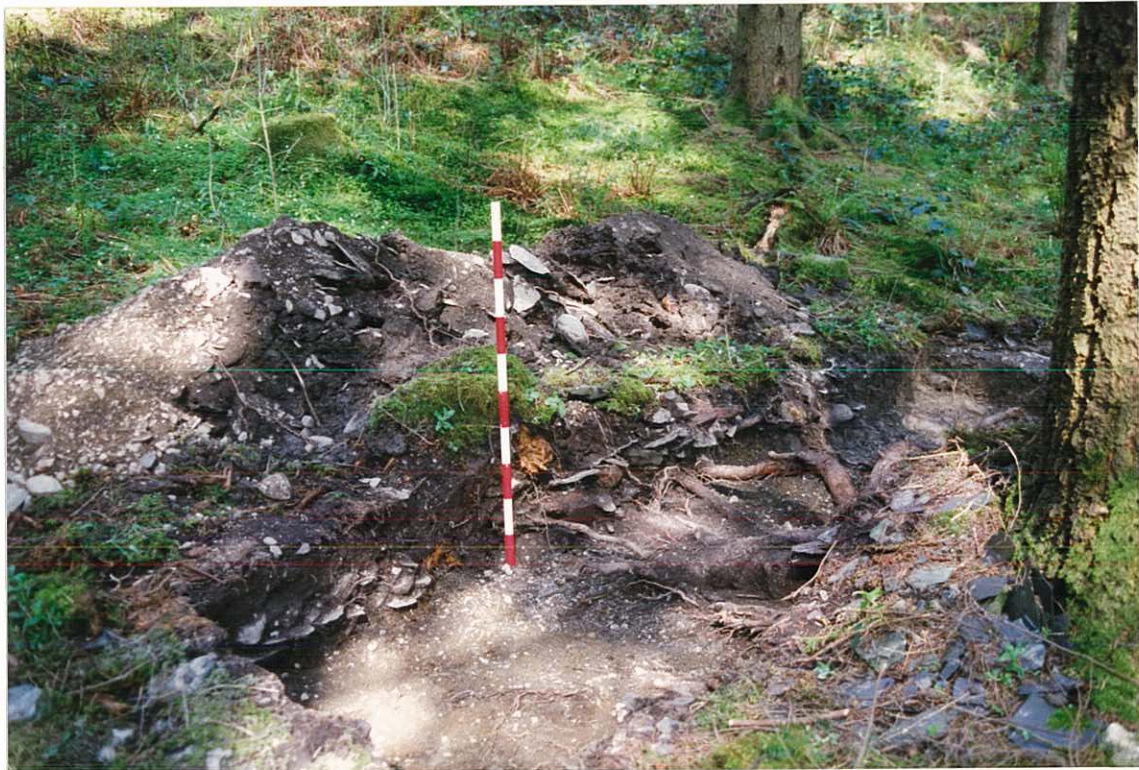
*16. Trench 4 after excavation.*

*17. Trench 4 after excavation.*

This is a reinvestigation of a trench excavated by Phillips in 1994 (p20, Trench X). The results recorded by Phillips and those of the present excavations are not easy to reconcile. Phillips noted several north to south aligned anomalies running across his trench which he considered might be archaeological, though they were not excavated. It seems likely that these were the surfaces of bands within the gravel subsoil. No archaeology was recognised in 1998 apart from the rubble layer described below.

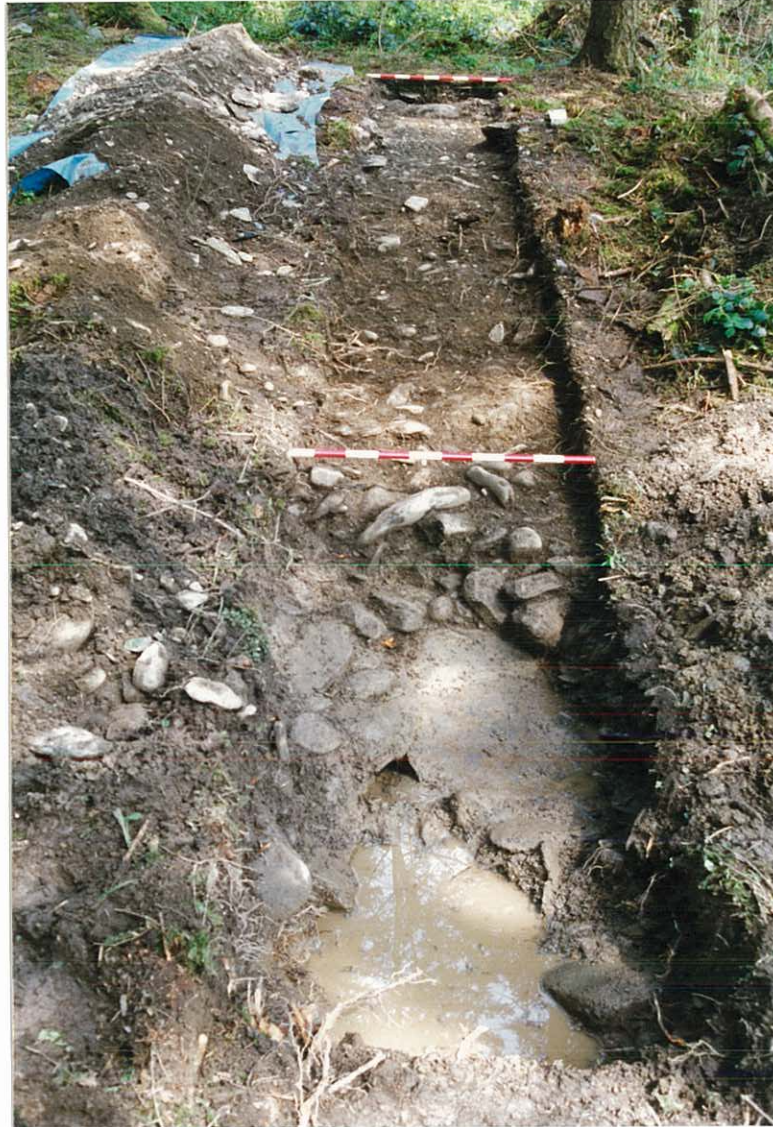
*18. Trench 5 after excavation showing culvert 26.*
