**HAFOD**  
**An archaeological investigation of**  
**THE LADY'S WALK S4**  
**and**  
**THE COLD BATH**  
Report no. 35903

May-June 1988

Commissioned by: Hafod Trust

Report by: K Murphy BA MIFA  
Archaeoleg Cambria Archaeology  
The Shire Hall  
Carmarthen Street  
Llandeilo  
Carmarthenshire  
SA19 6AF  
01558 823121

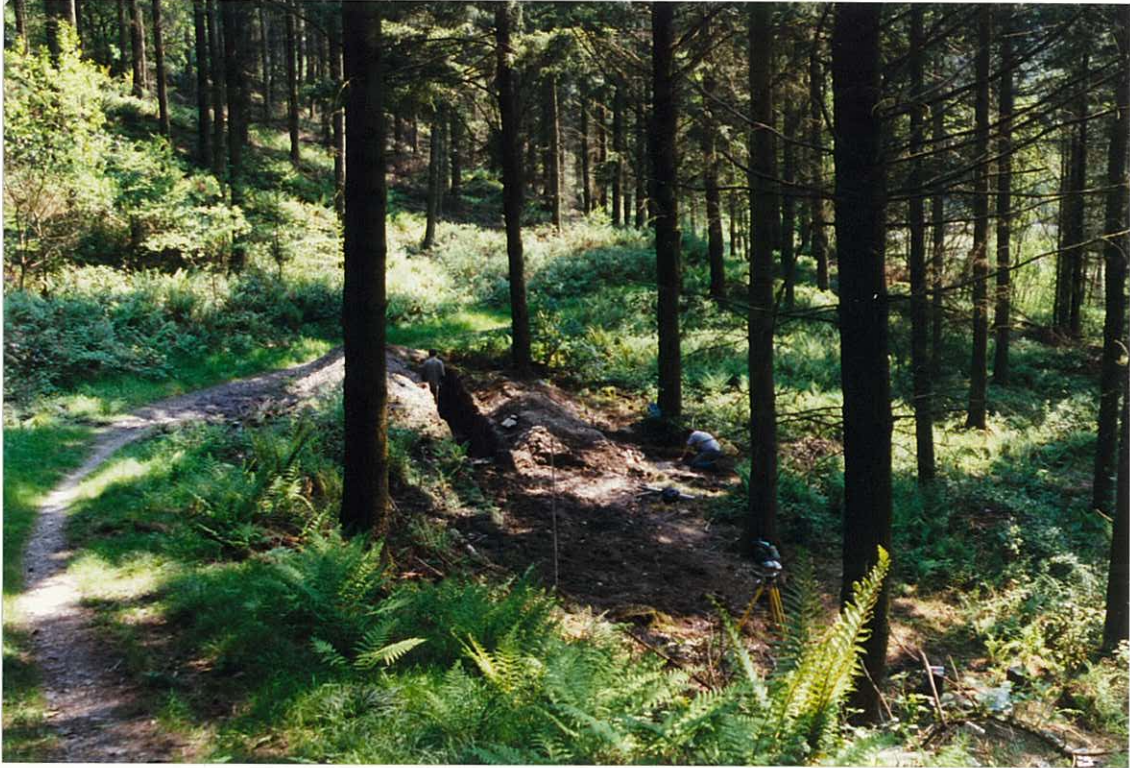
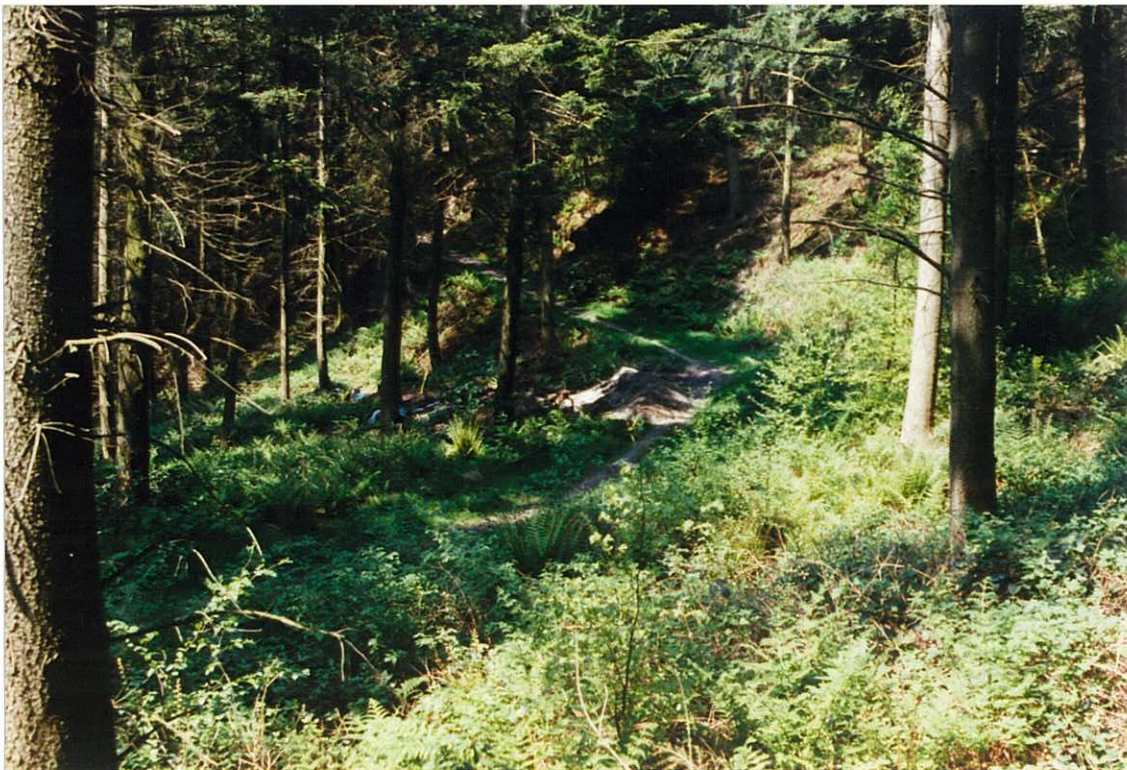
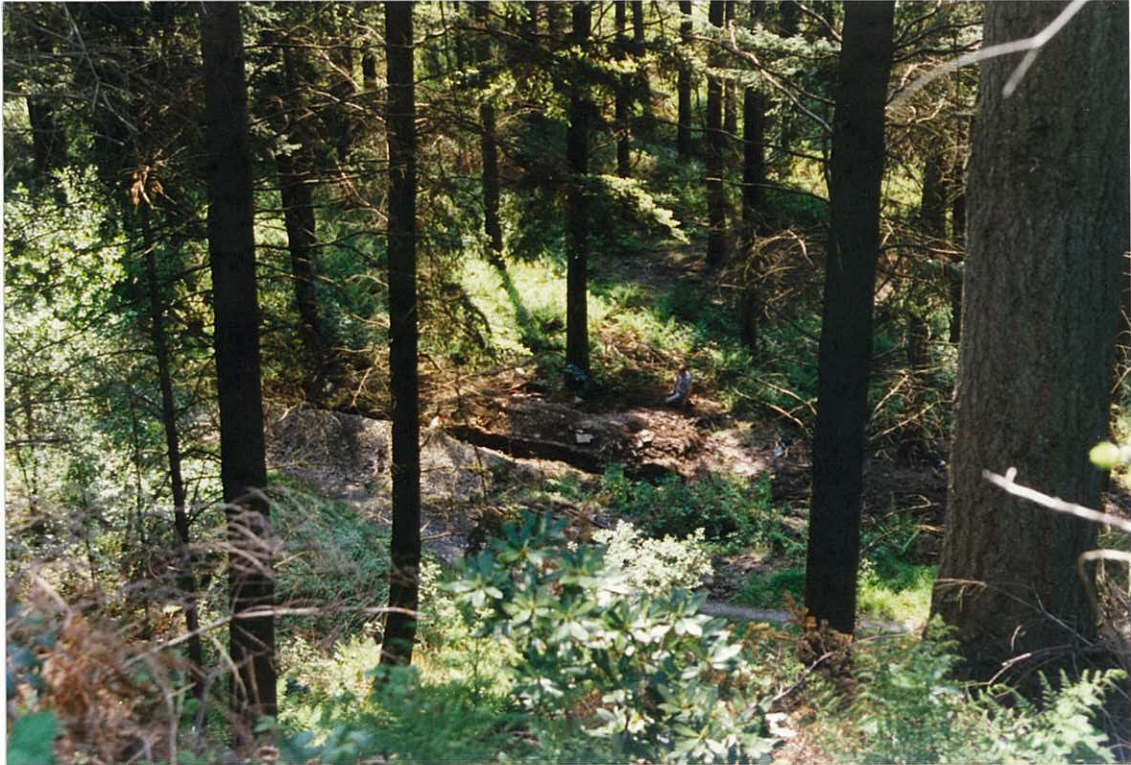
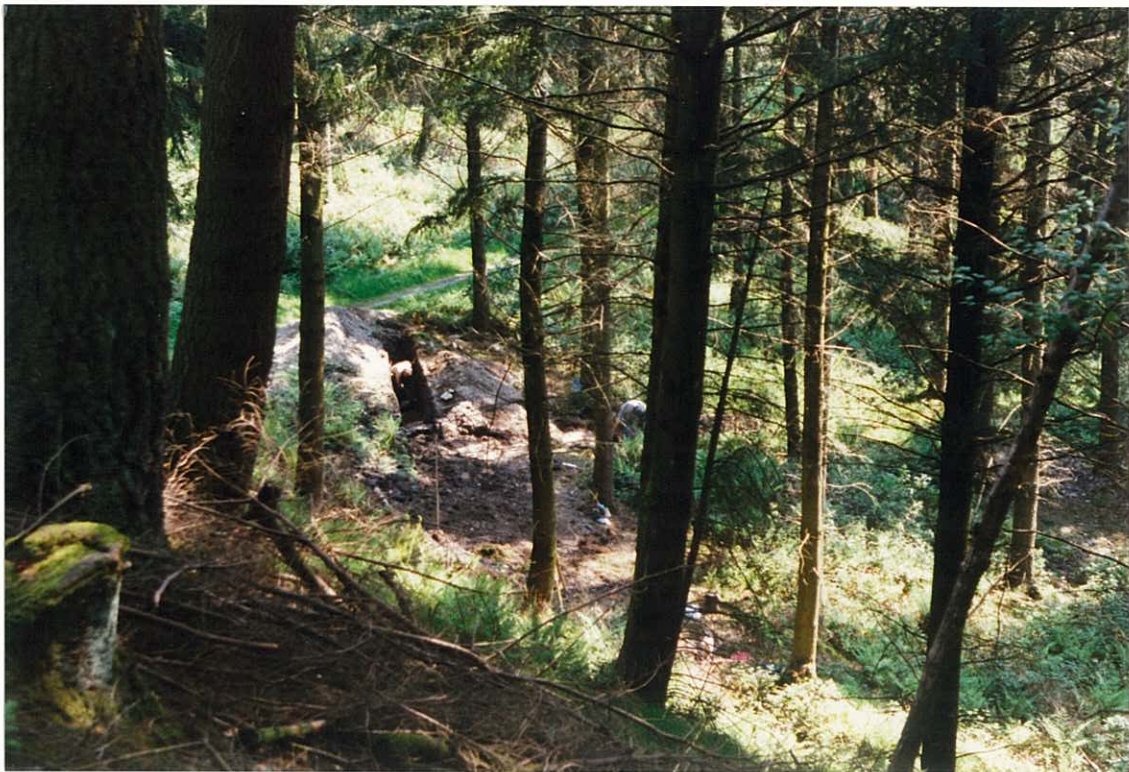
*19. General view of trenches 6-9 from west.*

*20. General view of trenches 6-9 from east.*

*21. General view of trenches 6-9 from north.*

*22. General view of trenches 6-9 from west.*

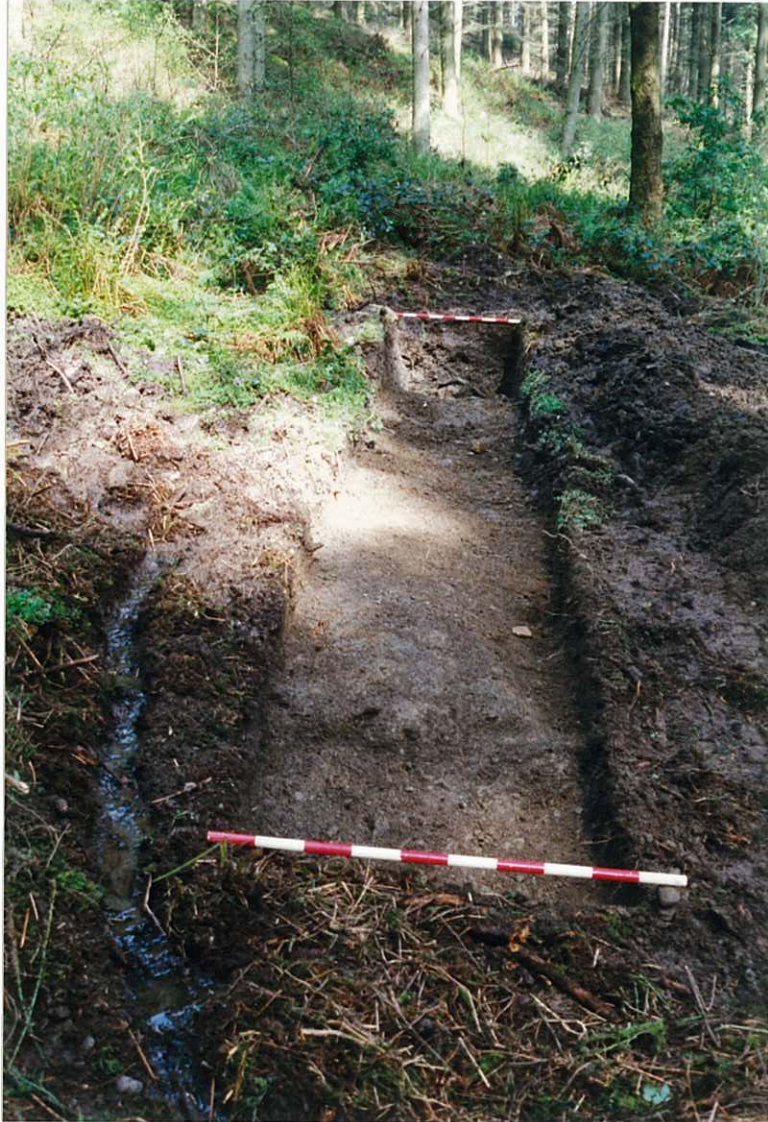
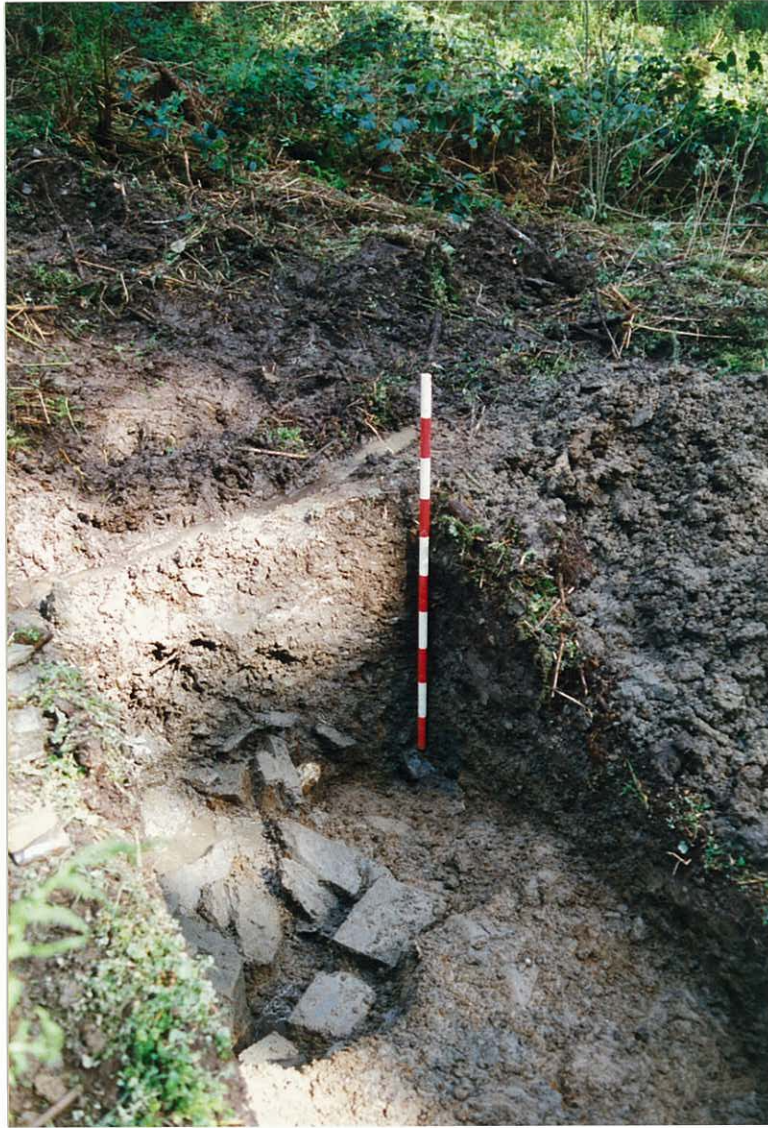
*23. West end of Trench 6 showing layer 29.*

*24. Trench 6 showing exposure of drainage gullies.*

Outside the building, to the east, the surface (51) of what appeared to be a foundation trench or the ground surface contemporaneous with the Bath House was revealed beneath the gravel/sand deposits (32, 43 & 44), but not excavated. This consisted of a loose, dark-brown, silty-loam which contained small- to large-sized, local stones, pieces of undressed oolitic limestone and grey-white mortar fragments.

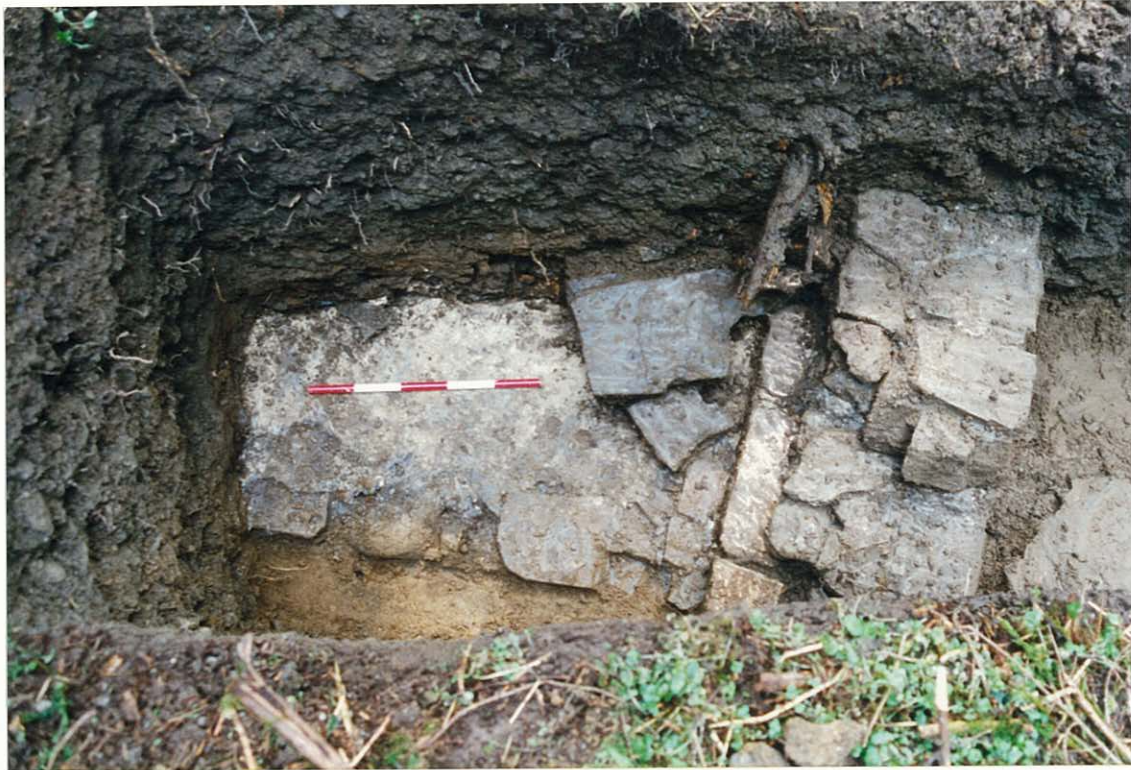
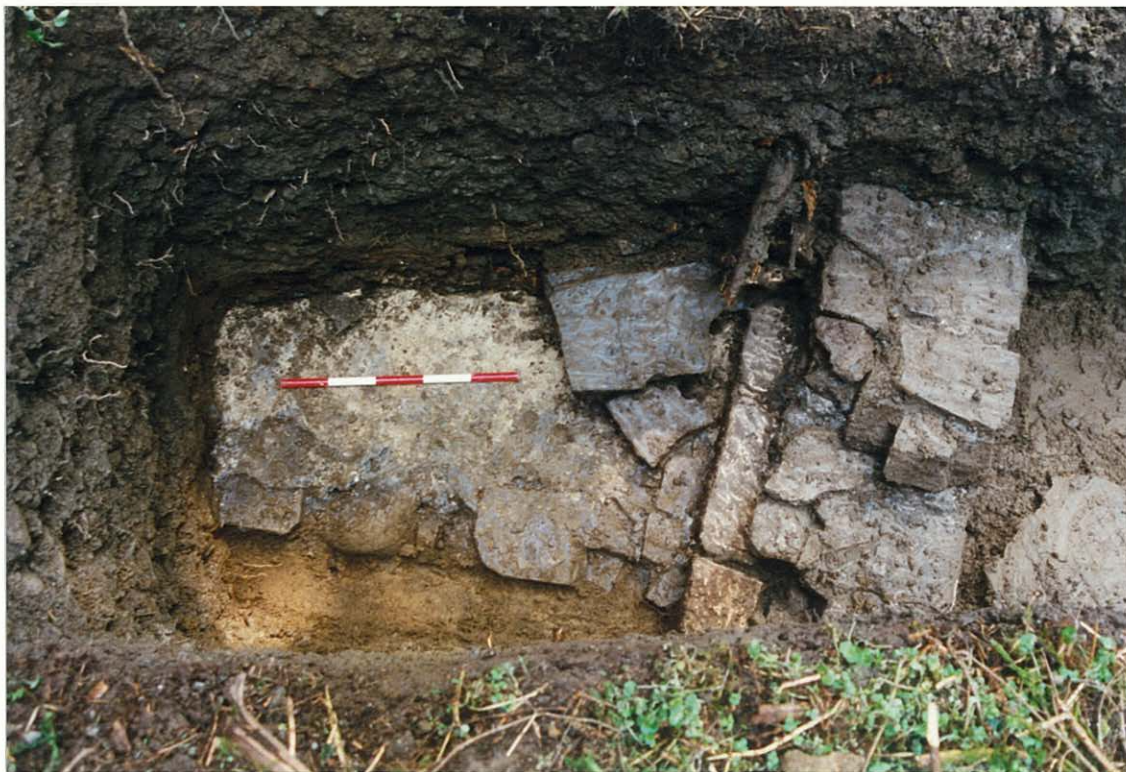
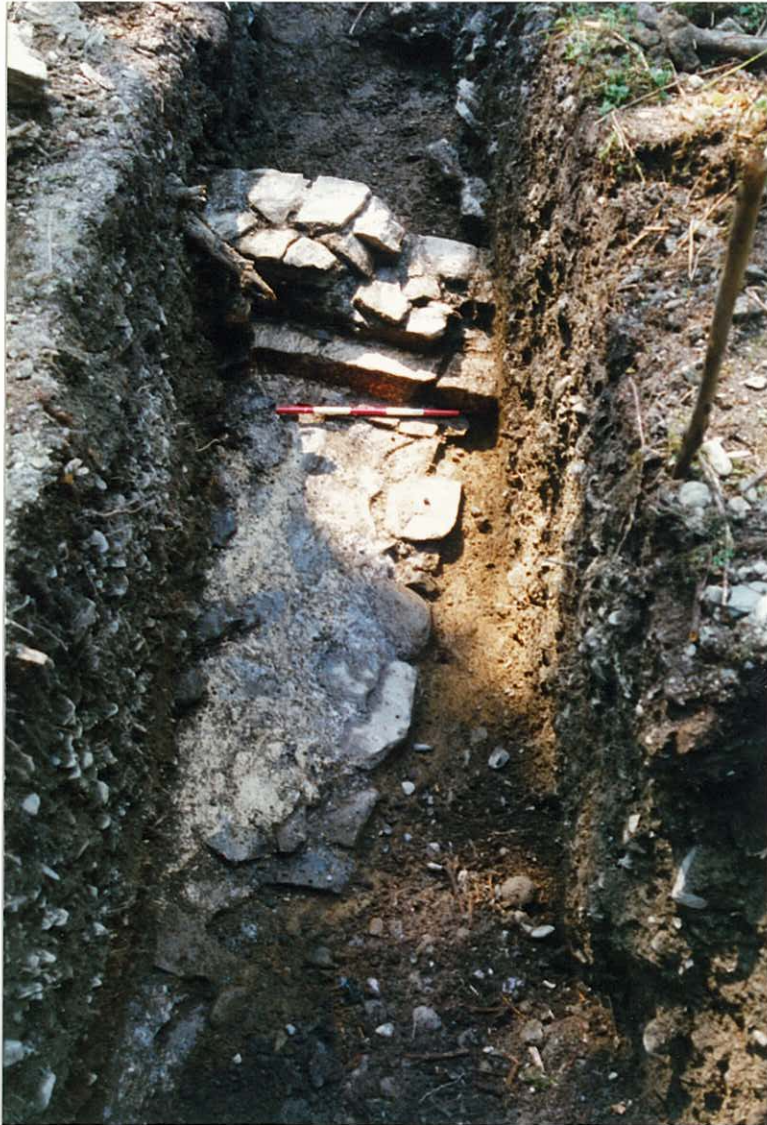
Wall 41, the east wall of the Bath House, comprised local stone bonded with a grey-white lime mortar. On the inner face a course of dressed oolitic limestone blocks was present. The wall was 0.50m wide. Bonded onto this wall was what a first was considered to be a just a sub-floor (42), but further, limited investigations revealed a wall-face to this descending on its northern edge. The ragged nature of this wall-face indicates that its facing stones have been robbed out. The sub-floor and wall-face was constructed from local stone bonded with grey-white mortar over which a skim of cream-coloured lime mortar had been laid. Sub-floor/wall 42 was bonded on its east side into wall 49, the east wall of the Bath House.

*25. Trench 6 showing wall 41 and sub-floor/wall 42.*

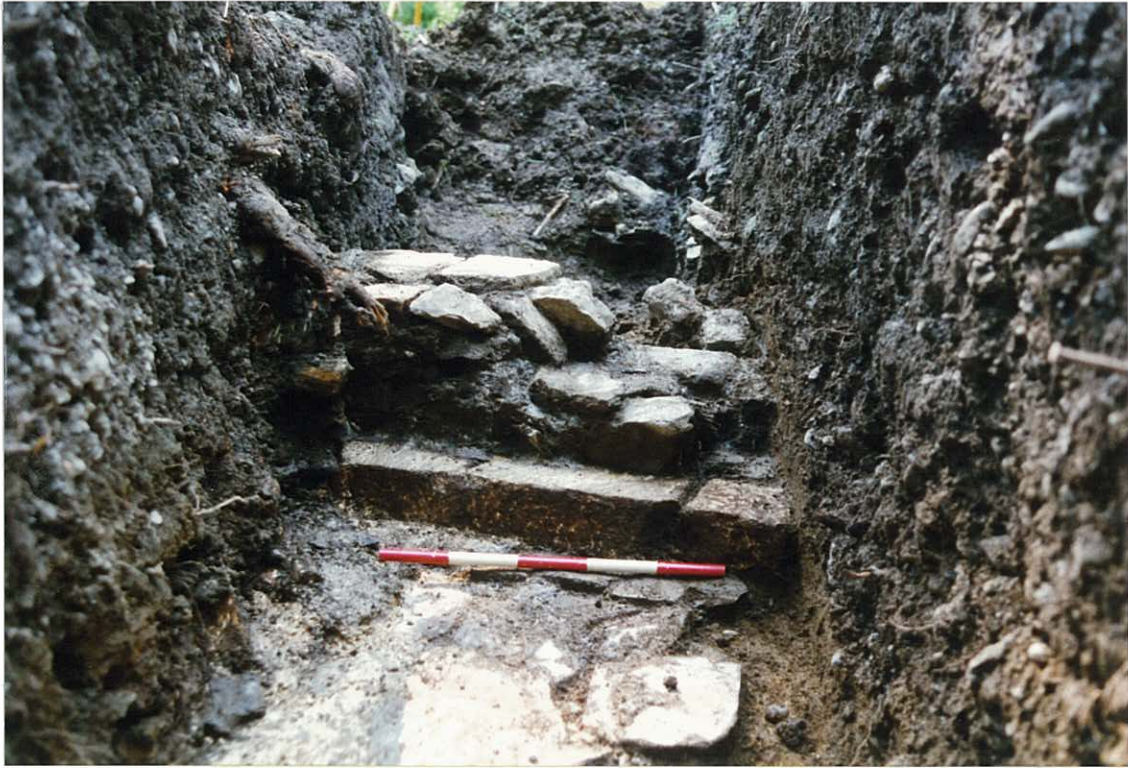
28. Trench 6 showing wall 41, dressed stone detail.

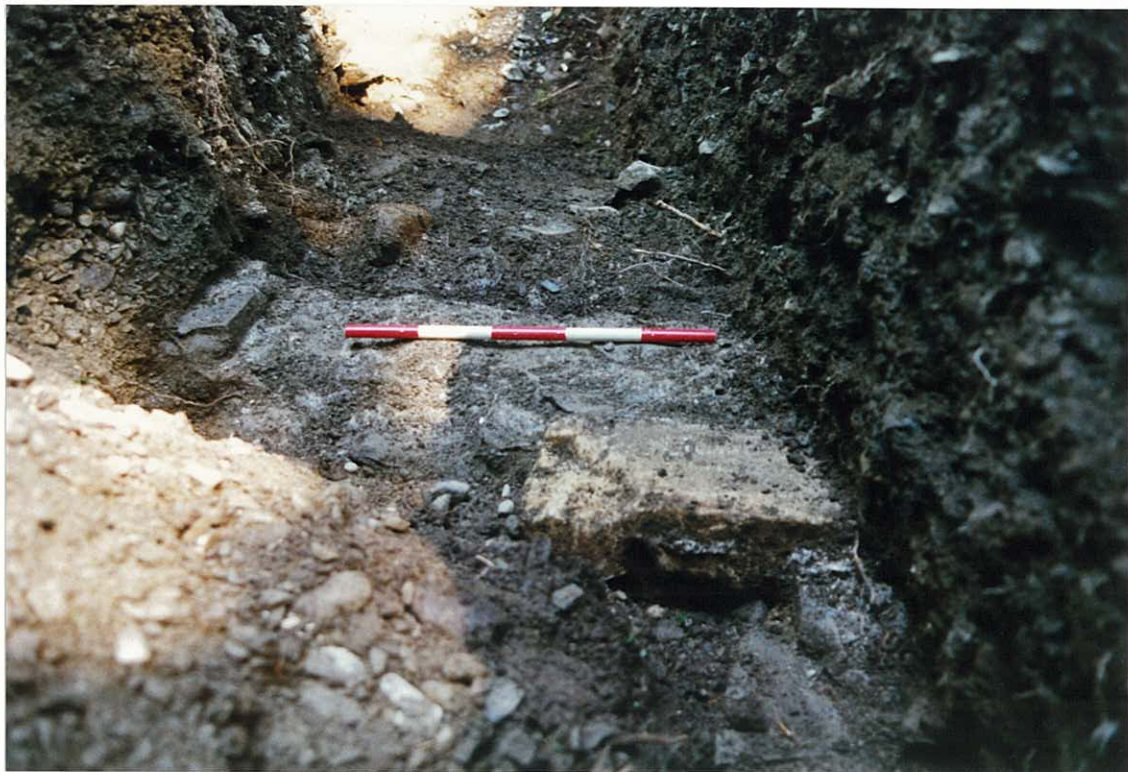
Wall 49 was of similar construction and dimension to wall 41. A single, dressed, oolitic-limestone block was present on the wall's inner face. A step on the wall to the north of this block indicates that further oolitic blocks have been removed. A mortise cut into the west-centre of this oolitic block suggests that a course of dressed stone lay at right angles to wall 49 along the northern edge of the sub-floor/wall 42. Deeper, but limited, excavation against wall demonstrated that the gravel and sand layers 32, 43 and 44 continued down, and that facing stones of wall 49 have been robbed out. The core of wall 49 at this lower level was seen to consist of undressed oolitic limestone rubble.

29. Trench 6 showing wall 49, detail of dressed stone.

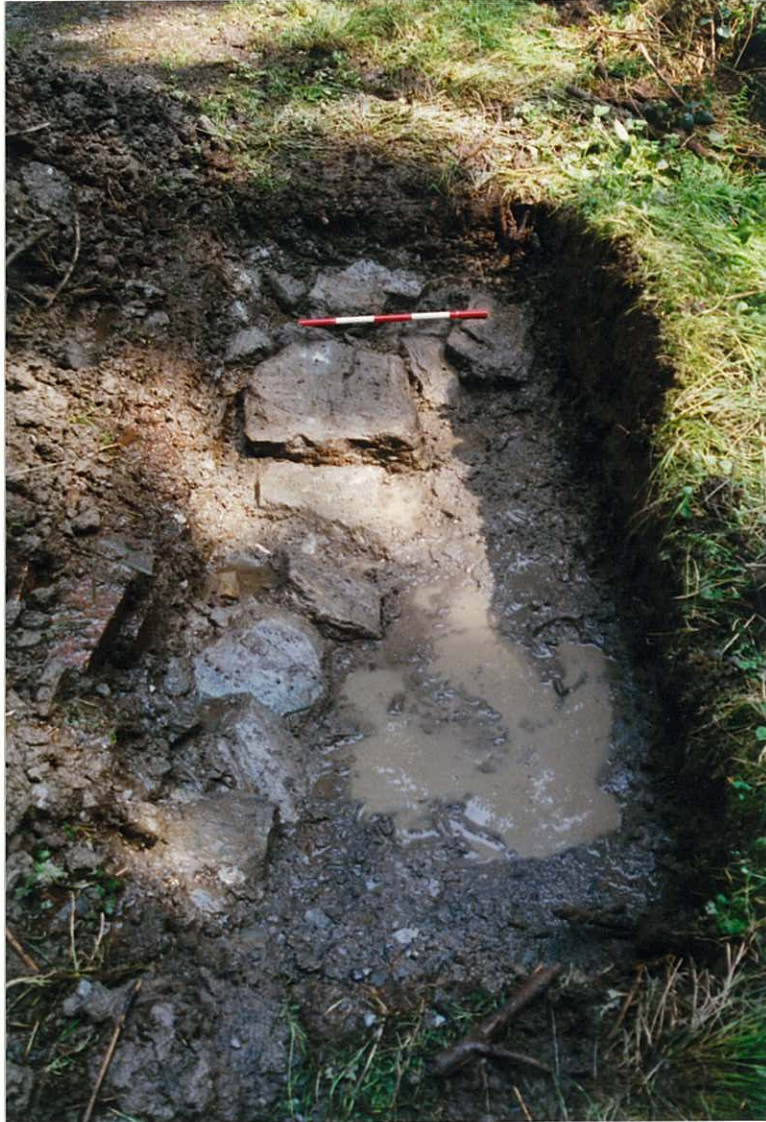
This was excavated immediately alongside the southern edge of the modern track. The upper deposits (20-30cm thick) comprised loose topsoil mixed with conifer branches and track hard-core. The whole was very wet due to the proximity of the spring. Immediately below these deposits lay an roughly east-west aligned line of large and very large, local stone-slabs (34). These were bedded into a compact, grey clay. The surface of the stones lay *c.* 1.50m above the level of the sub-floor within the Bath House. Because water was running across the surface of this trench, it was not possible to continue further investigation. The line of stones can be interpreted as the base of a culvert that fed water from the spring that rises to the north-west into the Bath House.

30. Trench 7 showing culvert base 34.

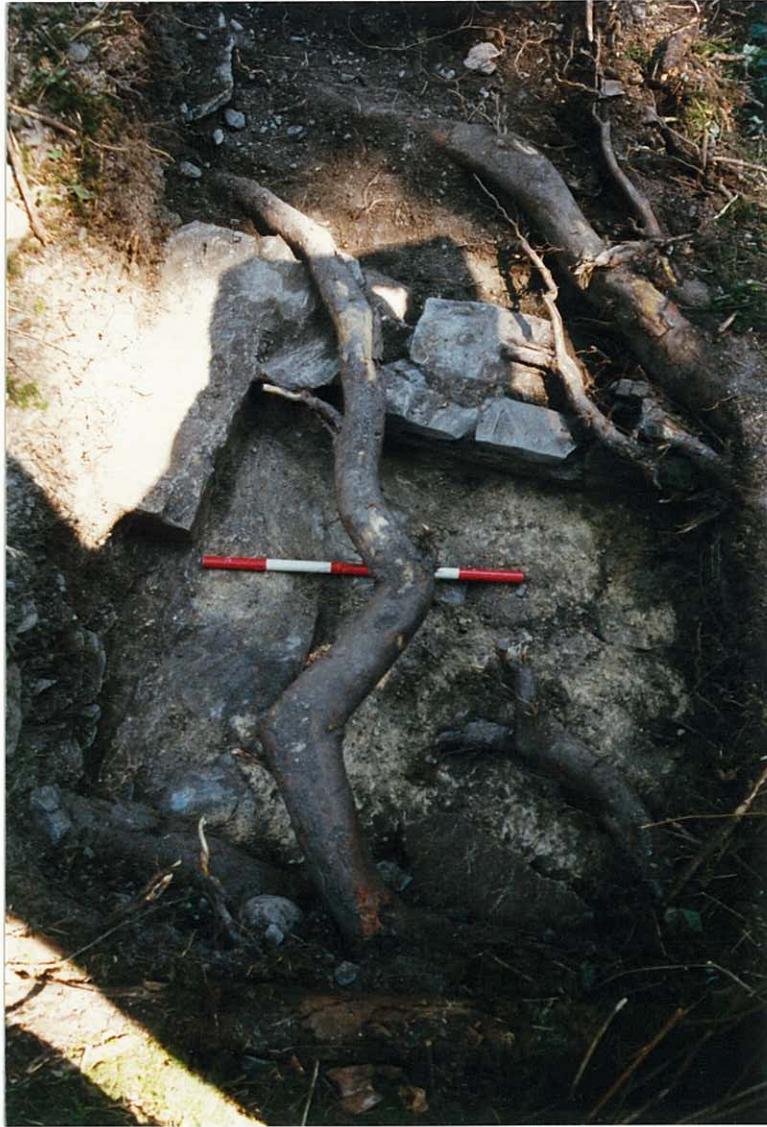
31. Trench 8.

This trench, 1.7m x 1m, was excavated on the down-slope, south, side of Trench 6 on the projected line of wall 49. A very thin deposit of rotting vegetation, root mat and pine needles containing sherds of late 19th-century and 20th century pottery and wine-bottle glass and overlay building debris (46). This layer was up to 30cm thick and had been penetrated by large roots from a conifer immediately to the west of the trench. The layer consisted of small- to medium-sized, angular, platy, local stones, fragments of oolitic limestone, pieces of grey-white mortar and some white-painted plaster. Beneath layer 46 lay wall 47 and sub-floor 48. Wall 47 was clearly a continuation of wall 49 uncovered in Trench 6. It was 53cm wide. A single block of dressed oolitic limestone lay on the inner wall-face - others to the south had clearly been robbed. The core of the wall was constructed from coursed local stone bonded with a grey-white lime mortar. The oolitic limestone had been bonded with cream-coloured mortar. The wall survived to one course above the sub-floor (48). This sub-floor was at the same level as that found in Trench 6 (42) and was of similar character; a cream-coloured lime mortar. A single piece of oolitic limestone resting on this sub-floor may have been

an *in-situ* floor tile. Ridges on the sub-floor may mark internal divisions, but are perhaps more likely to be scars from where further floor tiles have been removed. Roots from the conifer had not penetrated the sub-floor.

The large conifer tree located between trenches 8 and 9 at the Bath House should be felled to prevent further damage to the underlying archaeology. As the archaeological remains are securely buried, it is recommended that no further investigations or management work is required on the site.

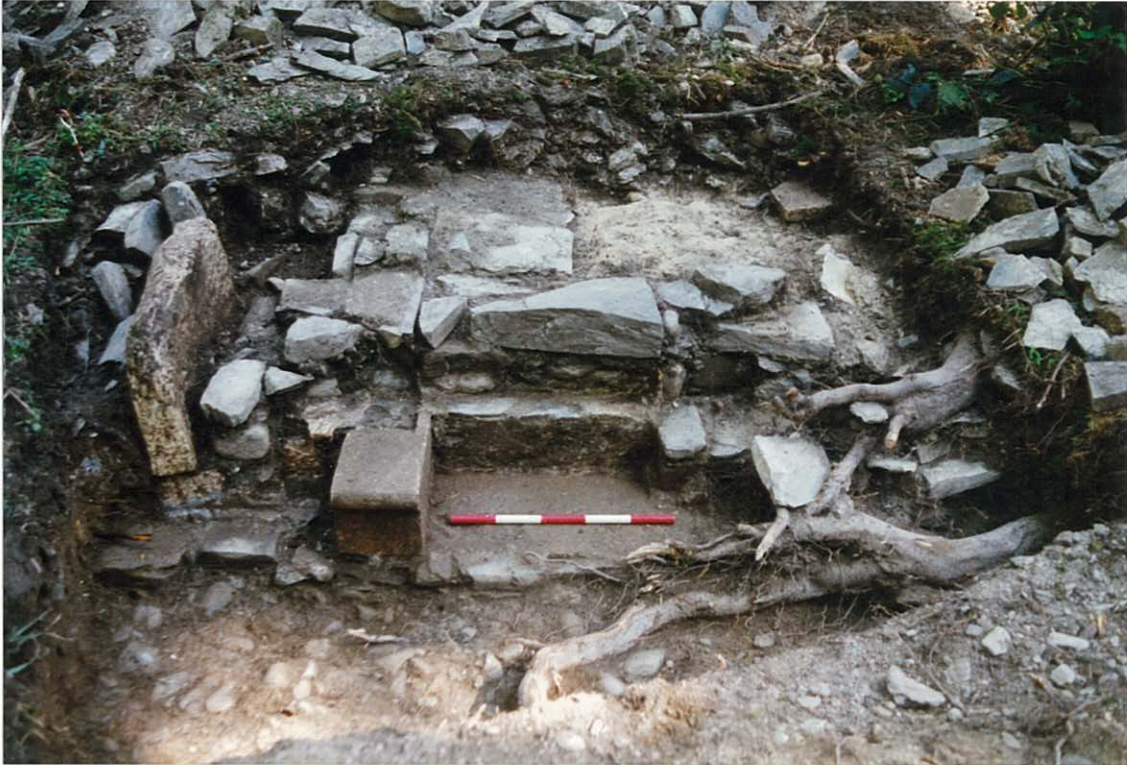
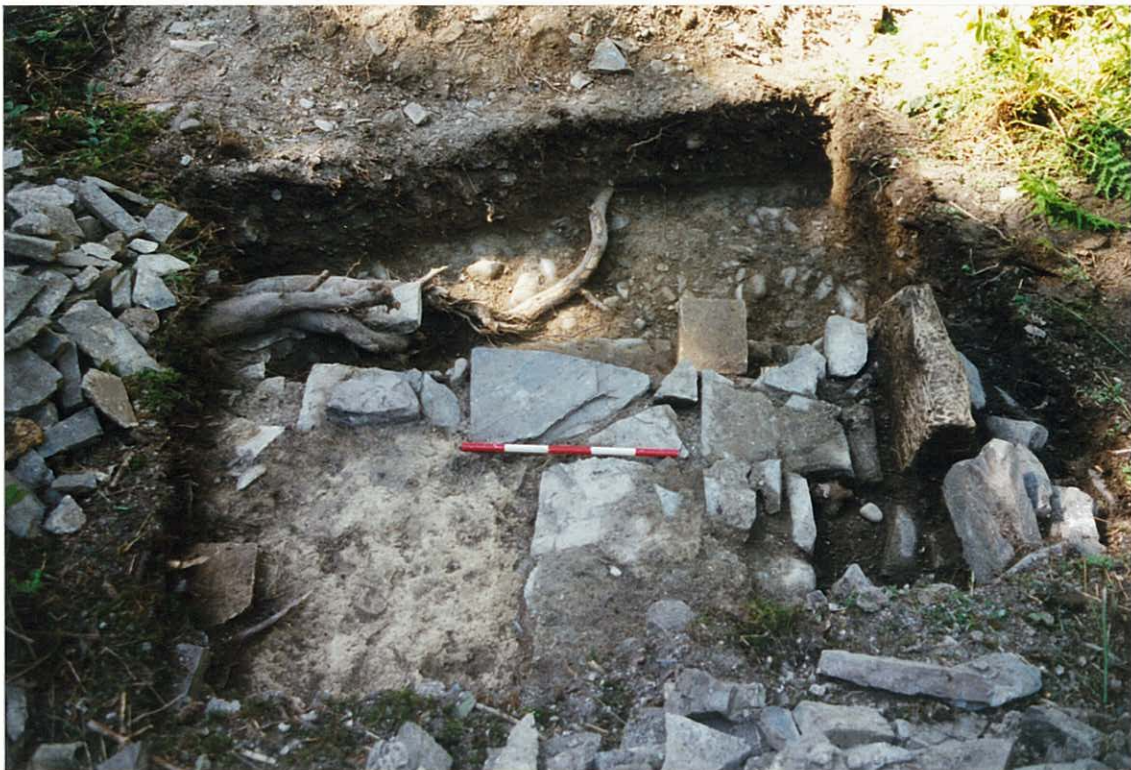
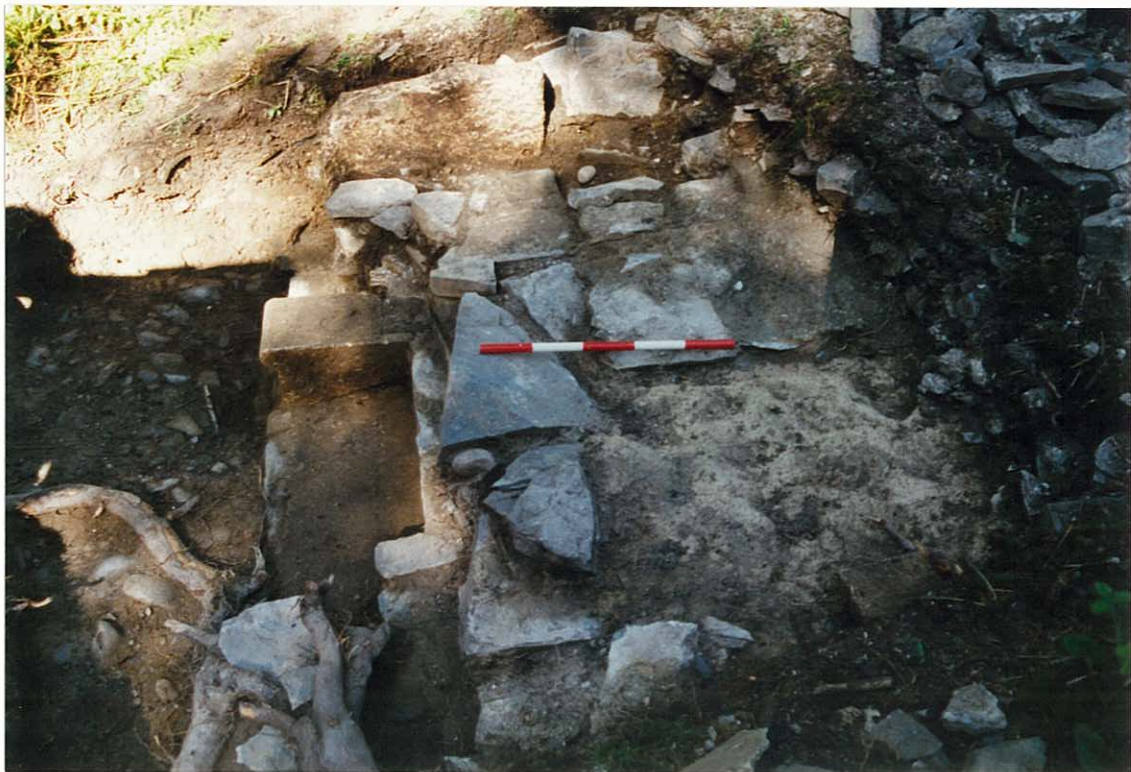
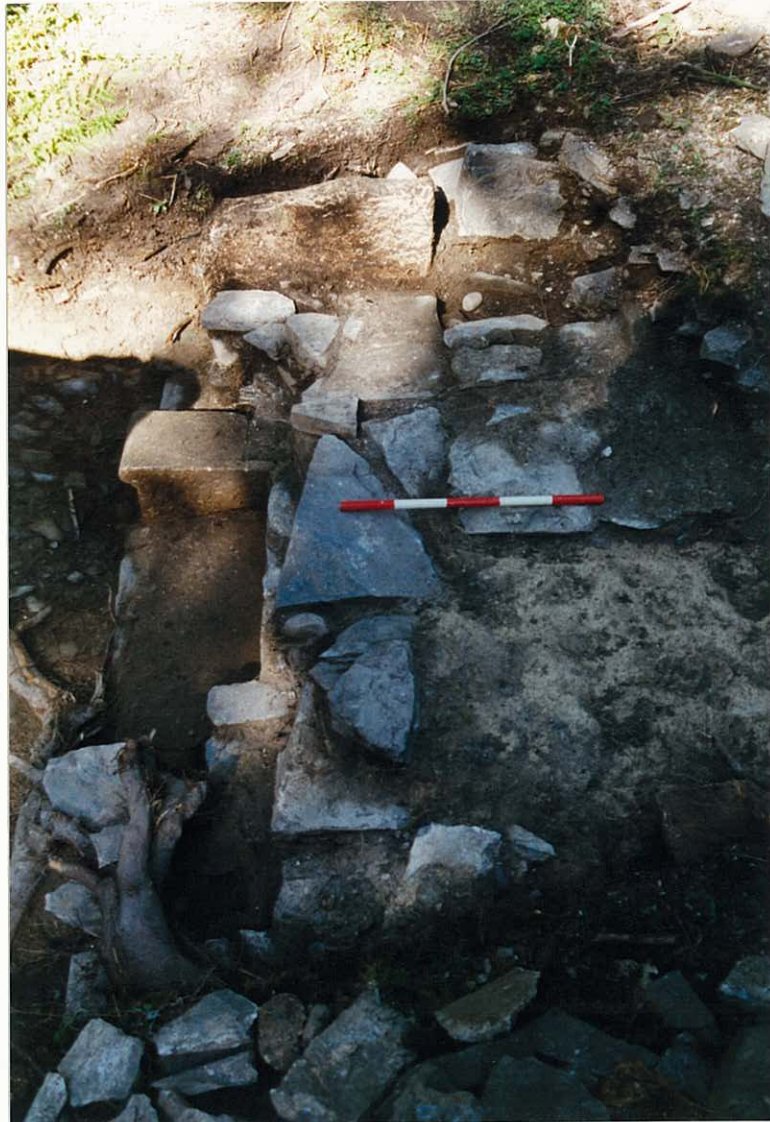
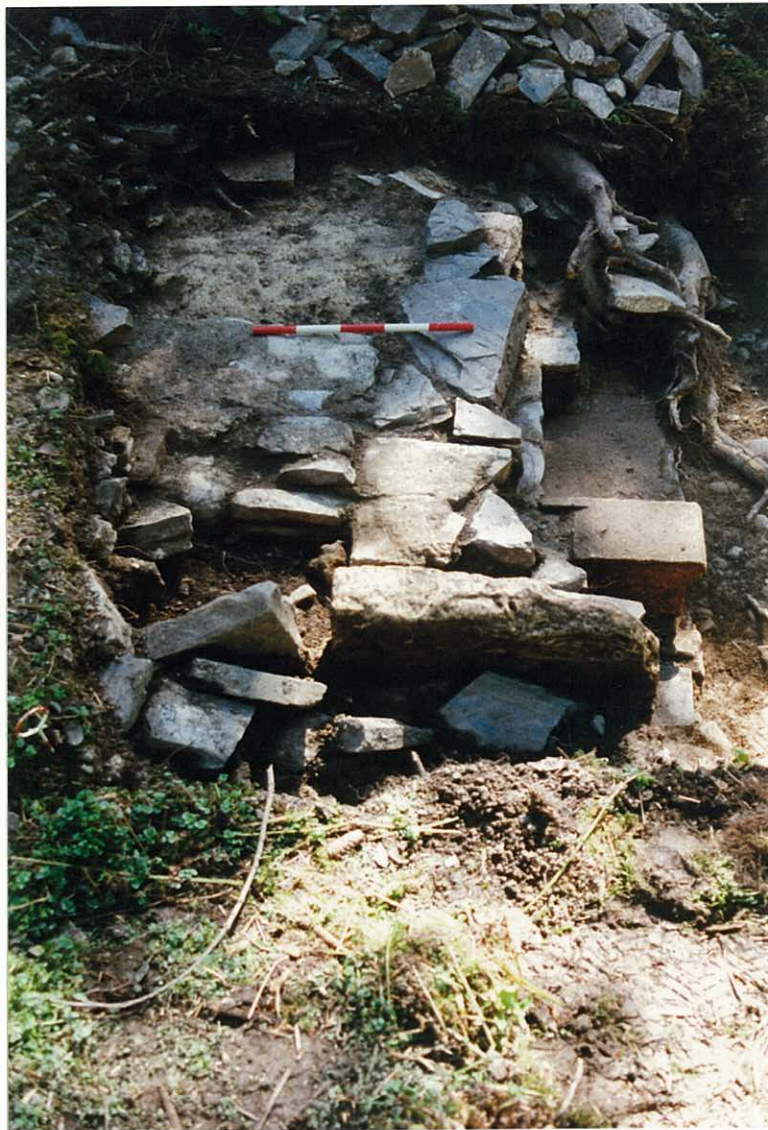
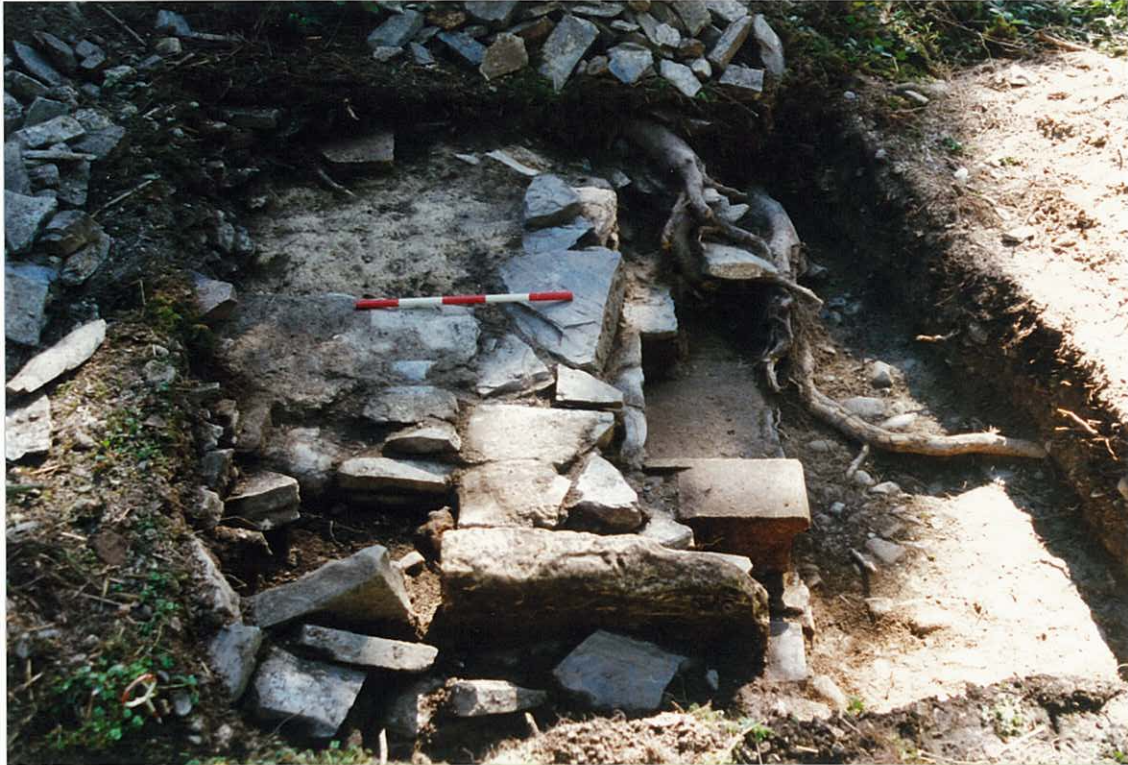
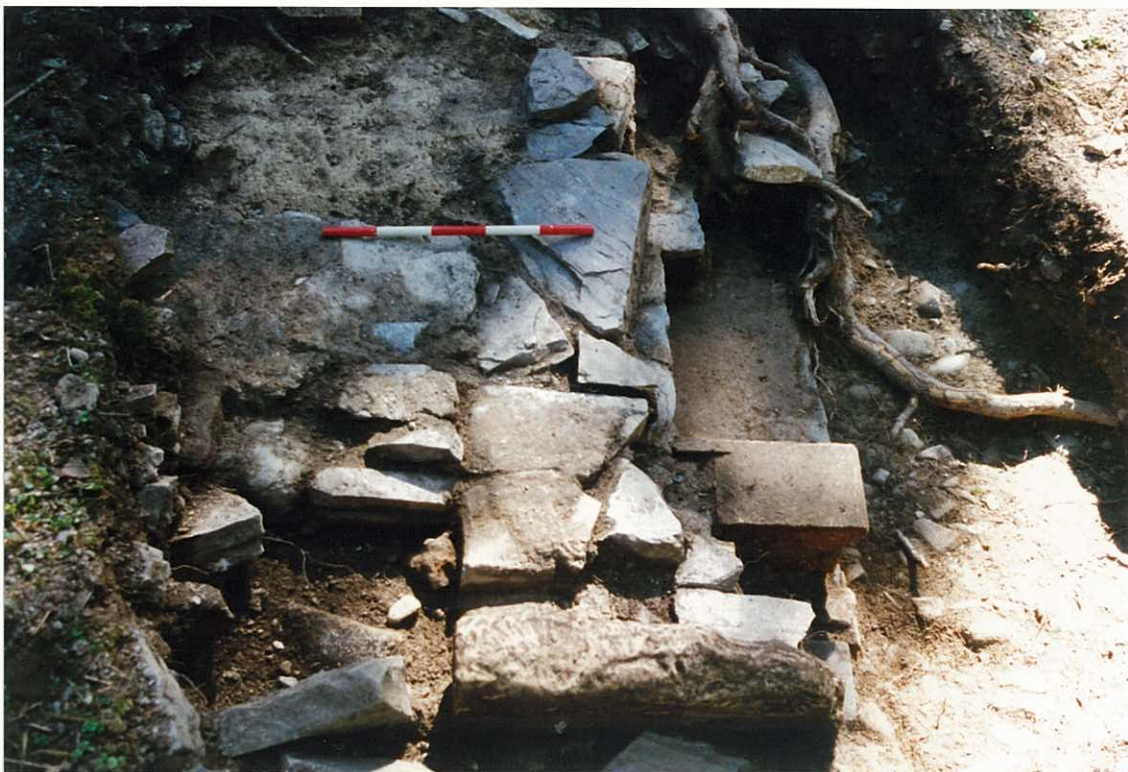
32. Trench 9.

33. Trench 9.

35. Trench 9.

36. Trench 9.

37. Trench 9.

38. Trench 9.

39. Trench 9.

(Figs. 2, 12 & 13; Colour photos. 32-39)

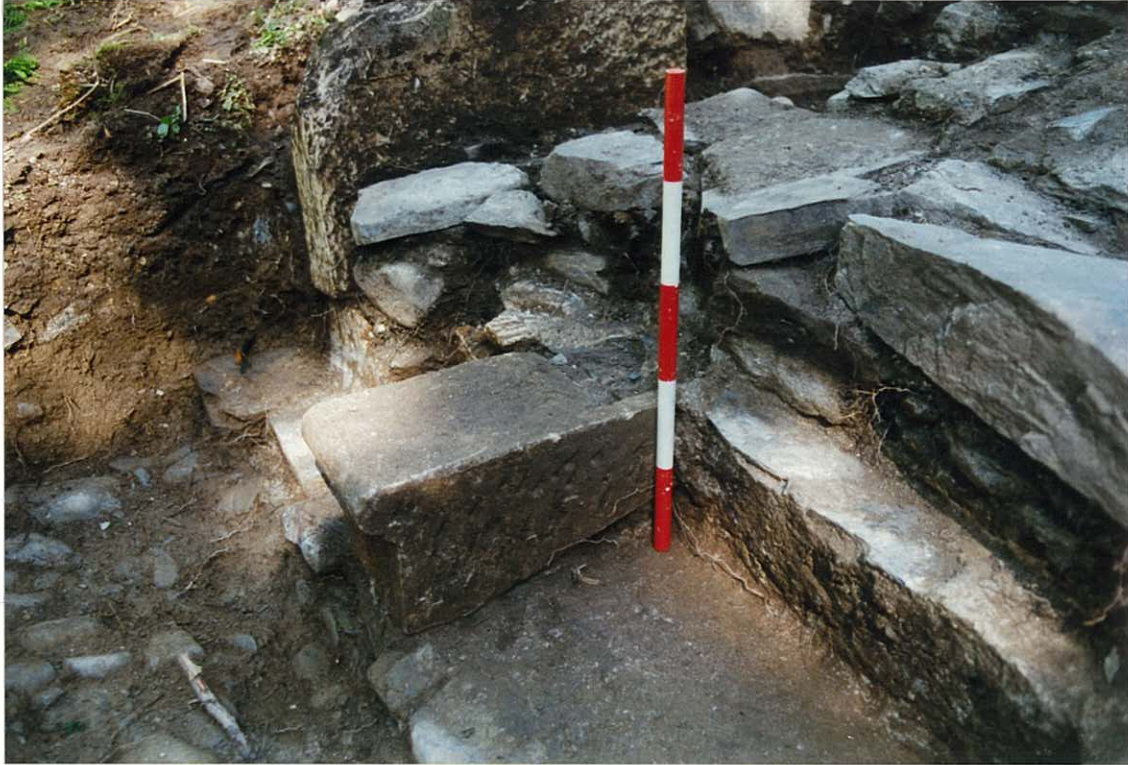
34. Trench 9, detail of step.
