HAFOD STABLE COURTYARD WATCHING BRIEF ON NEW SEWERAGE SERVICES

REPORT NO. 2001/50

AUGUST 2001

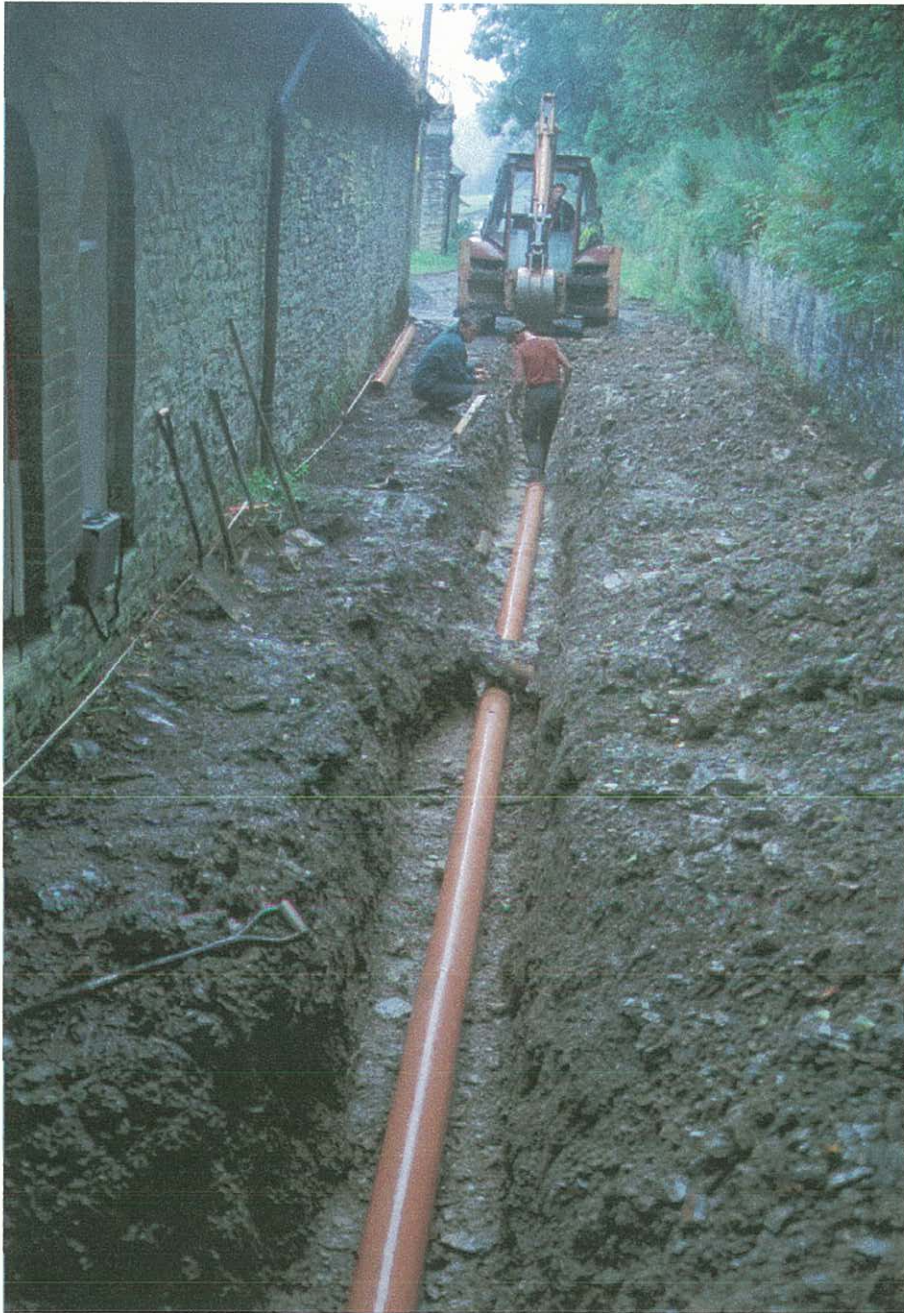
Photograph 2. Working shot during excavation of sewerage pipe trench on north-west side of stable block.

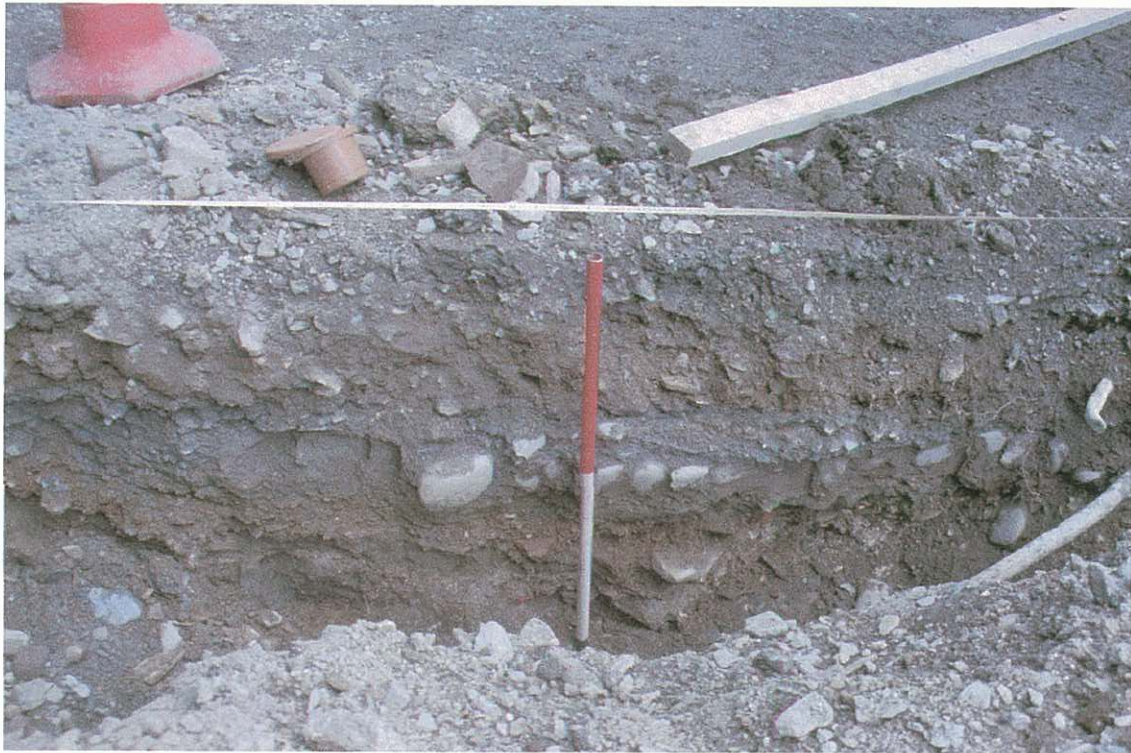
A discrete 2.2m length of pitched stone cobbling (**J**) was revealed in the west facing section of the pipe trench at a depth of 0.42m below the present ground surface. The rounded river washed pebbles averaged 0.10m x 0.10m in size and were set in a matrix of homogeneous greyish brown silty sand, the combined depth of the pebbles and sand averaged 0.22m. This pitched stone metalling exhibited a very gradual slope down from north to south and its upper surface was 0.45m below the present ground surface. The section also showed that the

previously mentioned buried ground surface lay 0.12m above the pitched stone cobbling. The cobbles were not represented in the opposite section of the pipe trench although the rest of the stratigraphic sequence appeared very similar, suggesting perhaps that the excavations destroyed a possible border edge of this feature.

Photograph 3. View of west facing section showing pitched cobbling (J).

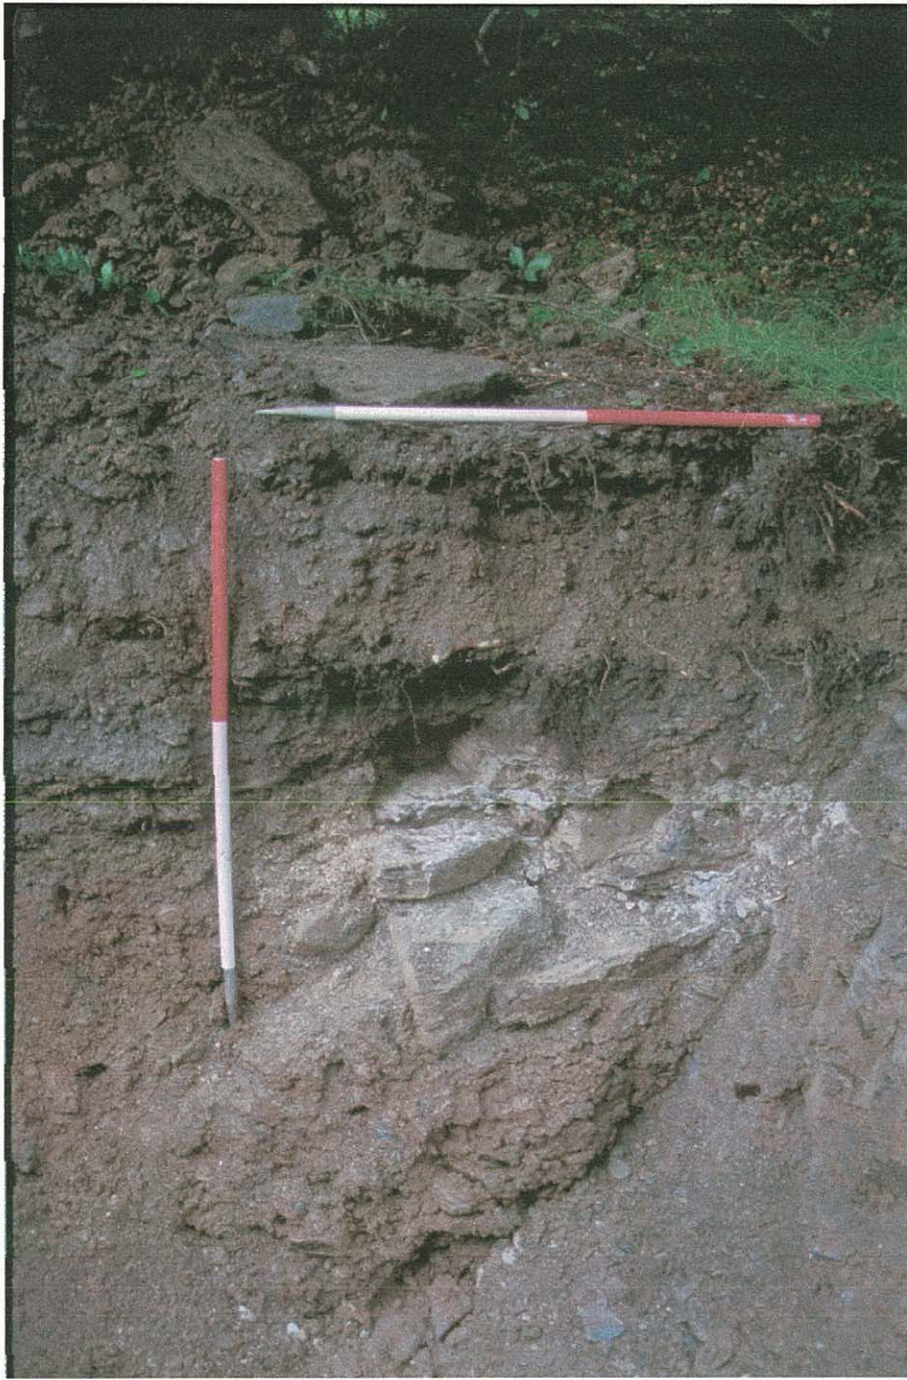
The corner of a possible building foundation for the mansion (**N**) was exposed in the south west corner of the cess pit trench, and showed clearly in the north facing section. This feature comprised three courses of lime mortared stone measuring 0.60m in height and 0.70m wide continuing into the east facing section of the cess pit trench. The coursed stonework, which was level, protruded at an angle of 90 degrees from the north facing section for some 0.40m and exhibited a right angle return as it continued to the west beyond the edge of the excavations. The top of the stonework lay 0.60m below the present ground surface, and was sealed by a 0.20m deep compact grey silty clay soil containing 70% small angular gravel fragments. This layer was topped by a thin layer of buried humic soil which again represented a soil horizon build-up on the buried ground surface make-up layers noted previously as lying

on the pitched cobble layers **J** and **M**. A near vertical foundation cut for **N** was seen to cut into the natural orange brown silty clay subsoil to a depth of 0.40m and the space between it and the footing was filled with a mortar rich silty clay soil. The stonework suffered a little damage during the groundworks but it was possible to leave the feature *in situ* and largely untouched.

Photograph 4. Probable foundation footing (N) of mansion.

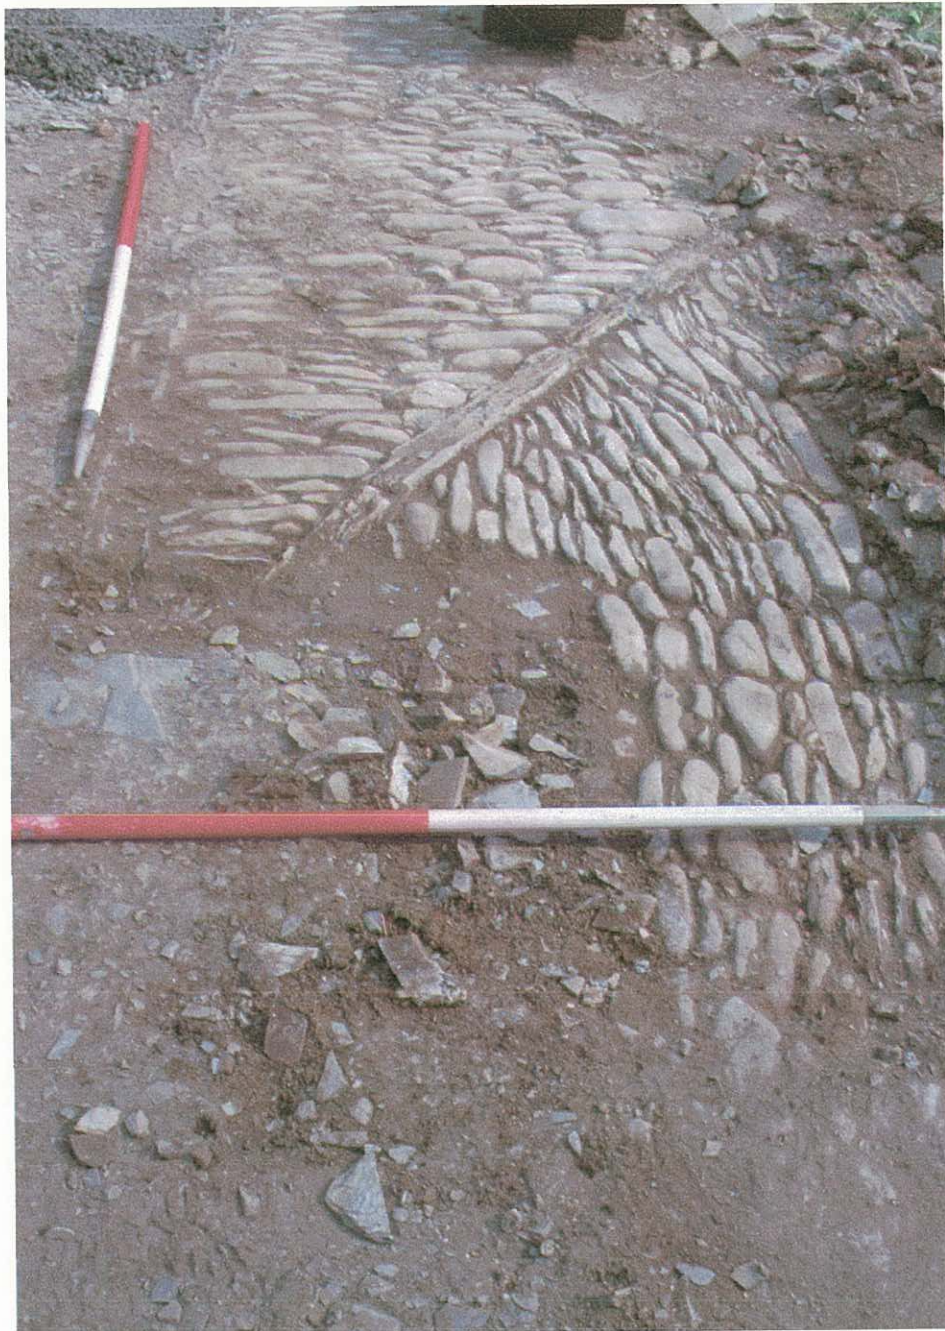
During topsoil clearance and preparation for the construction/laying of the stone apron in the stable courtyard a pitched cobble surface (**O**) was revealed. The cobbling was very well preserved and had been protected by a thin layer of concrete. As a result of this find the location of the stone apron was changed to a position which would leave the cobbling unaffected.

Photograph 5. View of pitched cobbling (O) uncovered in stable courtyard.

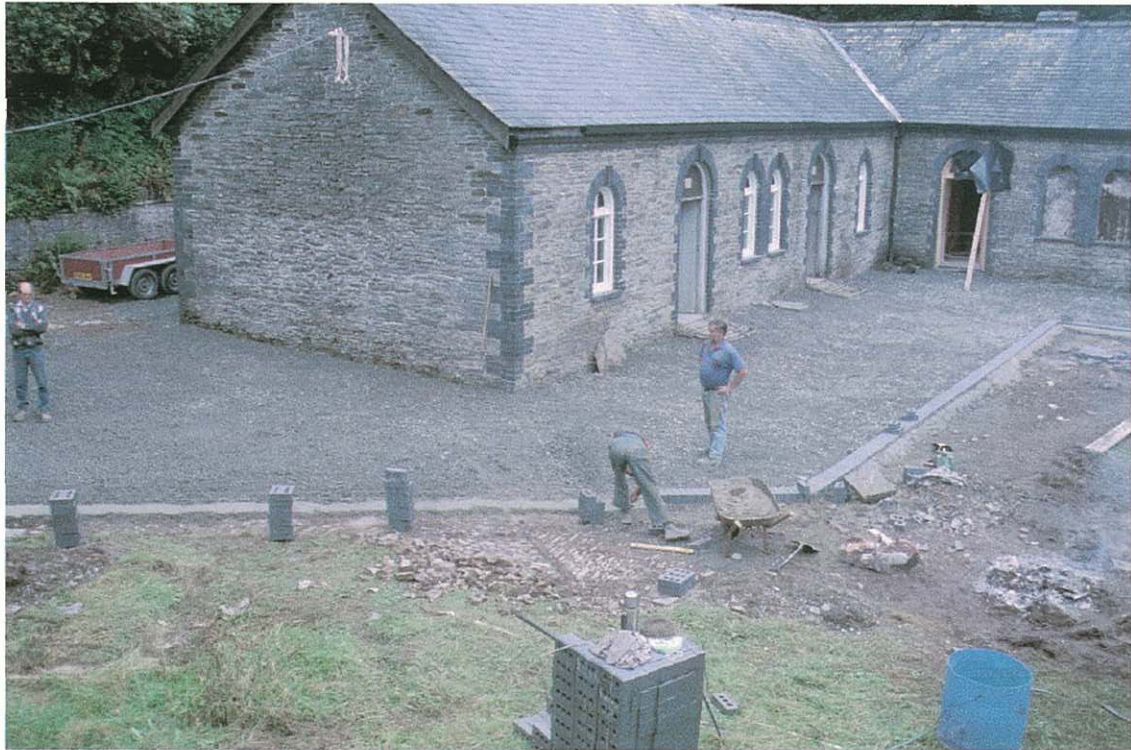
Photograph 6. View of stable courtyard looking north during laying of stone apron. Pitched cobbling (O) in foreground.
