MRS JOHNES' FLOWER GARDEN, HAFOD

RHIF YR ADRODDIAD / REPORT NO. 2010/29
Project No 99577

Mrs Johnes' Flower Garden, Hafod

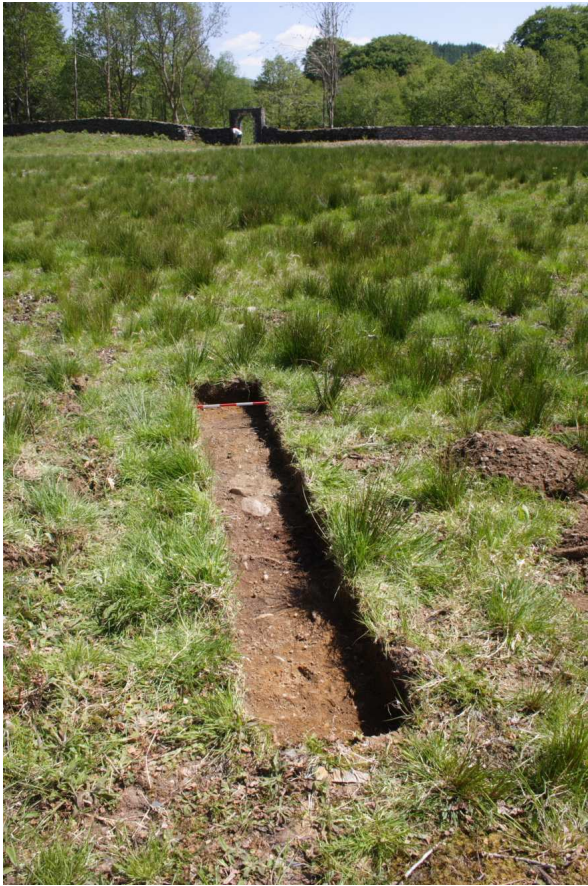
Photograph 1. Trench 1 looking east.
Scale 0.5m. The path is visible as a
slightly darker band running across the
trench.

Trench 1 (Photo 1)

Trench 1 was located over the circuit path on the west side of the garden. The path was found to coincide with the position of the one shown on the 1st Edition OS 1:2500, though narrower.

Topsoil: c. 180mm thick, but less, c. 120mm thick over the path. Loose mid/dark brown, loose silty-loam with occasional small/medium-sized rounded stones. High organic content and many roots. A sherd of a red pottery flower pot was found in the topsoil.

Path: A slightly raised band of loose stones and gravel, c. 1.5m wide. It was very poorly defined, with the stones spread over the neighbouring subsoil. Occasional river cobbles (200mm x 100mm x 50mm) were present, but most of this layer was made up of rounded stones c. 50mm x 20mm x 20mm and gravel. The gravel was patchy, but where present formed a coherent surface. The path had been laid in a shallow, linear hollow (c. 100mm deep maximum) scraped out of the subsoil. At its thickest, this layer of stones and gravel making up the path was c. 150mm thick. It is likely that most material for this path was obtained from the river gravels of the Ystwyth 100m to the south.

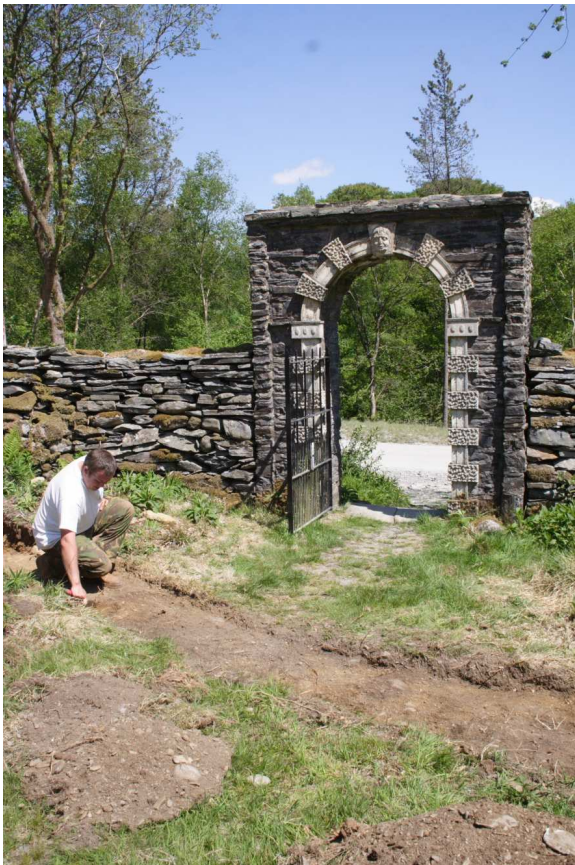
Photograph 2. Trench 2 looking
east towards the east gate.

Trench 2 (Photos 2-4)

This trench was located just within the east gate to the garden. The 1st Edition OS 1:2500 map seems to show the gate in a slightly different position to its present location. It has been suggested that it was relocated during restoration in the 1980s. The trench was located to ascertain whether the gate had been moved.

Path: This was difficult to identify as it had been spread over the surface of the subsoil. It consisted of a c. 1m wide band of loose stones and soil – the stones comprising c. 70% of the total. Gravel was the main component of the stones, but with occasional cobbles and smaller rounded stones. The stony/soily layer making up the path was set in a shallow linear hollow up to c. 100mm deep. The path was aligned on the present gate, indicating the gate is still in its original location, and that the locational discrepancy between the 1st Edition OS 1:2500 map and the modern survey is due to differences in surveying and is not actual. It is likely that most material for this path was obtained from the river gravels of the Ystwyth 100m to the south.

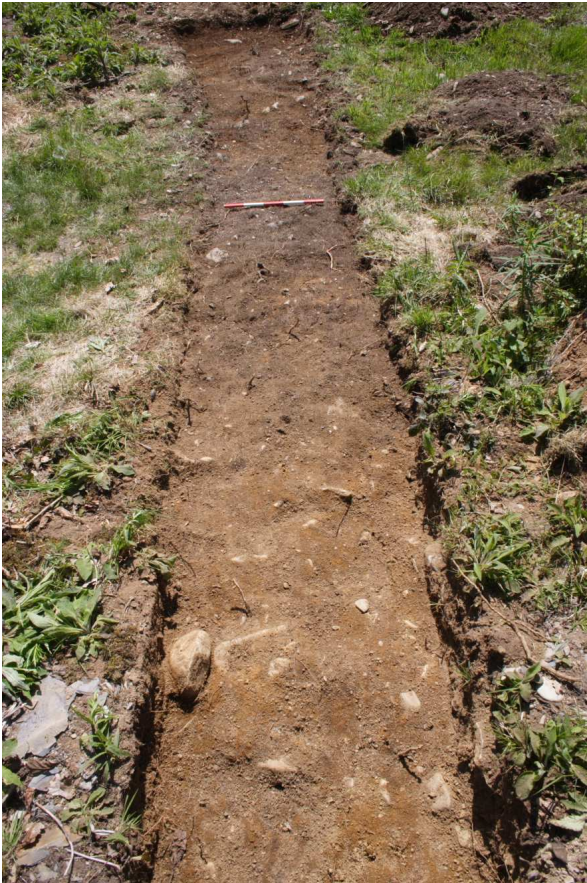
Left. Photograph 3. Trench 2 looking south. Scale 0.5m. The scale rests on the path running across the trench.

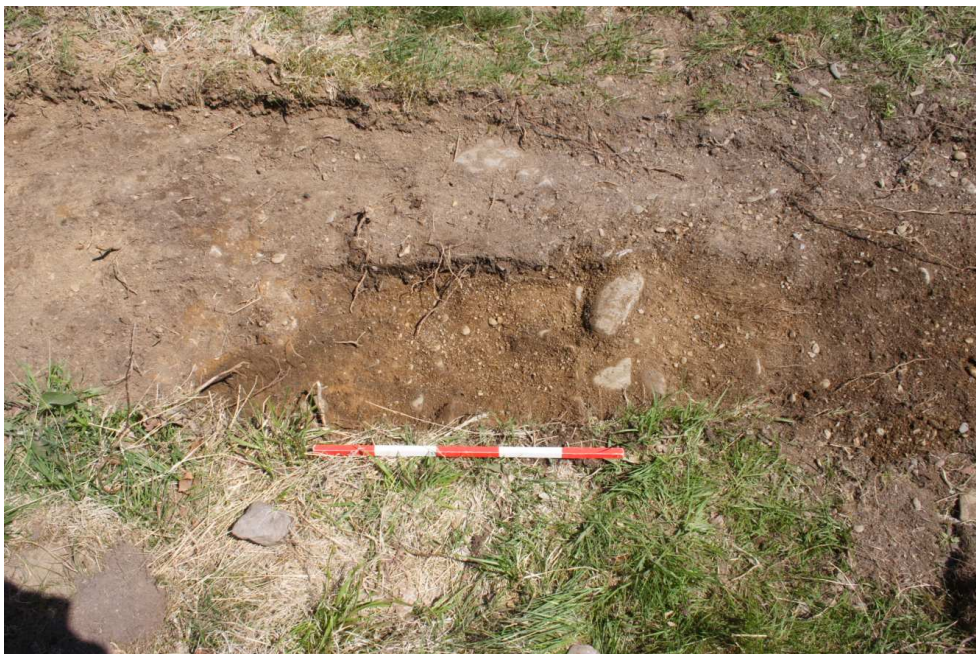
Below. Photograph 4. Trench 2. The path partly excavated showing the hollow in which the path make-up sits. Scale 0.5m.
