Prepared by DAT Archaeological Services  
for the Hafod Trust

RHIF YR ADRODDIAD / REPORT NO. 2017/48  
RHIF Y DIGWYLLIAD / EVENT RECORD NO.110511

# NEW BRIDGE CONSTRUCTION WORKS AT PONT NEWYDD (CD174), HAFOD, CEREDIGION ARCHAEOLOGICAL WATCHING BRIEF (SN77047361)

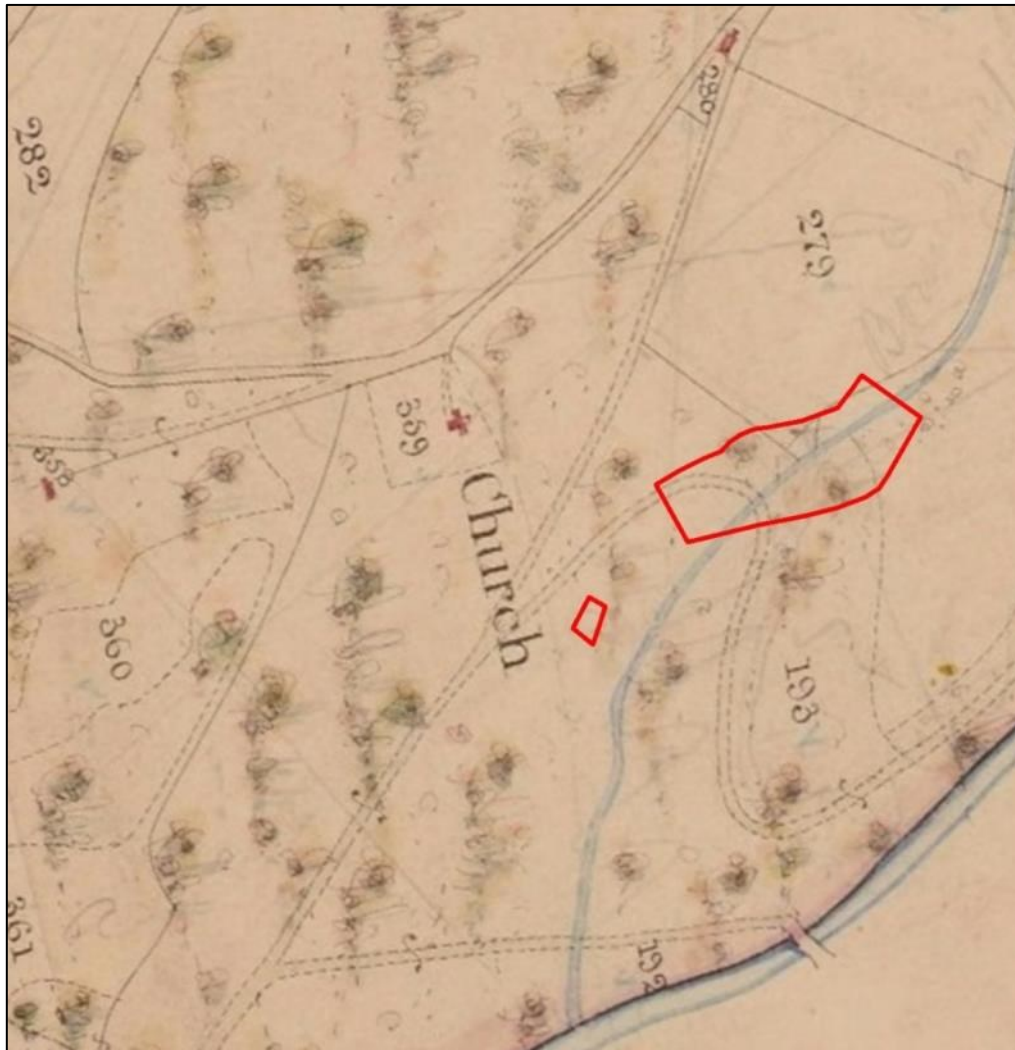
**Figure 4:** An extract from the Llanfihangel-y-Creuddyn tithe map of 1877 showing the carriage-ride crossing the Nant Peiran. The scheduled area of CD174 is shown in red.

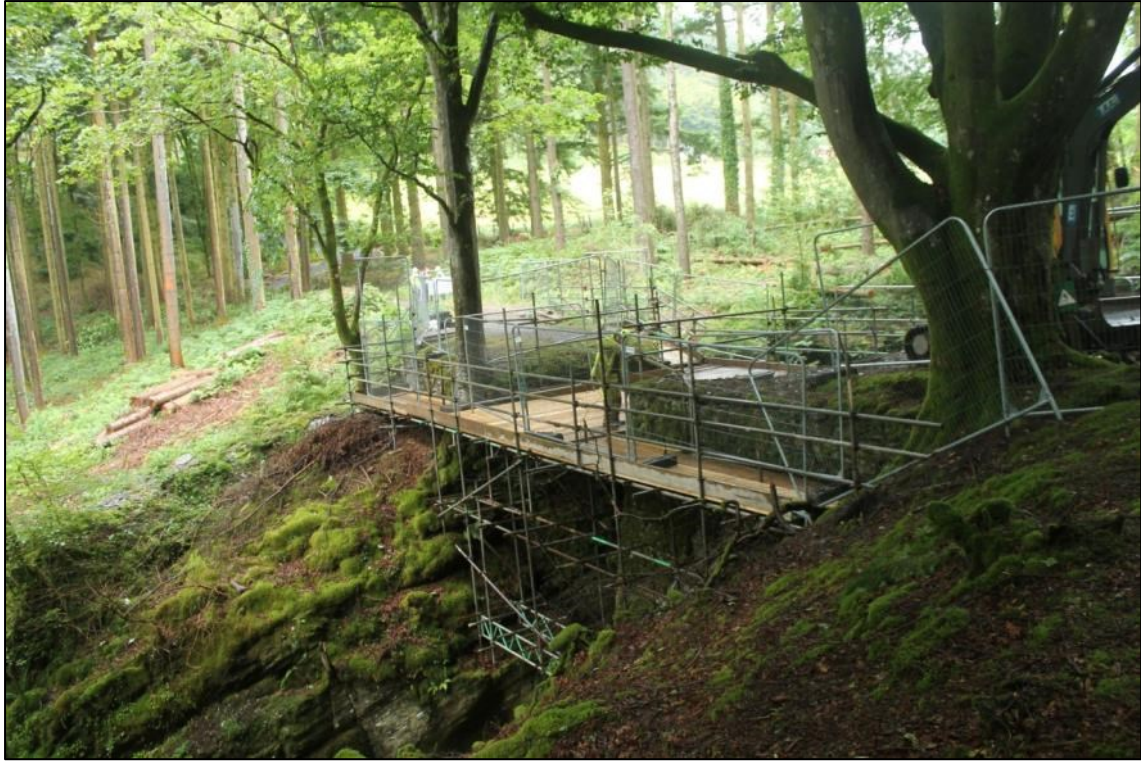
**Photo 1:** The scaffolding platform erected around Pont Newydd abutments. View facing north (DAT Photo 110511\_0021)

- 5.3 Work began first on the south-eastern abutment. The scaffolding platform enabled access to three sides of the top of the abutment which measured approximately 4.3m wide (Photo 2). A thick swathe of moss and leaf litter capped the western end of the structure but the south-western cap stone was visible, indicating the top of the masonry. The stonework in the southern elevation was visible and appeared to be coursed mudstone with no traces of mortar giving the appearance of being dry stone walled. Roughly dressed quoins were visible below the capstone which appeared to be the terminus for a number of capping stones along the southern wall. These overlapped the wall slightly, creating a short ledge c.0.1m over the top of the wall.

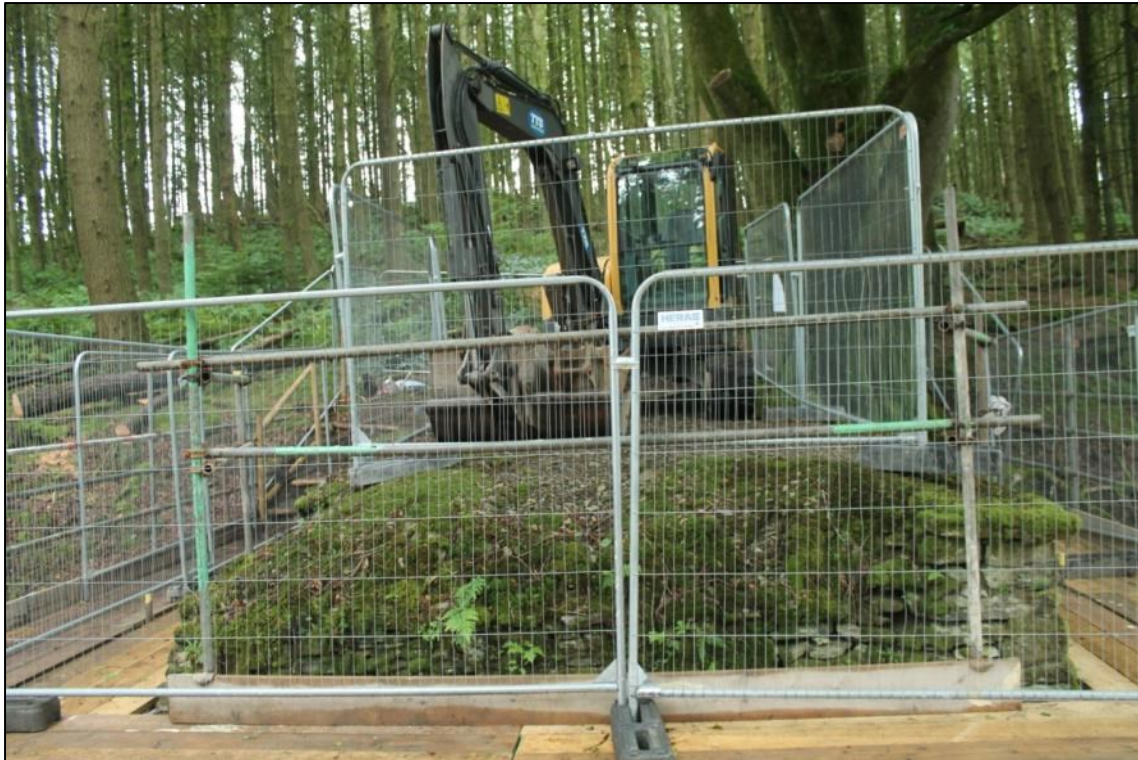
**Photo 2:** The south-eastern bridge abutment prior to works (DAT Photo 110511\_0001).

- 5.4 The majority of the masonry on the northern elevation had collapsed and there were no surviving capstones along this side. Approximately 0.3m of wall had been lost. Only a small section of the north-western corner masonry was visible from the scaffolding platform but there did not appear to be any quoins at this side of the abutment.

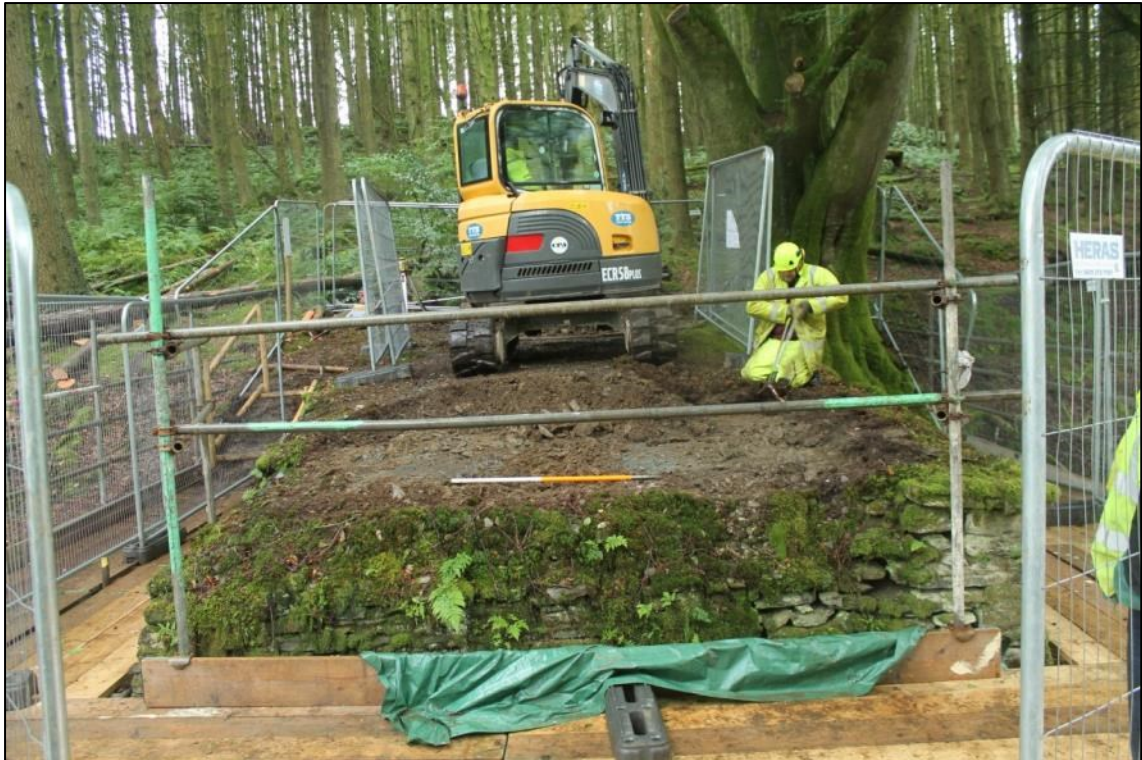
**Photo 3:** Removal of the surface deposits revealed the former carriage-ride surface. This had been truncated by a test pit in the centre of the abutment (DAT Photo 110511\_0006)

- 5.5 Excavation of the abutment fill was undertaken in careful spits and encompassed an area measuring 3.2m in length from the external face of the western elevation and roughly 3.40m wide (including approximately 0.3m intrusion into the southern wall). Around 0.2m of humic soils and leaf litter (101) was removed to reveal compacted grey, medium gravel (102) which is likely to have been the road surface of the carriage-ride (Photo 3). A test pit previously undertaken by the Hafod Trust to determine the nature of the abutment fill was revealed in the centre of the abutment (see Photo 3).

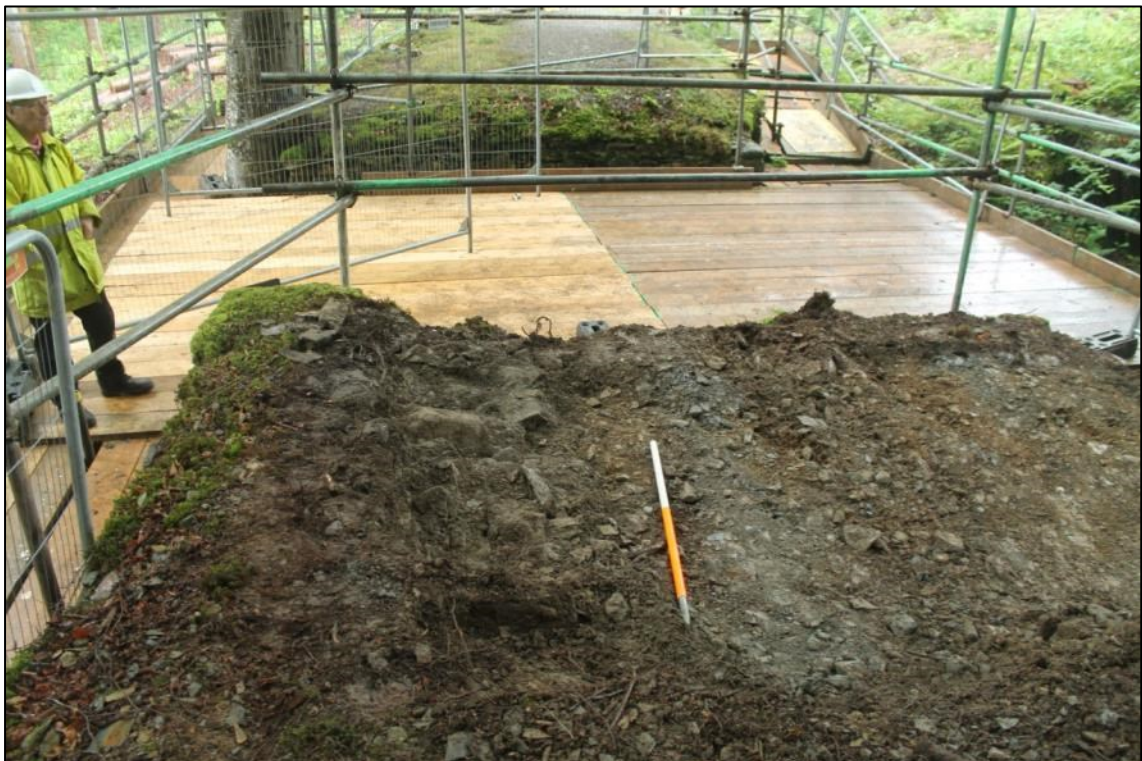
**Photo 4:** The internal wall line of the southern wall of the south-eastern abutment was revealed after removing the compacted grey deposit (102). A remnant of this is still visible to the right of the ranging pole (DAT Photo 110511\_0009).

- 5.6 Removal of deposit (102) revealed that this material partially overlapped the masonry of the southern wall of the abutment, the full width of which was revealed at this level (Photo 4). This overlaid a bright orange, shattered mudstone and clay-silt subsoil (103) fill of the abutment. This deposit formed a slight camber, dipping away at the sides of the carriage-ride, butting the abutment walls. Two iron objects, likely to be components from the former timber superstructure, were retrieved from the detritus of this fill (Photo 5). The removal of this material from the surface of the western abutment wall was done by hand so as not to cause any unnecessary damage to the monument. This revealed an inset in the wall masonry for a timber bearing beam (Photo 6). This measured 0.2m wide, 0.12m deep and 2.0m in length and would have supported a square cut timber of similar dimensions.

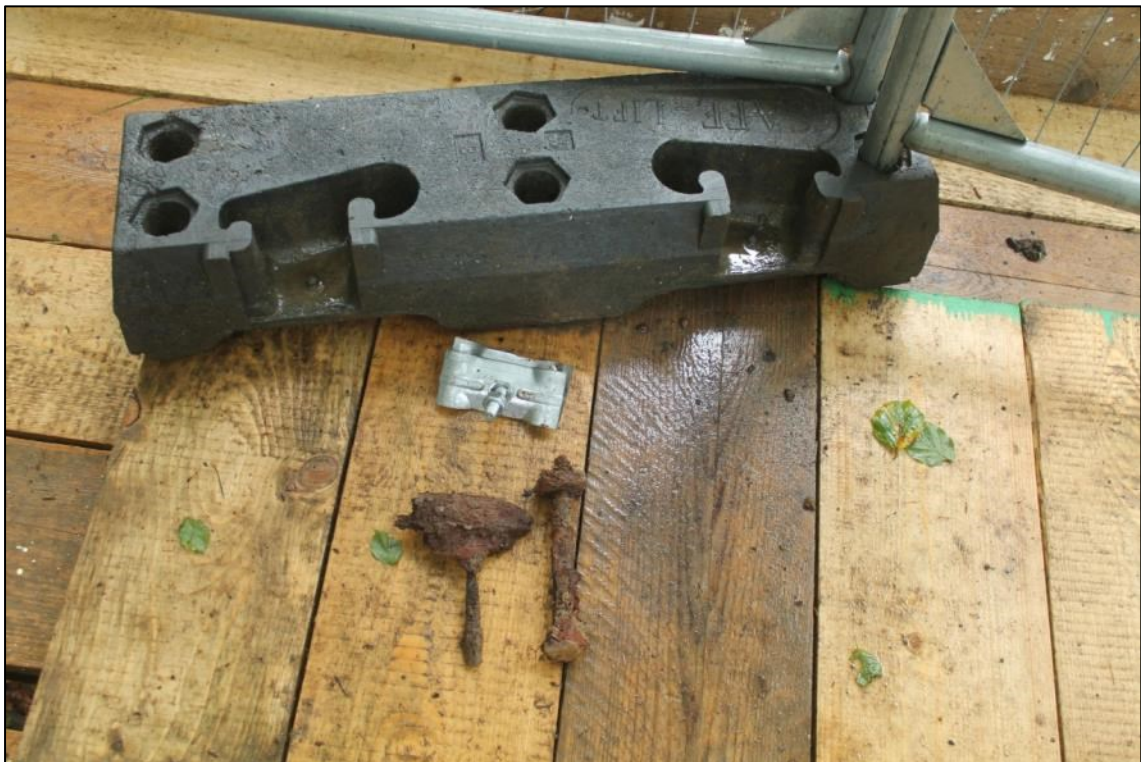
**Photo 5:** The two iron objects removed from the detritus of the abutment fill (DAT Photo 110511\_0022).

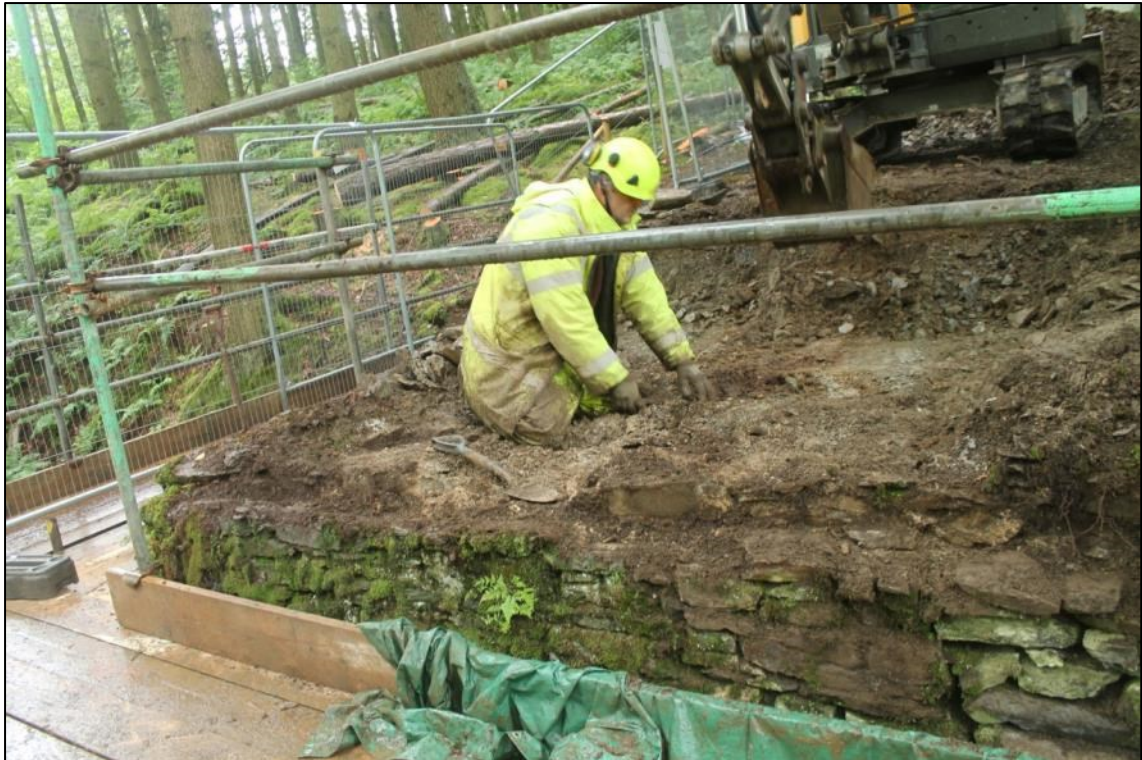
**Photo 6:** The insert for the bearing beam on the western face of the south-eastern abutment. The height of this wall was reduced by hand (DAT Photo 110511\_0014).

5.7 The architect's scope of works outlined the necessity for approximately 0.3m of the western wall masonry to be reduced below the level of the capstone to accommodate the concrete slab. Further to this it was necessary to dismantle between 0.3m and 0.5m width of the each of the walls (depending on how sound they were) to enable the liquid concrete to key into the existing masonry so as to spread the weight of the load down the walls of the existing structure. Owing to the condition of the structure, the western wall was reduced in height by around 0.4m. The dismantling of the walls was done by hand to limit un-necessary damage to the monument. These excavations revealed that the southern wall was quite substantial, measuring between 1.4m – 1.5m thick and was actually lime mortared with a rubble core (Photos 7 & 8). This returned from the western wall which also retained lime mortar and a rubble core but measured only 0.9m wide (Photo 9). The returning northern wall measured approximately 0.8m and was in very poor condition. It seemed that this wall had suffered the brunt of the elements for the lime mortar had weathered out or was much degraded. Consequently, the horizontally bedded mudstone masonry had lost its structural integrity causing it to slump and collapse into voids in the rubble core (Photo 10). This is the likely cause for the collapse and loss of masonry on this side of the monument.

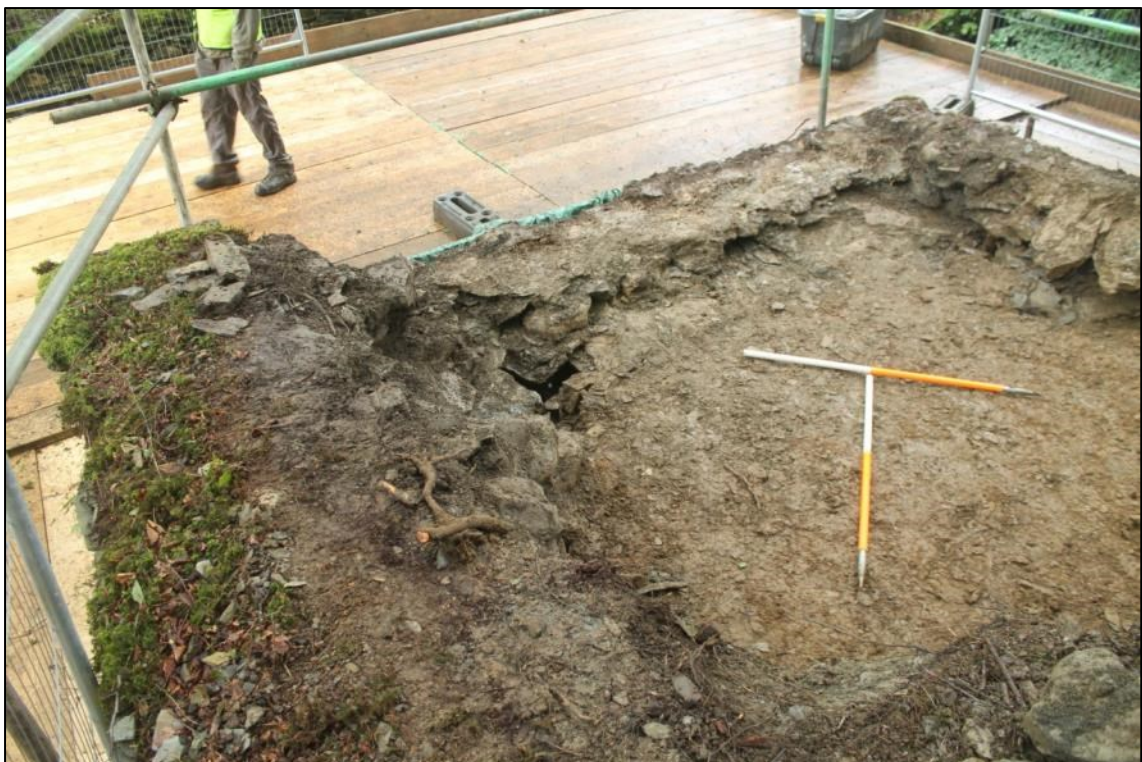
**Photo 7:** Overview of the final extent of the excavation in the south-eastern abutment. The extent of the southern wall is shown in the left side of the photograph (DAT 110511\_0029)

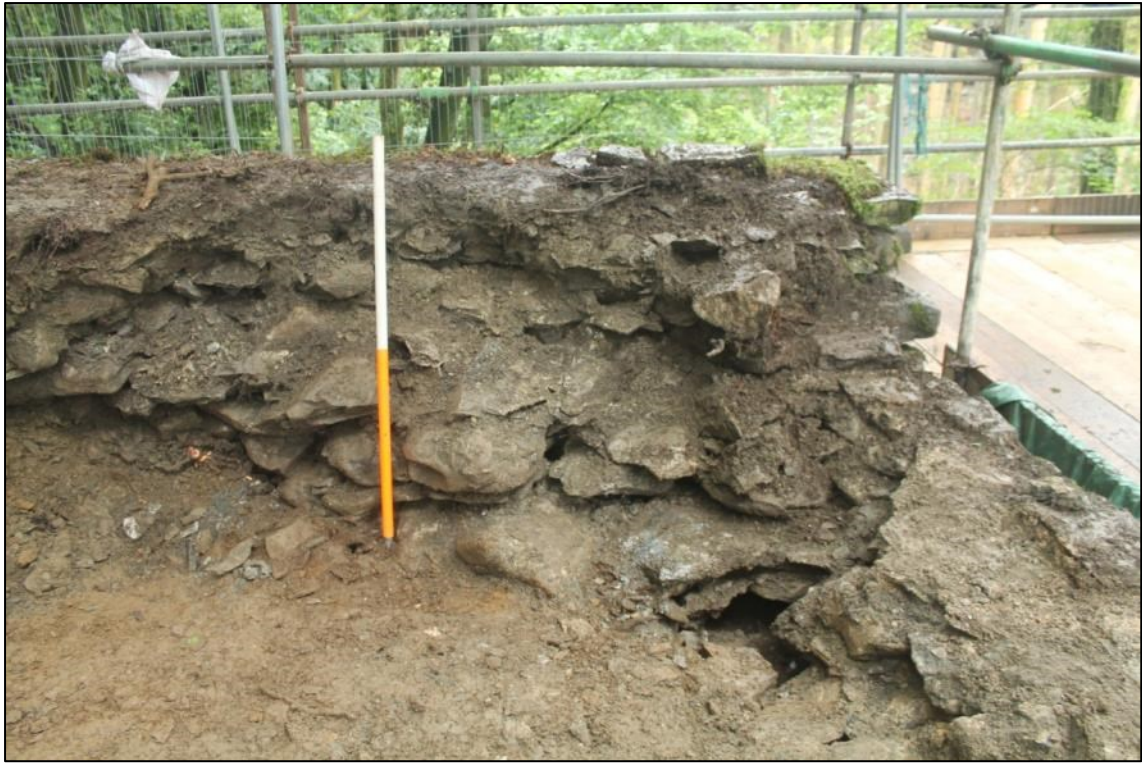
**Photo 8:** The partially dismantled internal face of the southern wall of the south-eastern abutment (DAT Photo 110511\_0026)

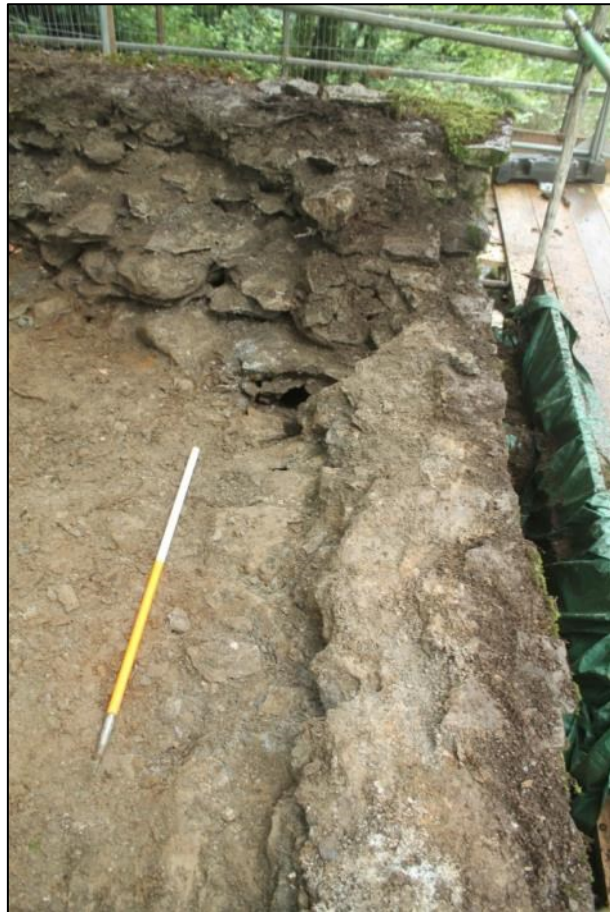
**Photo 9:** The partially dismantled western wall and southern return wall of the south-eastern abutment (DAT Photo 110511\_0028)

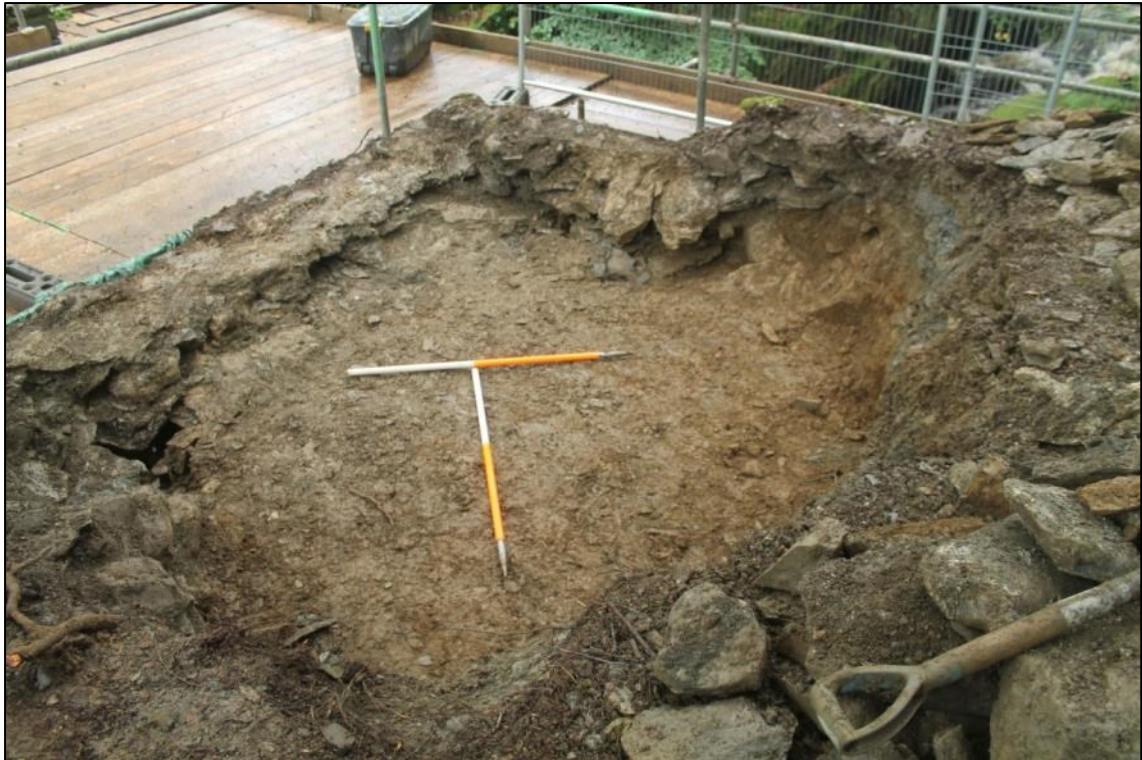
**Photo 10:** An overview of the final extent of the excavations in the south-eastern abutment showing the partially dismantled western and northern walls of the abutment (DAT Photo 110511\_0030)

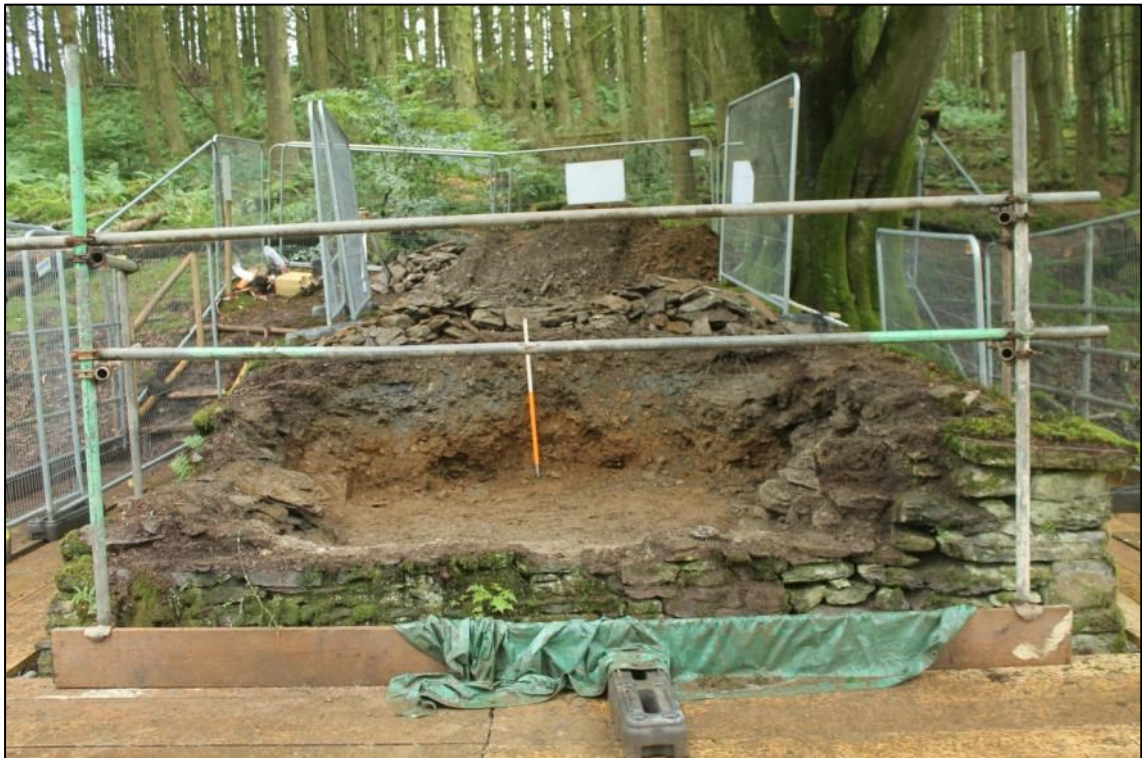
**Photo 11:** The section of the abutment infill and the reduced walls at the end of the excavations of the south-eastern abutment (DAT Photo 110511\_0024).

- 5.8 Overall, the excavated pit, including the partial dismantling of the abutment walls, measured roughly 3.2m long and 3.1m wide and revealed a section through the abutment fill measuring approximately 1m in depth (Photo 11). In this section around 0.4m of surface deposits (101 & 102) and 0.6m of the orange subsoil (103) were removed. The depth of the excavation from the top of the capstone on the south-eastern corner was approximately 0.5m.

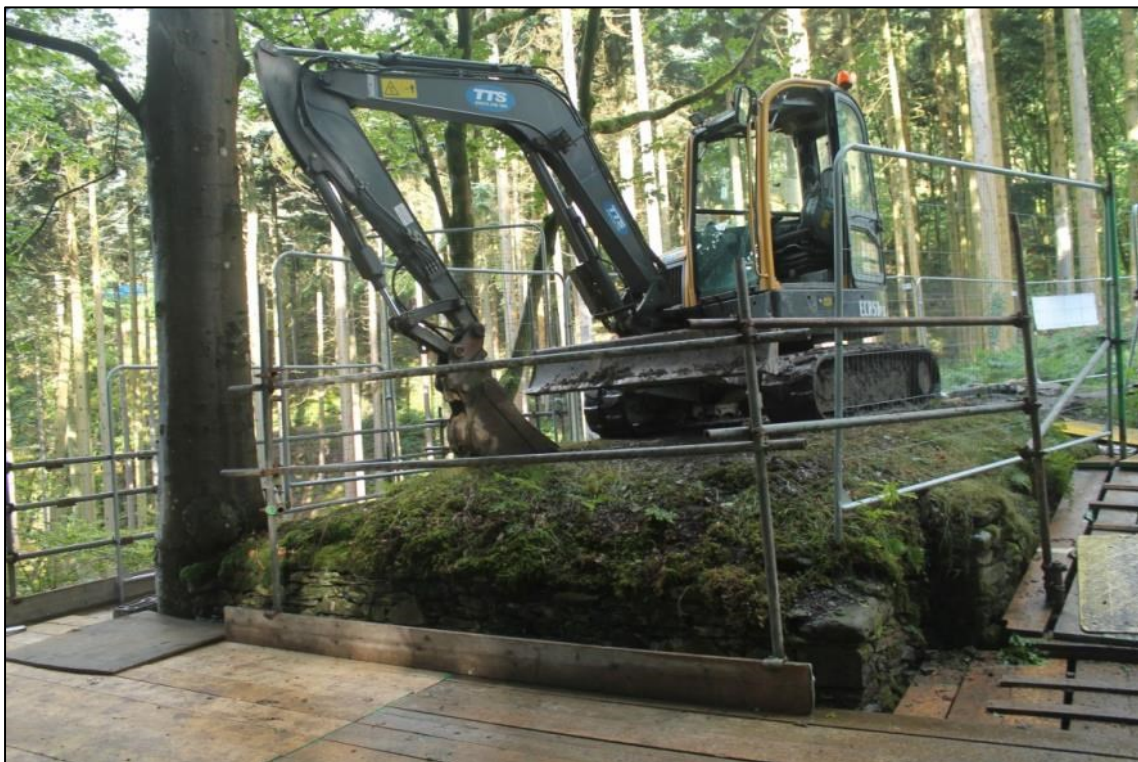
**Photo 12:** The north-western abutment prior to the start of works. Note the dogleg inset along the northern wall of the abutment (DAT Photo 110511\_0031).

- 5.9 The excavation of the north-western abutment followed a very similar process. Much like its partner, the abutment was topped by a thick carpet of moss and leaf litter. A large beach tree with a significant girth leaned heavily against the south-eastern corner of the abutment. The eastern elevation of the abutment measured 4.85m wide. Around 1.1m along the northern elevation, the abutment dog-legged some 0.3m and created an inset along this side of the monument (Photo 12).

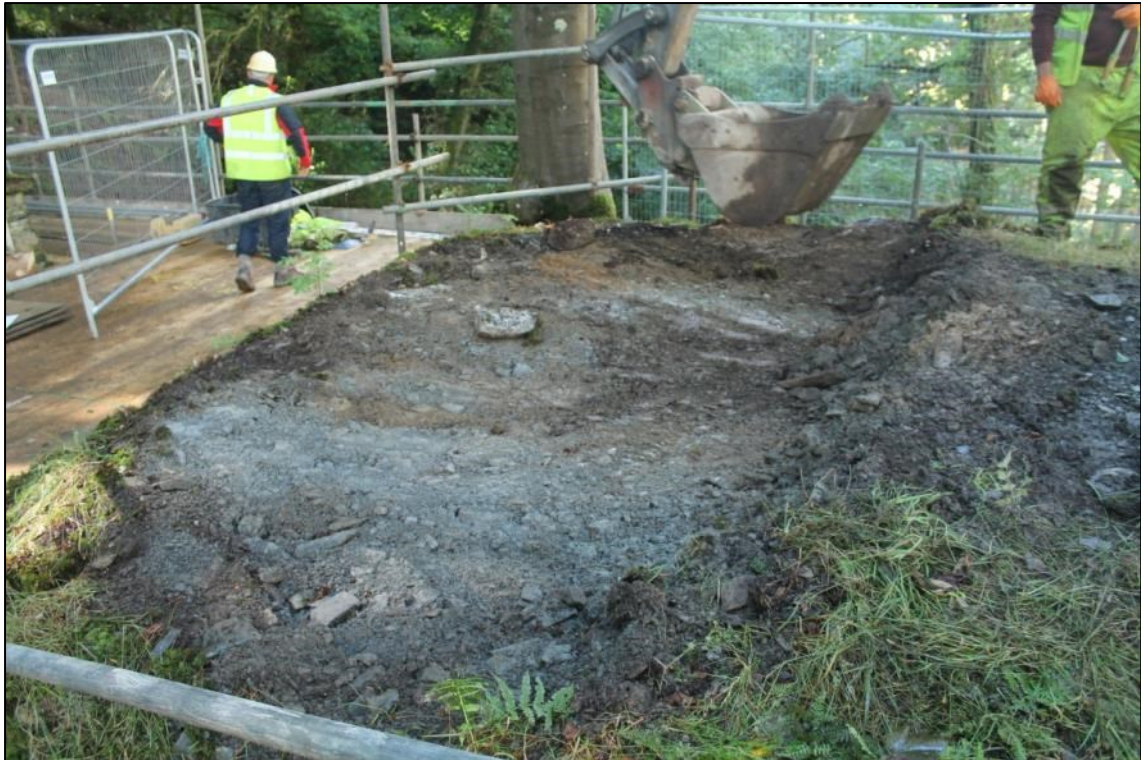
**Photo 13:** The grey deposit (202) revealed during the early stage of excavation of the north-western abutment (DAT Photo 110511\_0033).

- 5.10 The superficial humic deposits (201) were removed and revealed a deposit of grey, gravel (202); the former carriage-ride (Photo 13). Evidence of another test pit was noted here and the excavation continued with the removal of the bright orange, shattered mudstone, clayey-silt subsoil (203) abutment infill (Photo 14). The widths of the walls were revealed including a corresponding inset for a bearing timber along the eastern wall which measured 0.18m wide, 0.15m deep and 2m long (Photo 15).

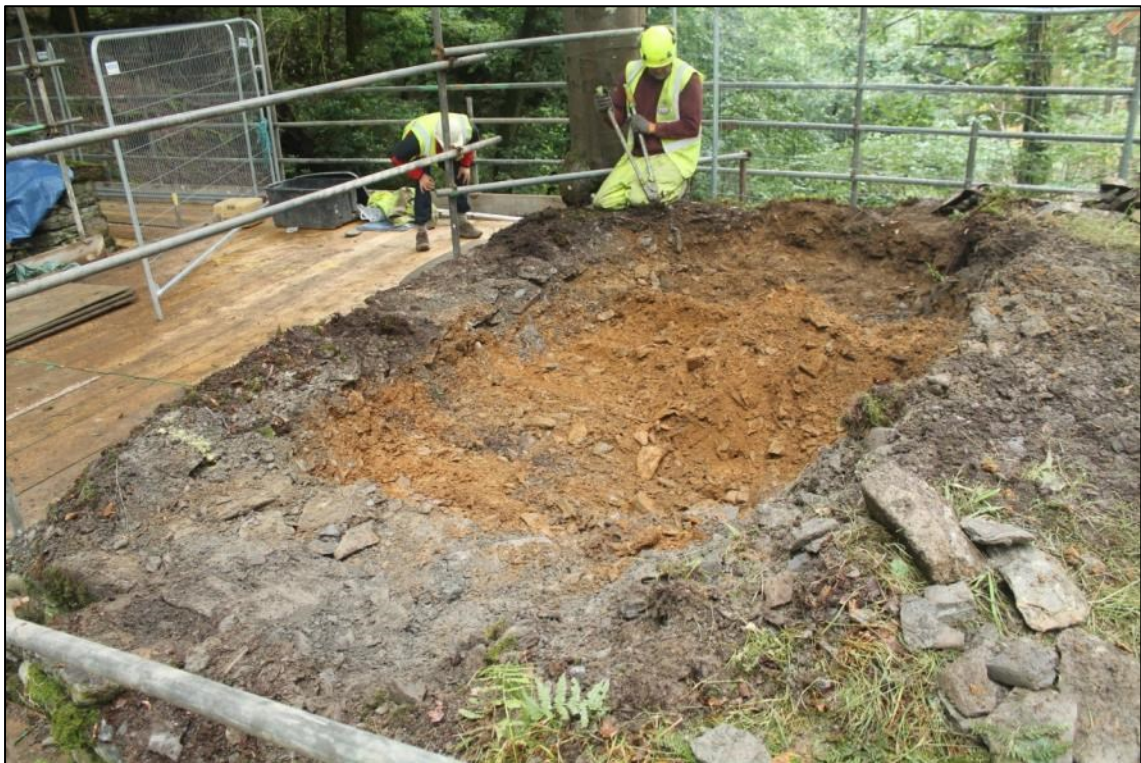
**Photo 14:** The orange subsoil infill (203) revealed in the north-western abutment (DAT Photo 110511\_0034).

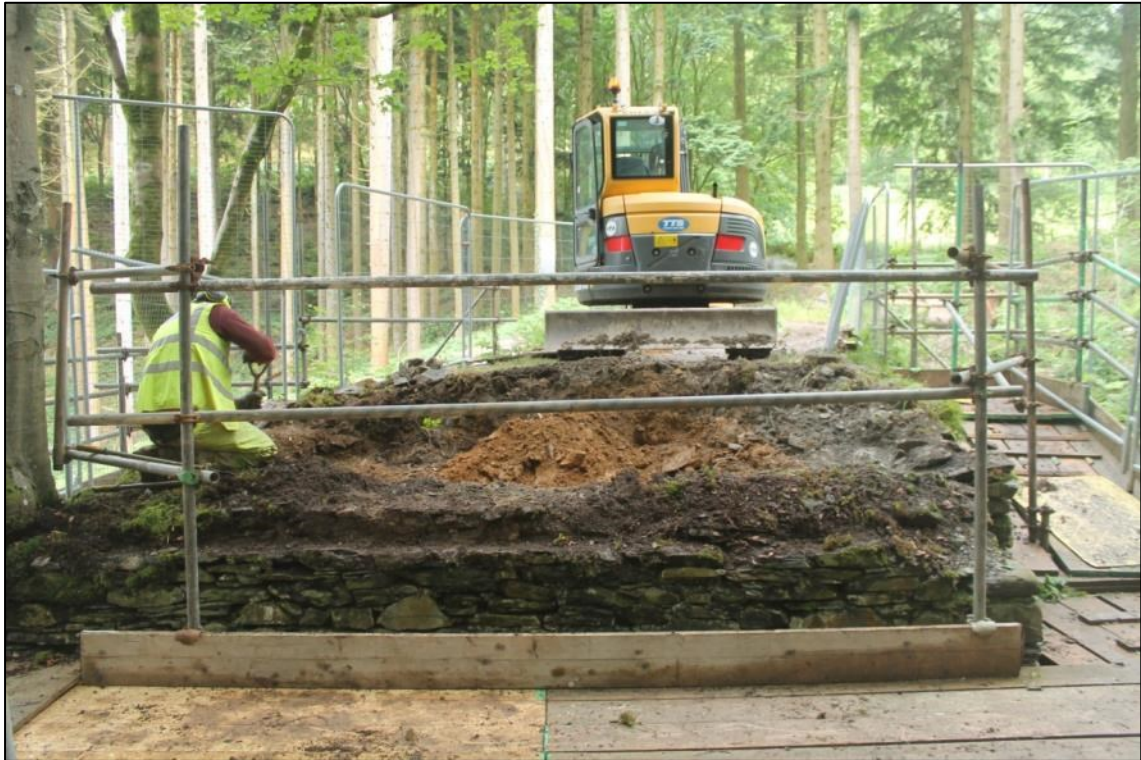
**Photo 15:** The bearing beam inset revealed on the eastern wall of the north-western abutment (DAT Photo 110511\_0035).

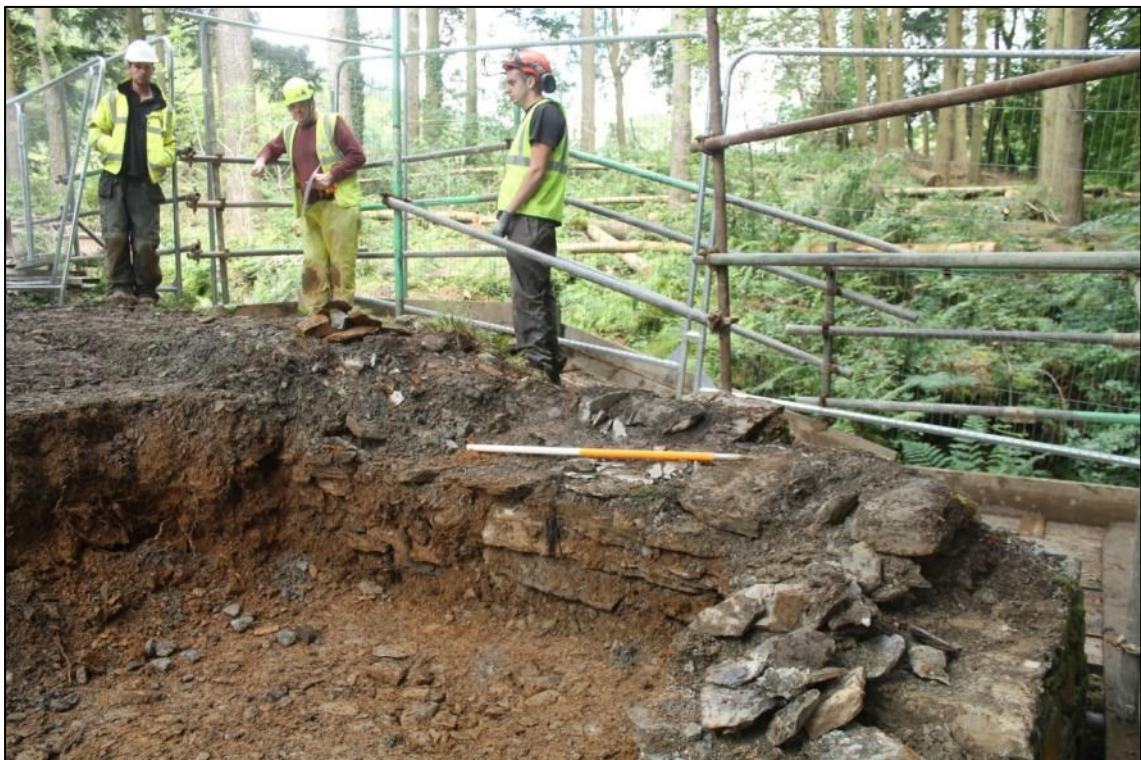
**Photo 16:** The substantial northern wall of the north-western abutment (DAT Photo 110511\_0046).

5.11 In contrast to the other abutment, the northern wall was found to be far more substantial and measured between 0.8m and 1.2m wide (including the width of the dogleg inset) and retained its lime mortar and coursing (Photo 16). It returned from the eastern wall of the abutment which measured 0.8m wide and was also lime mortared with a rubble core

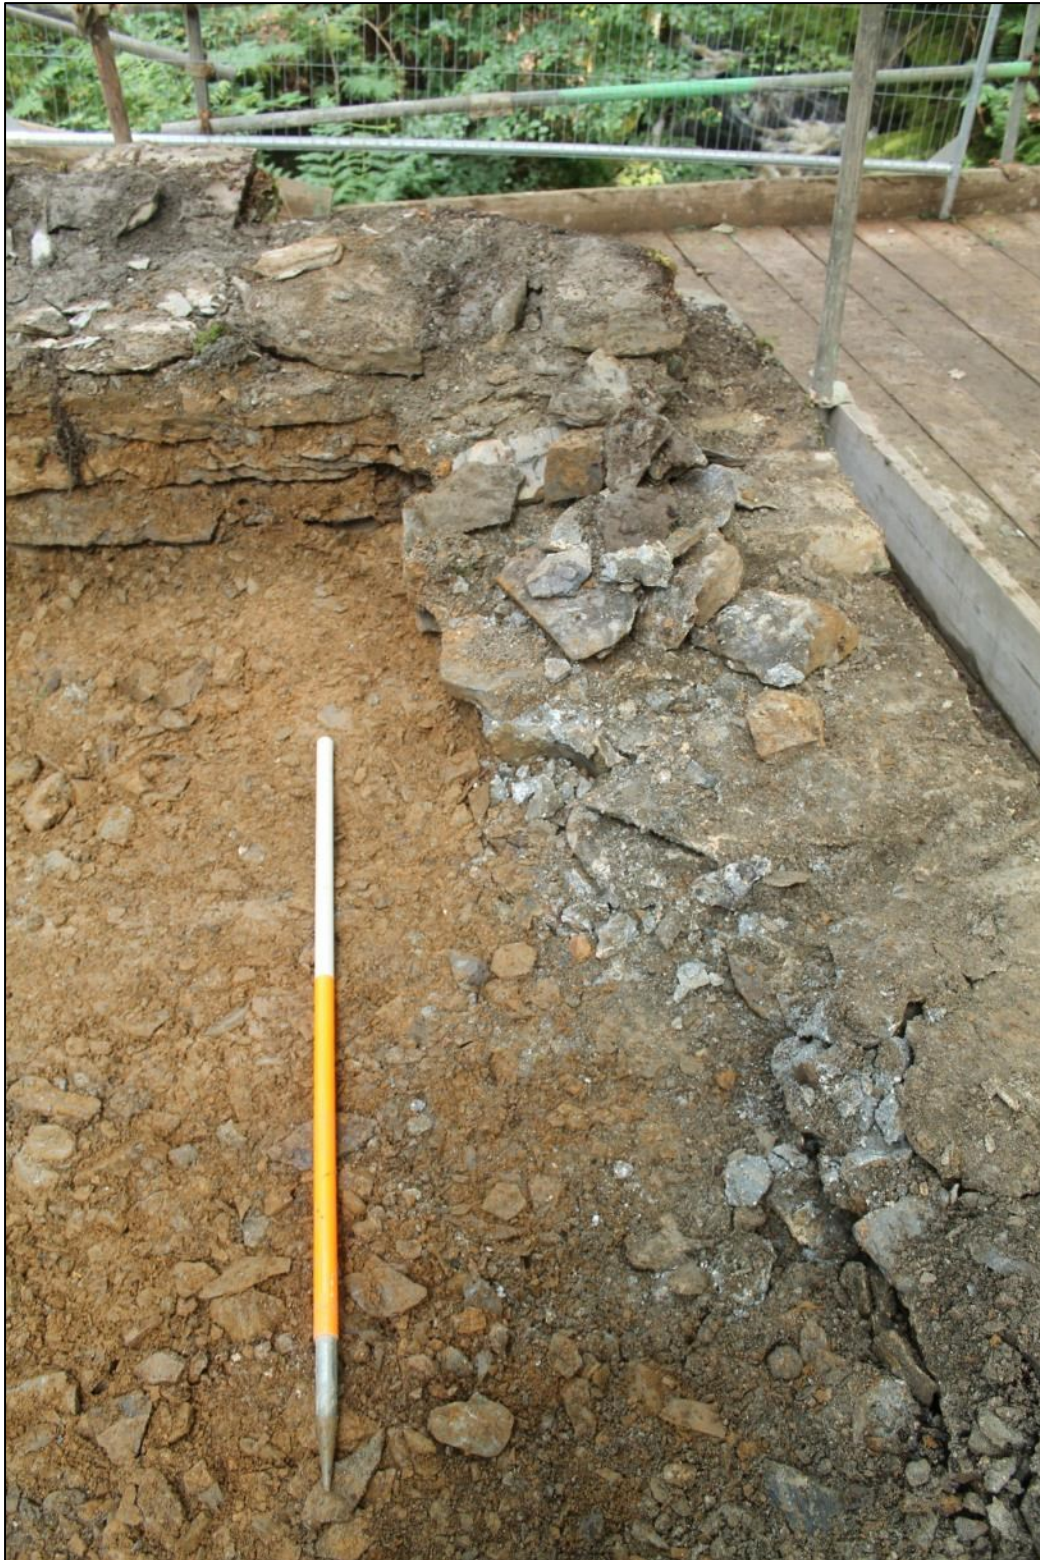
**Photo 17:** The corner of the northern and western walls of the north-western abutment (DAT Photo 1105511\_0043).

(Photo 17). The southern wall had been significantly damaged by roots and was considerably narrower than the corresponding wall on the other abutment measuring only 0.7m wide (Photo 18).

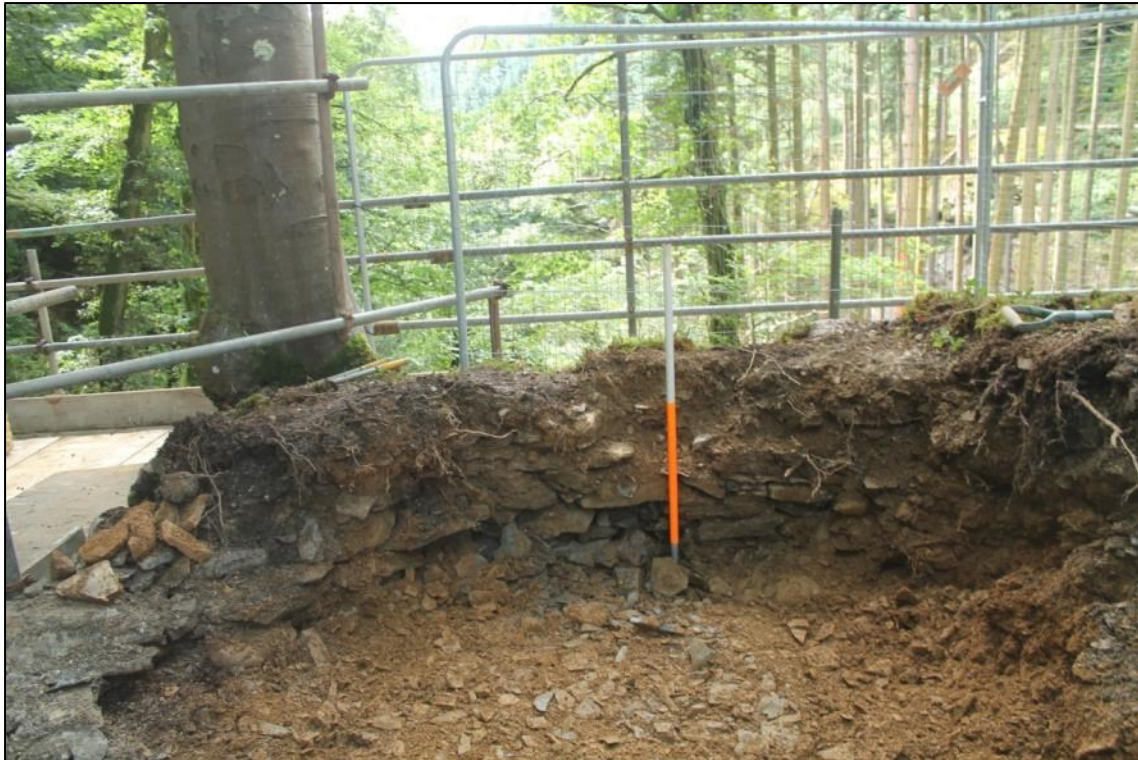
**Photo 18:** The root damaged southern wall of the north-western abutment (DAT Photo 110511\_0041)

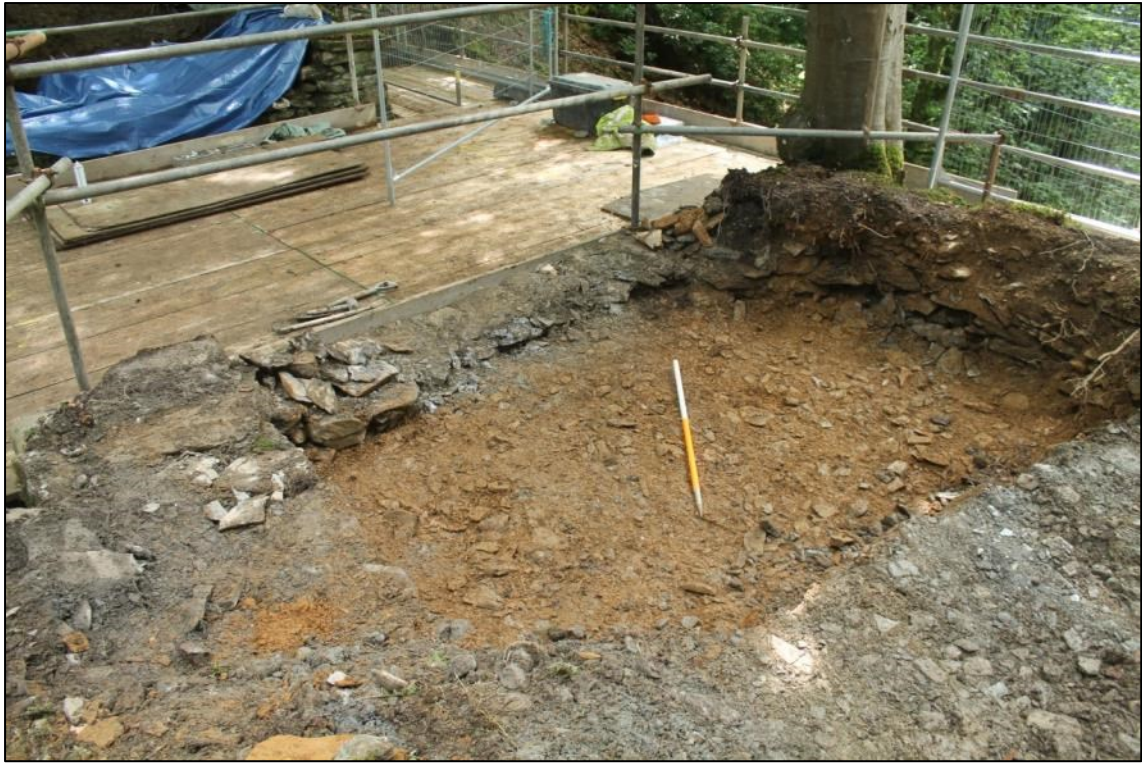
**Photo 19:** An overview of the final extent of excavations in the fill of the north-western abutment (DAT Photo 110511\_0049).

- 5.12 Around 0.35m of the eastern wall was reduced in height and roughly 0.3m was dismantled from the width of each wall to accommodate the concrete slab. The excavated pit measured approximately 3.0m long and 3.2m wide and created a section through the abutment fill measuring a total of 1.2m depth of road deposits ((201) & 202) and orange, shattered mudstone subsoil (203) (Photos 19 & 20). The depth of the excavation below the level of the existing masonry at the north-eastern corner of the abutment was approximately 0.4m.

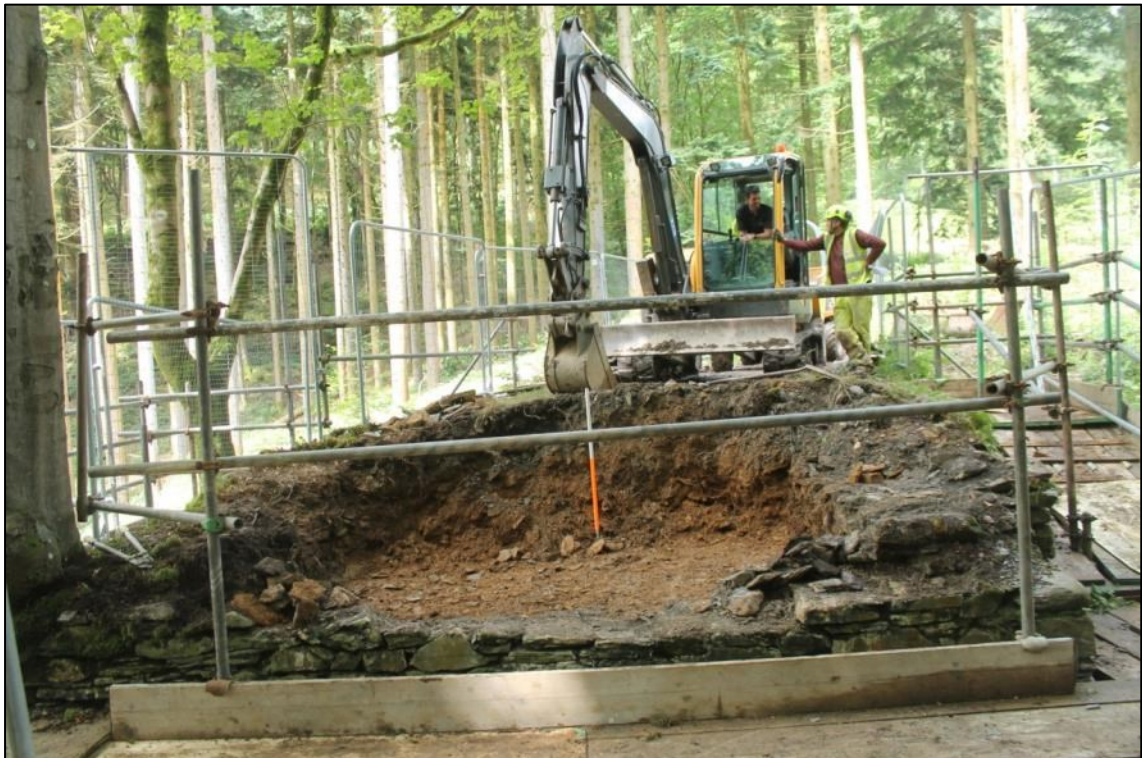
**Photo 20:** The section of the abutment infill and the reduced walls at the end of the excavations of the north-western abutment (DAT Photo 110511\_0038).

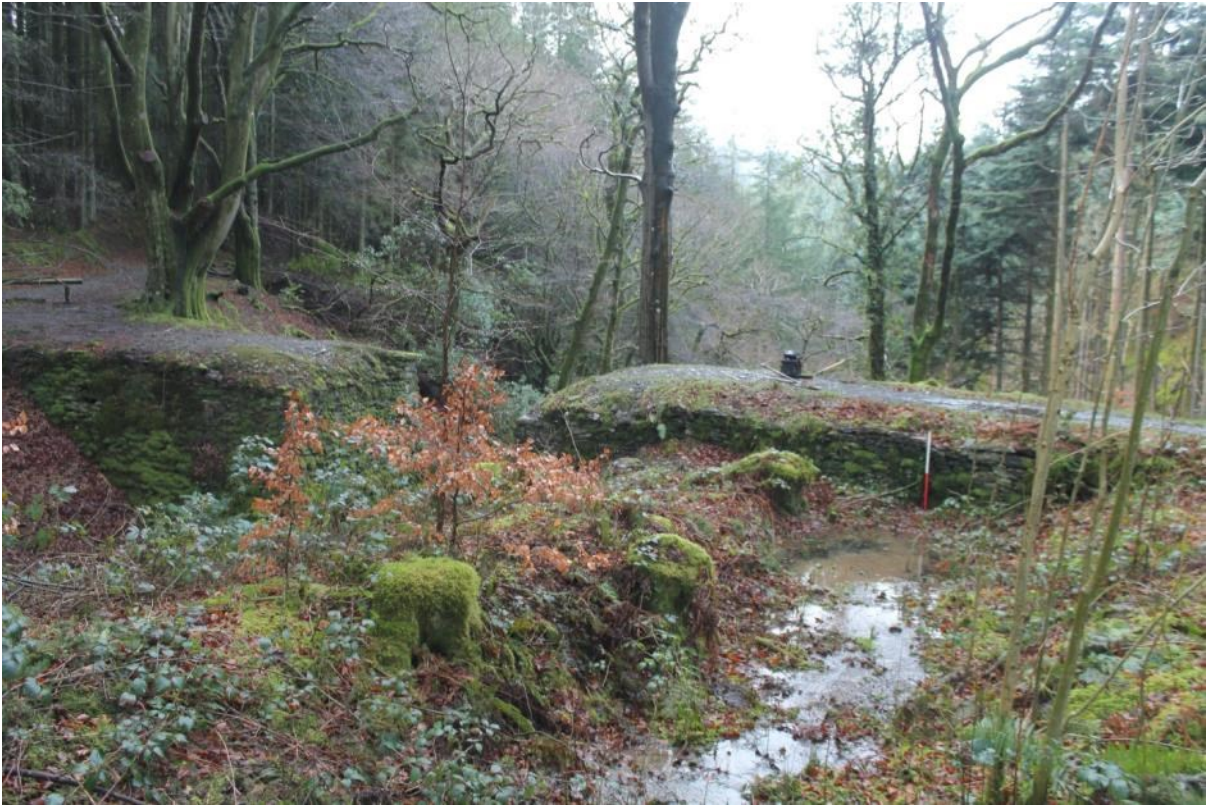
**Photo 1:** View east showing both bridge abutments of Pont Newydd following tree clearance
