Prepared by DAT Archaeological Services  
for the Hafod Trust

RHIF YR ADRODDIAD / REPORT NO. 2017/48  
RHIF Y DIGWYLLIAD / EVENT RECORD NO.110511

# NEW BRIDGE CONSTRUCTION WORKS AT PONT NEWYDD (CD174), HAFOD, CEREDIGION ARCHAEOLOGICAL WATCHING BRIEF (SN77047361)

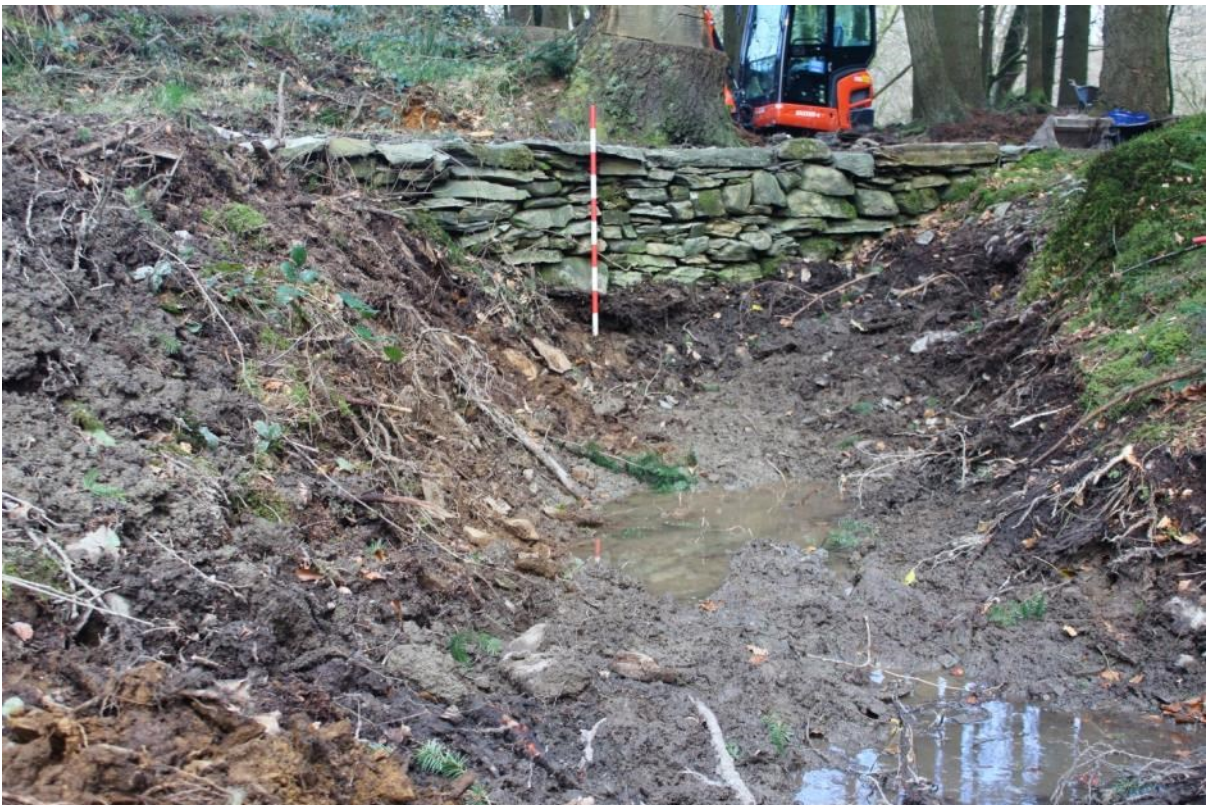
**Photo 2:** The leat and the modern-built pathway over it, with a 1m scale, after excavation

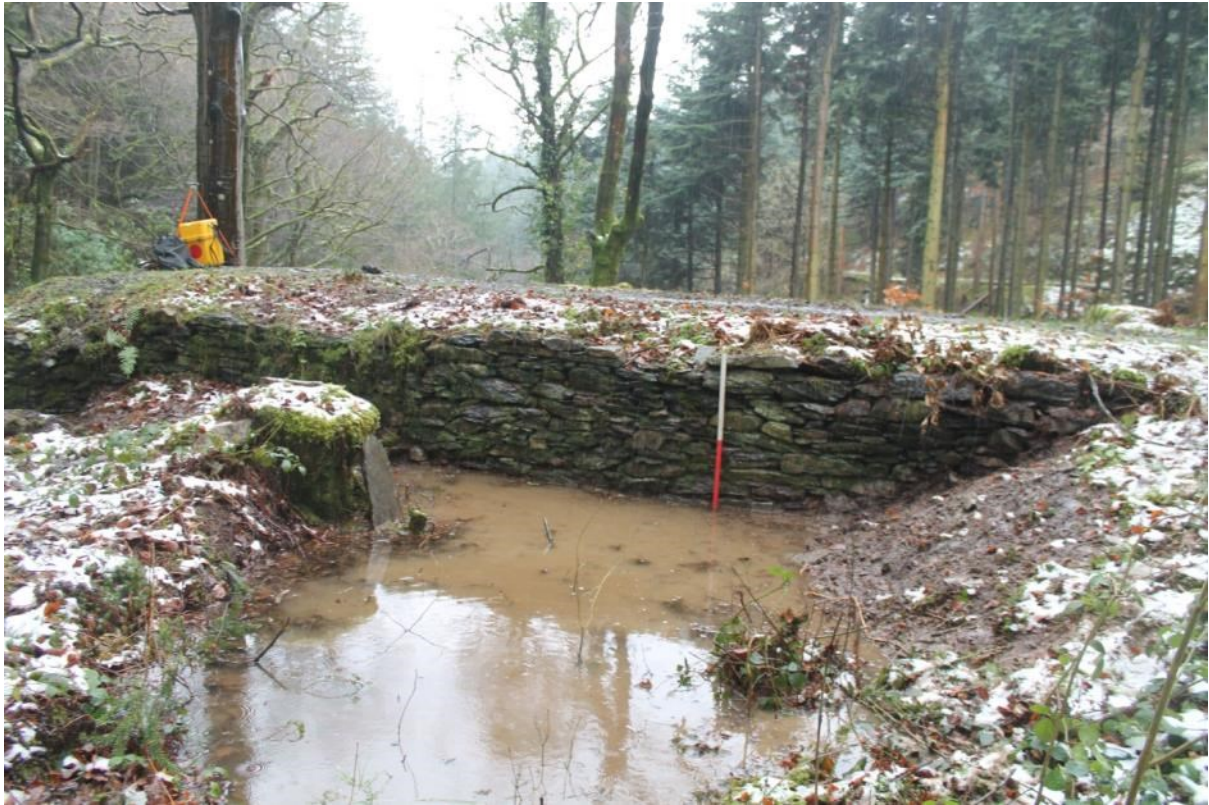
**Photo 3:** North-eastern facade of the northern abutment exposed during the evaluation.  
1m scale
