HAFOD: CAVERN CASCADE WALK ARCHAEOLOGICAL WATCHING BRIEF

RECORD NO. 35852

MARCH 1998

Report by: K Murphy

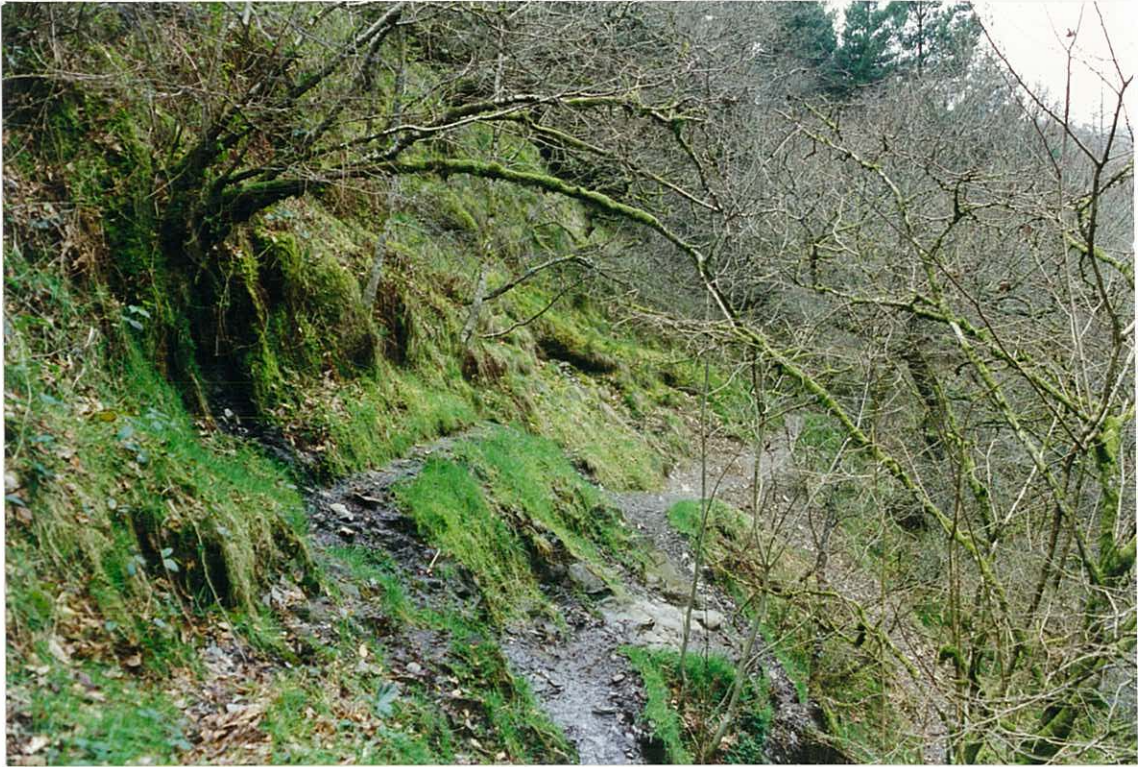
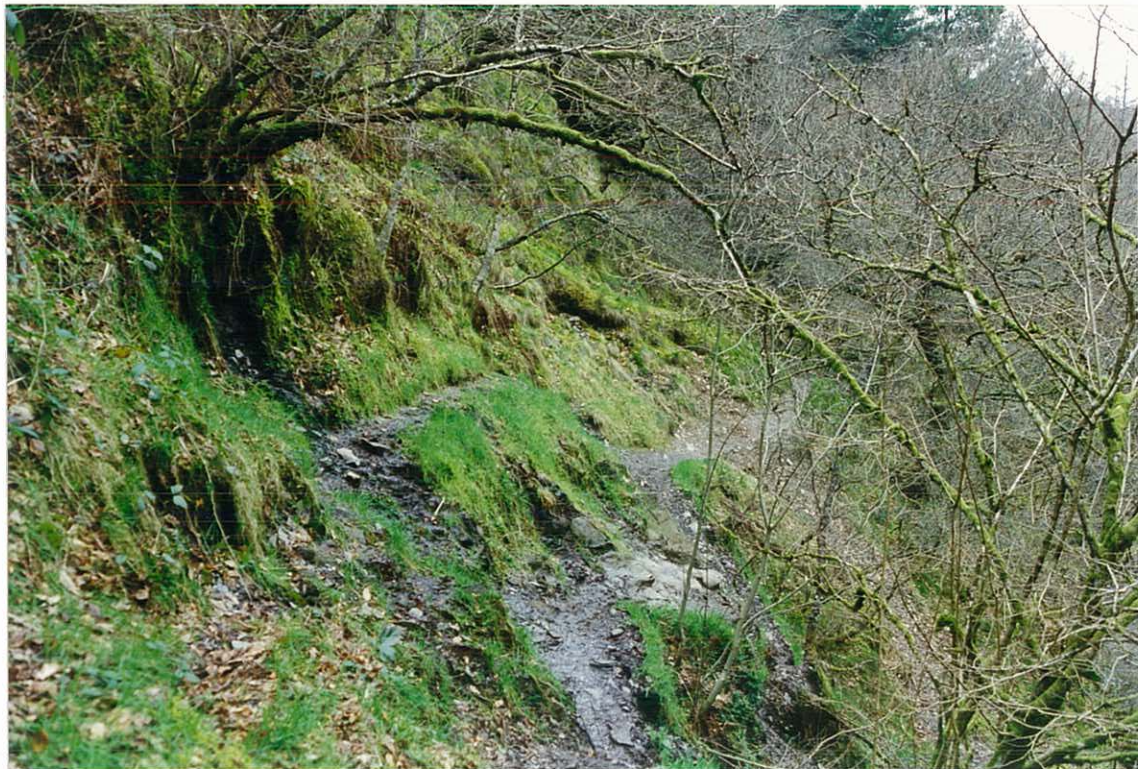
coincided. The Gentleman's Walk was discernible as a narrow, c. 0.7m wide, overgrown terrace partially covered in hill-wash, 1-2m below which was the recent path-line - a worn and very narrow undulating path on the edge of a steep slope (Fig. 2, Photos. 1 & 2). The vegetation and hill-wash which had accumulated on the terrace of the Gentleman's Walk was cut back (Photos. 3 & 4) and the resulting spoil used to help create a wider walk-way and so re-establish the public footpath on its historic route. This created a walk-way terrace approximately 1.5m wide.

Photos. 1 & 2. North of the old mine level. Prior to the remedial work. The overgrown terrace of Gentleman's Walk can be seen with the worn modern path below.

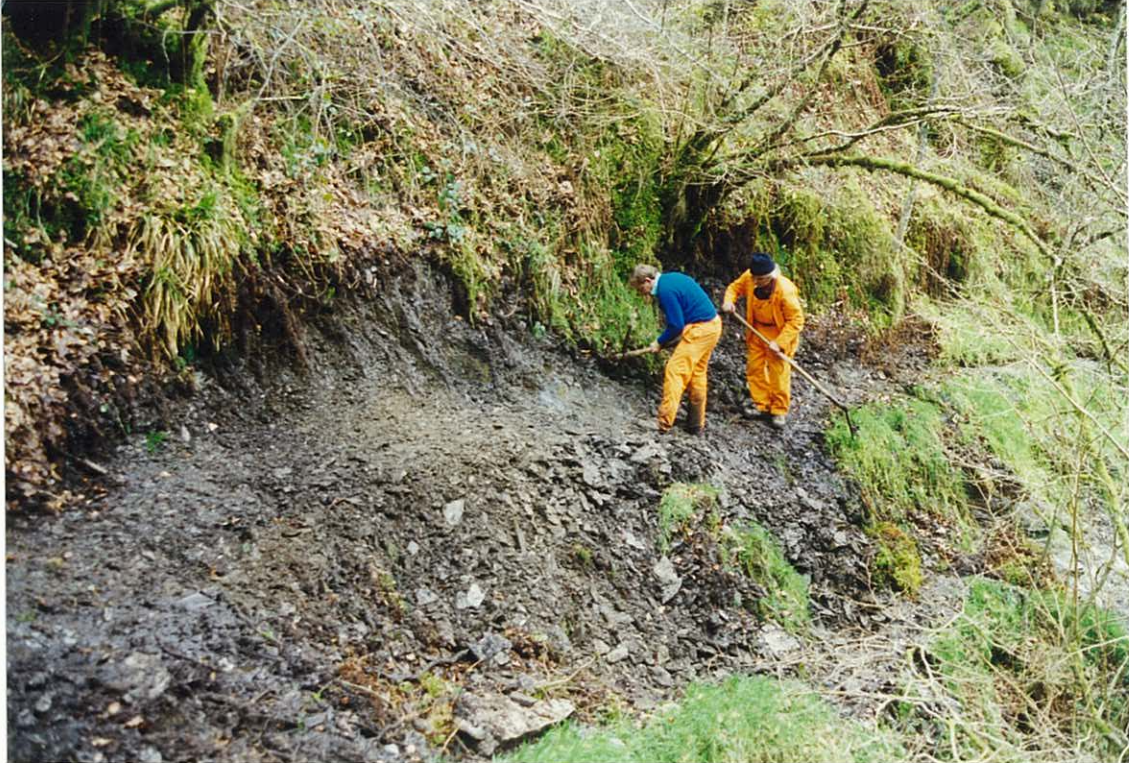
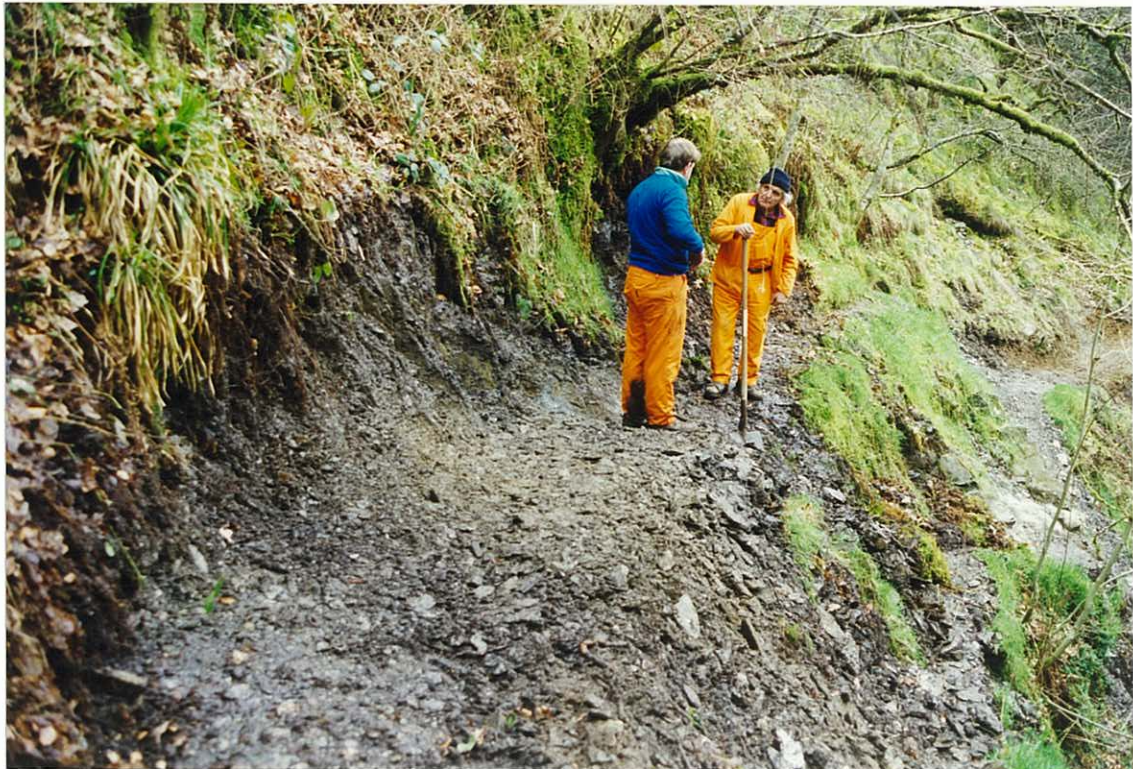
Photos. 3 & 4. Remedial work being carried out on the terrace of the Gentleman's Walk

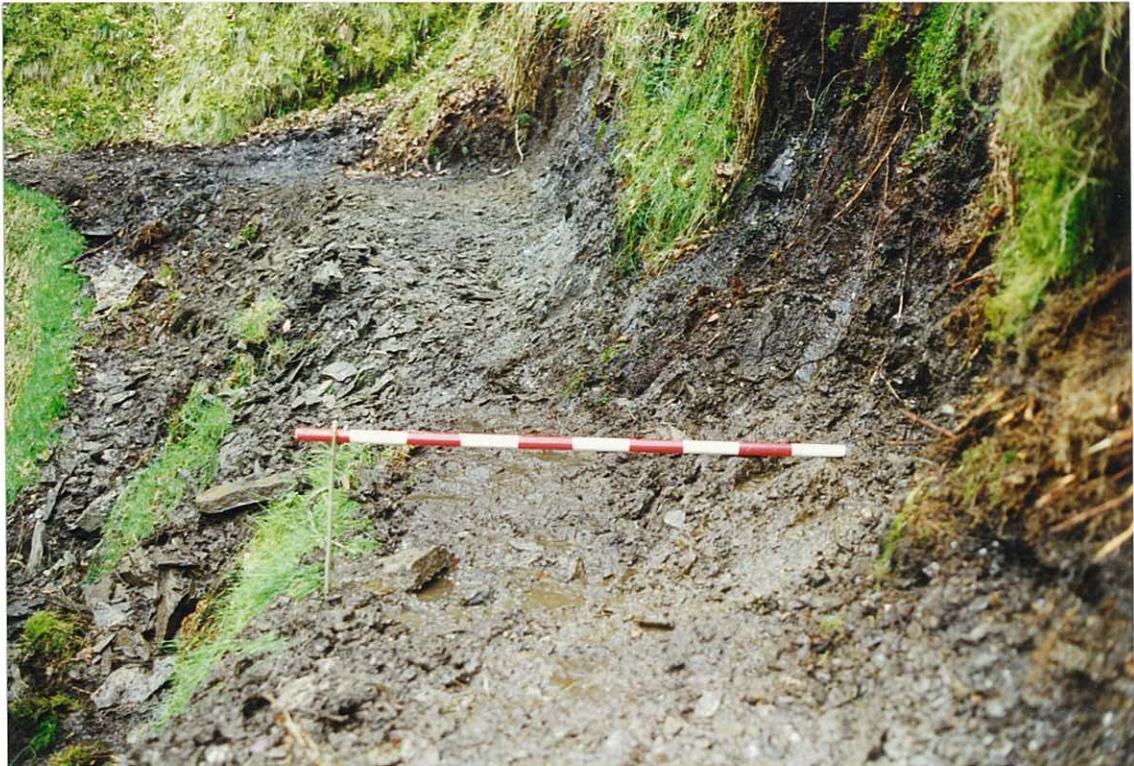
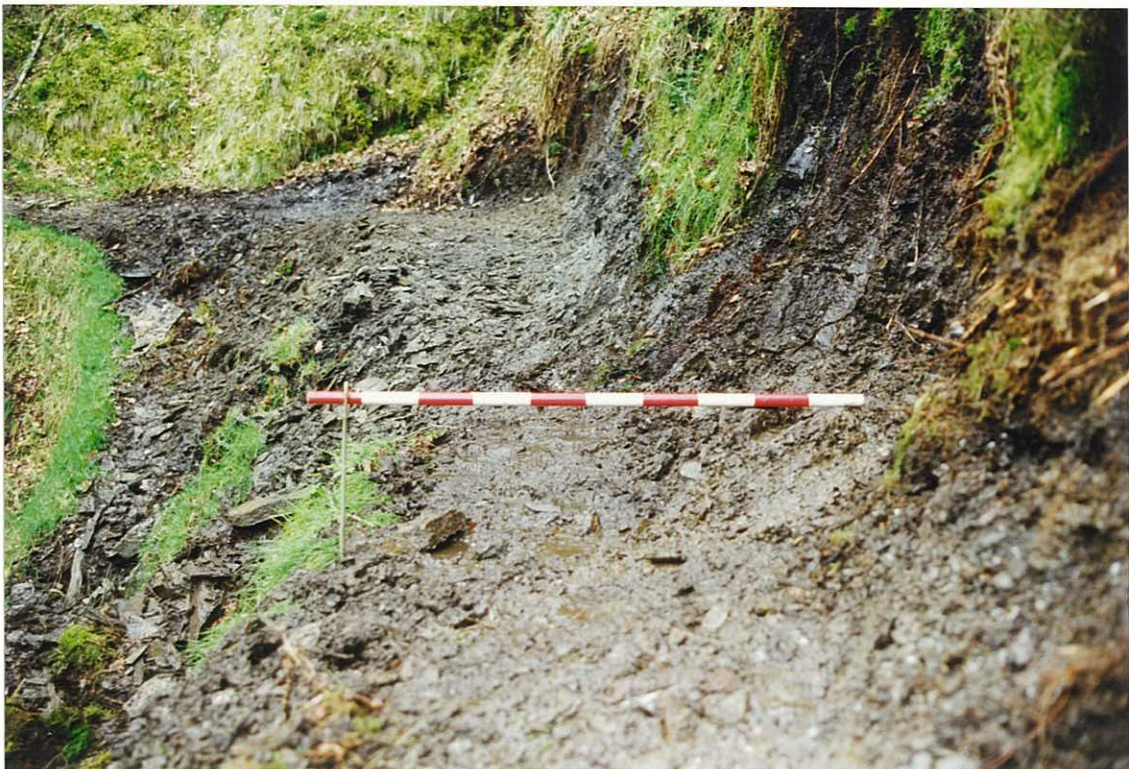
A good terrace was present in the northern part of the 15m long section. Here, however, it was discovered that erosion prior to recent accumulation of hill-wash and vegetation had stripped off any walk surfaces that may have once existed down to the rock-cut Johnian terrace (Fig. 4, Photos. 5-7). In some very short lengths this rock-cut terrace lay some 70mm above the height of the proposed path restoration level and therefore was lowered to during the remedial work. At the northern end of this section low steps were created on bedrock to bring the footpath up from its worn course onto the newly created/historic terrace described above.

Photos. 5 & 6. Location of section shown on Fig. 4. The right-hand end of the scale rests on the rock-cut terrace of excavated for the Gentleman's Walk

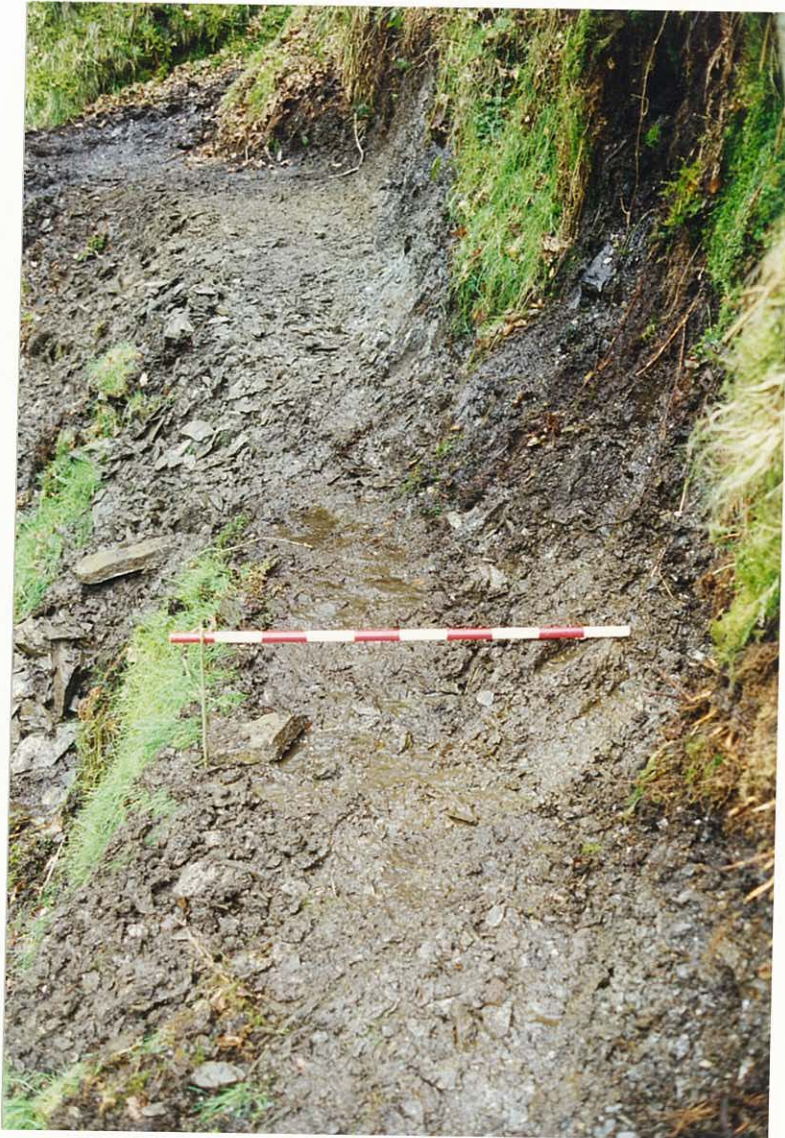
Photo. 7. Location of section shown on Fig. 4. The right-hand end of the scale rests on the rock-cut terrace of excavated for the Gentleman's Walk

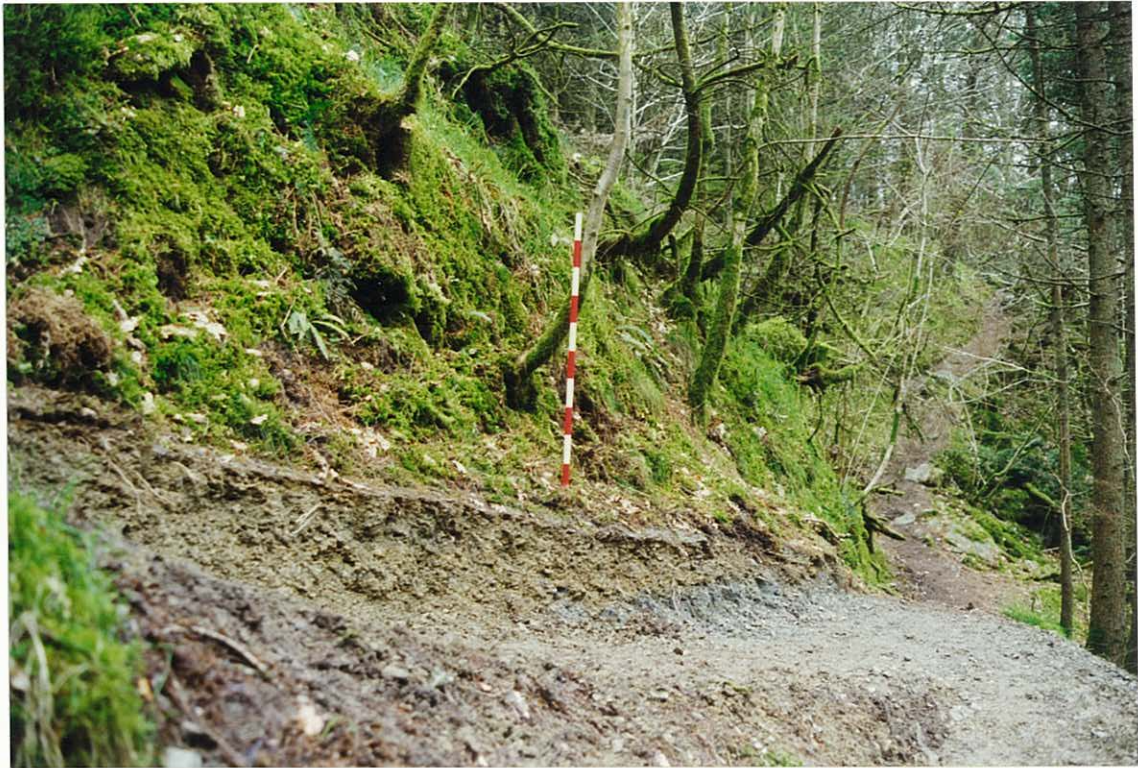
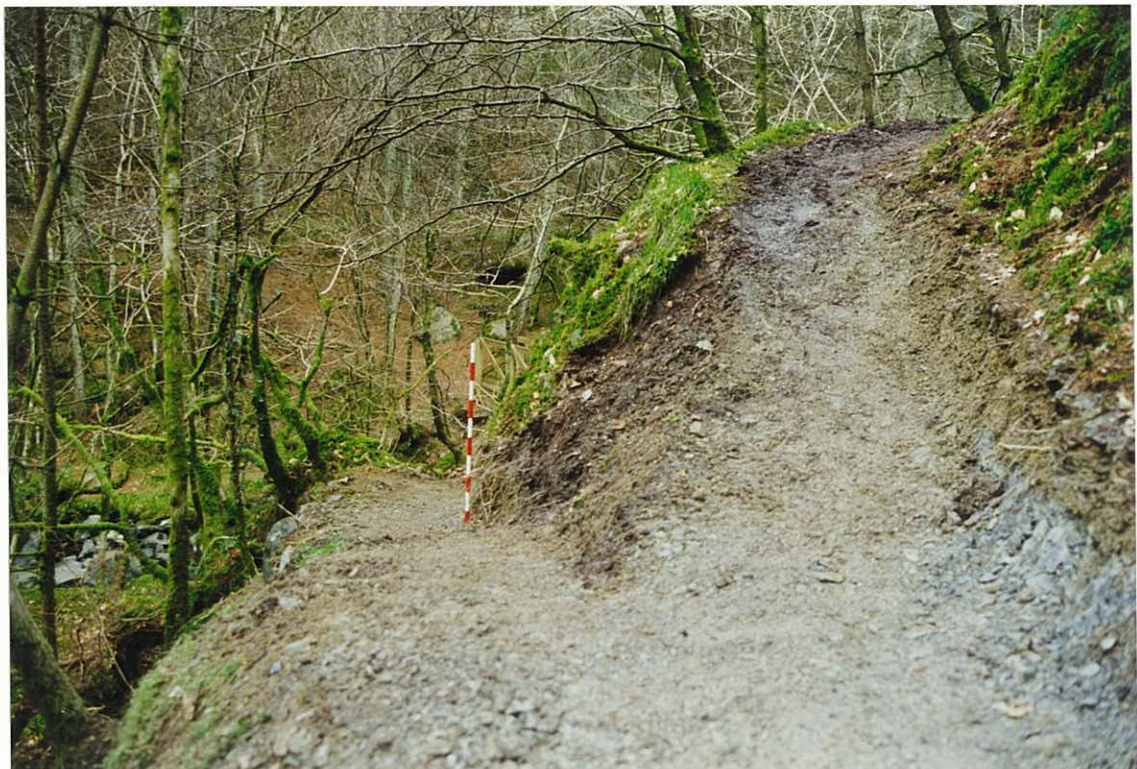
To the north of the 15m long section described above the public footpath was, and is still, situated on a worn terrace below the Gentleman's Walk (Photo. 8). From the junction of the path down to a footbridge over Nant Cau to the north, the public footpath and the Gentleman's Walk coincide. At the junction, cutting back of the up-slope side of the public footpath/Gentleman's Walk was required. Here, in this very small-scale work, only natural glacial deposits overlying bedrock were observed (Photos. 9 & 10).

Photos. 9 & 10. Remedial work on the path at the junction of the Gentleman's Walk and the path down to the footbridge over Nant Cau
