RUSTIC ALCOVE **HAFOD** CEREDIGION

ARCHAEOLOGICAL EVALUATION
Project Record No. 32476
MAY 1996

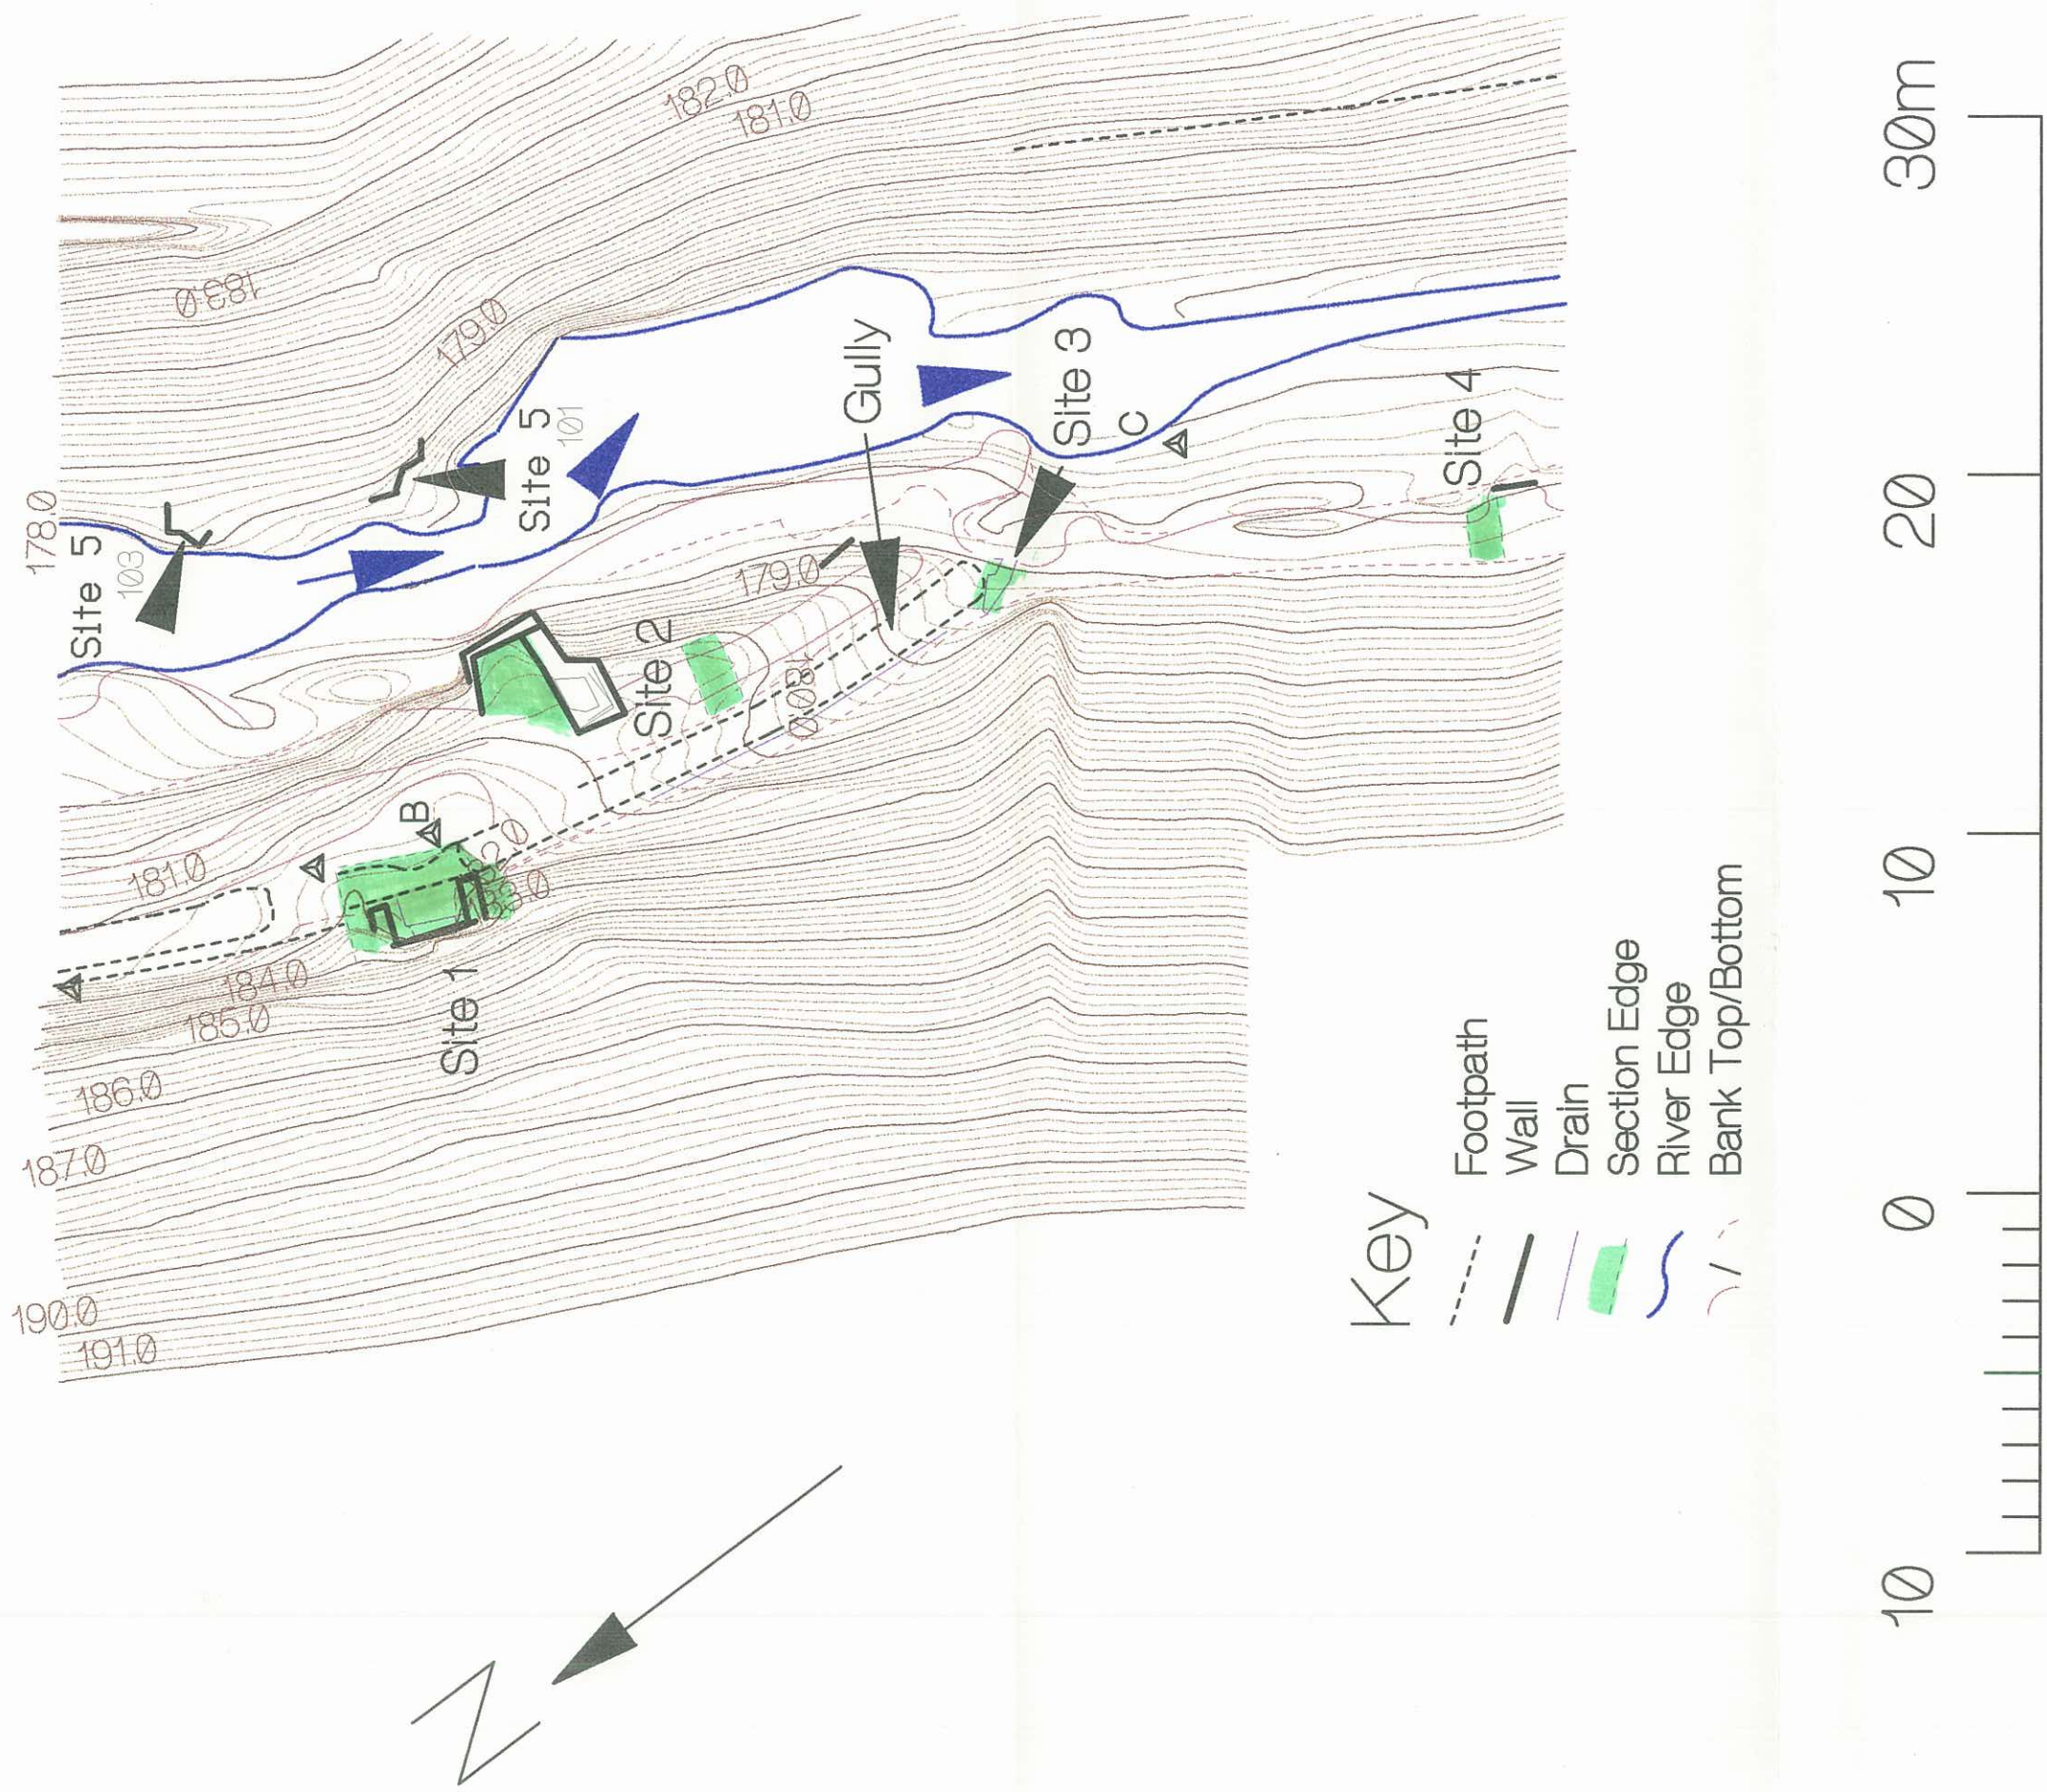
Figure 3

side walls (6 and 11) and the rear 'revetment' wall (7) which was visible prior to the excavation (figure 3).

Site 1: Gazebo Elevation and Plan

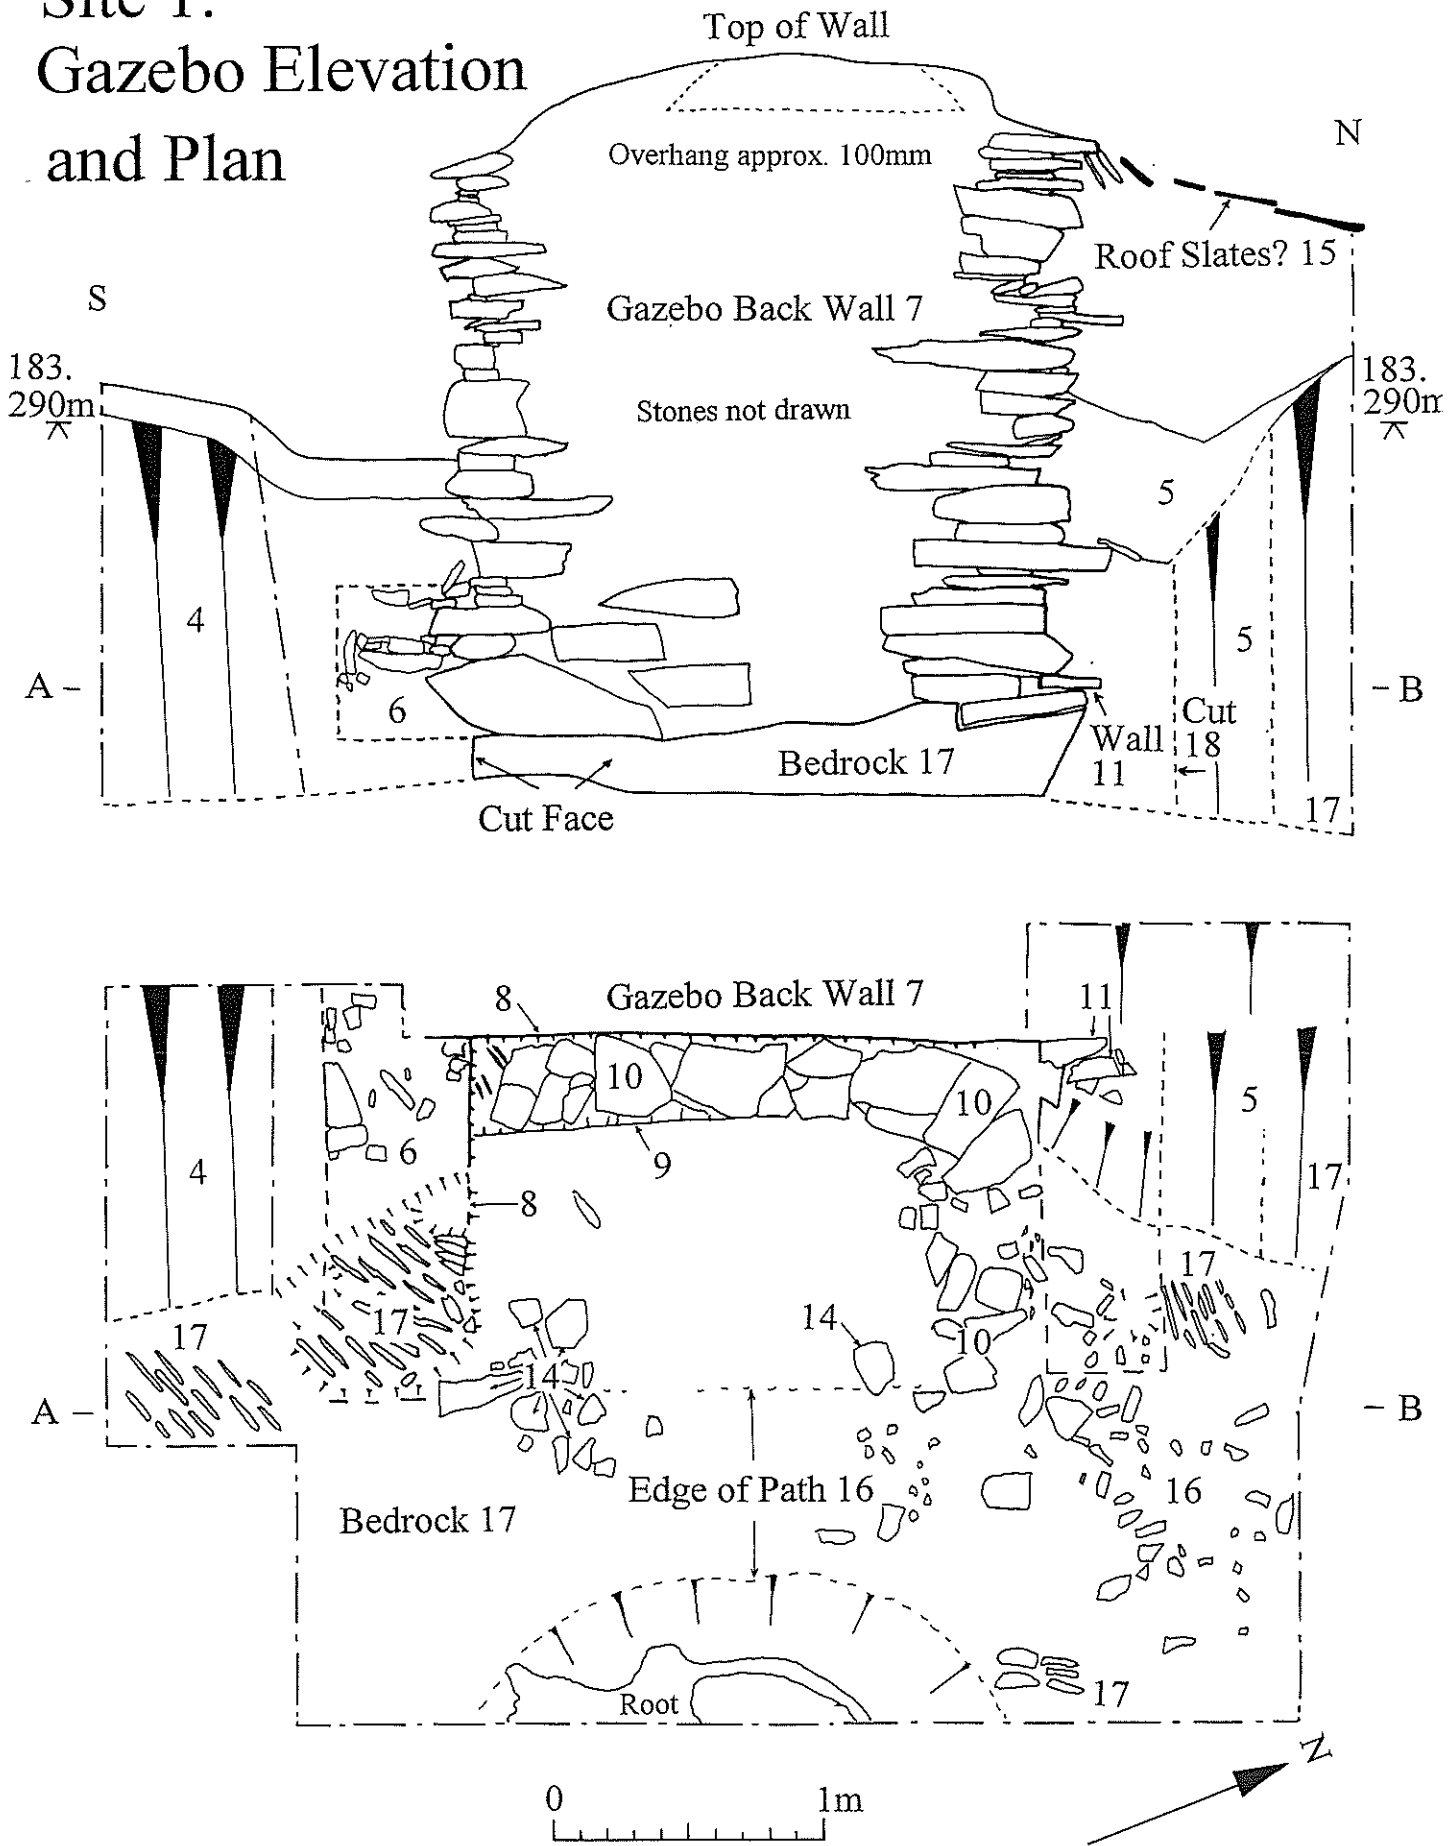
Figure 4

The earliest feature appeared to be the cutting of the bedrock (17) (figure 4) to form a level platform (8) into the base of the hill slope, on a level with the path. This platform was cut so that three sides formed the bottom edge and base for two short

The footpath metalling (16) only remained to any extent at the north eastern end of the excavation area (figures 4 and 8). This consisted of small shale slabs and fragments set on a greyish brown silty clay, lying directly on bedrock (17) and probably over part of the drain capping (10).

Both ends of the remaining back wall (7), which revets the hillside, were clearly incomplete. Excavation revealed the remains of two side walls (6 and 11) and it was evident that these were keyed in, apparently to the full height of the back wall, at least on the south western corner (figure 4). These side walls appeared to have projected about 1.3m up to the line of the path. It was evident that these side walls had been deliberately robbed (figure 9) and there were the minor remains of one possible robber trench fill (19) on the north eastern side. The robbing appeared to have been done with some care, in order to leave the rear wall intact.

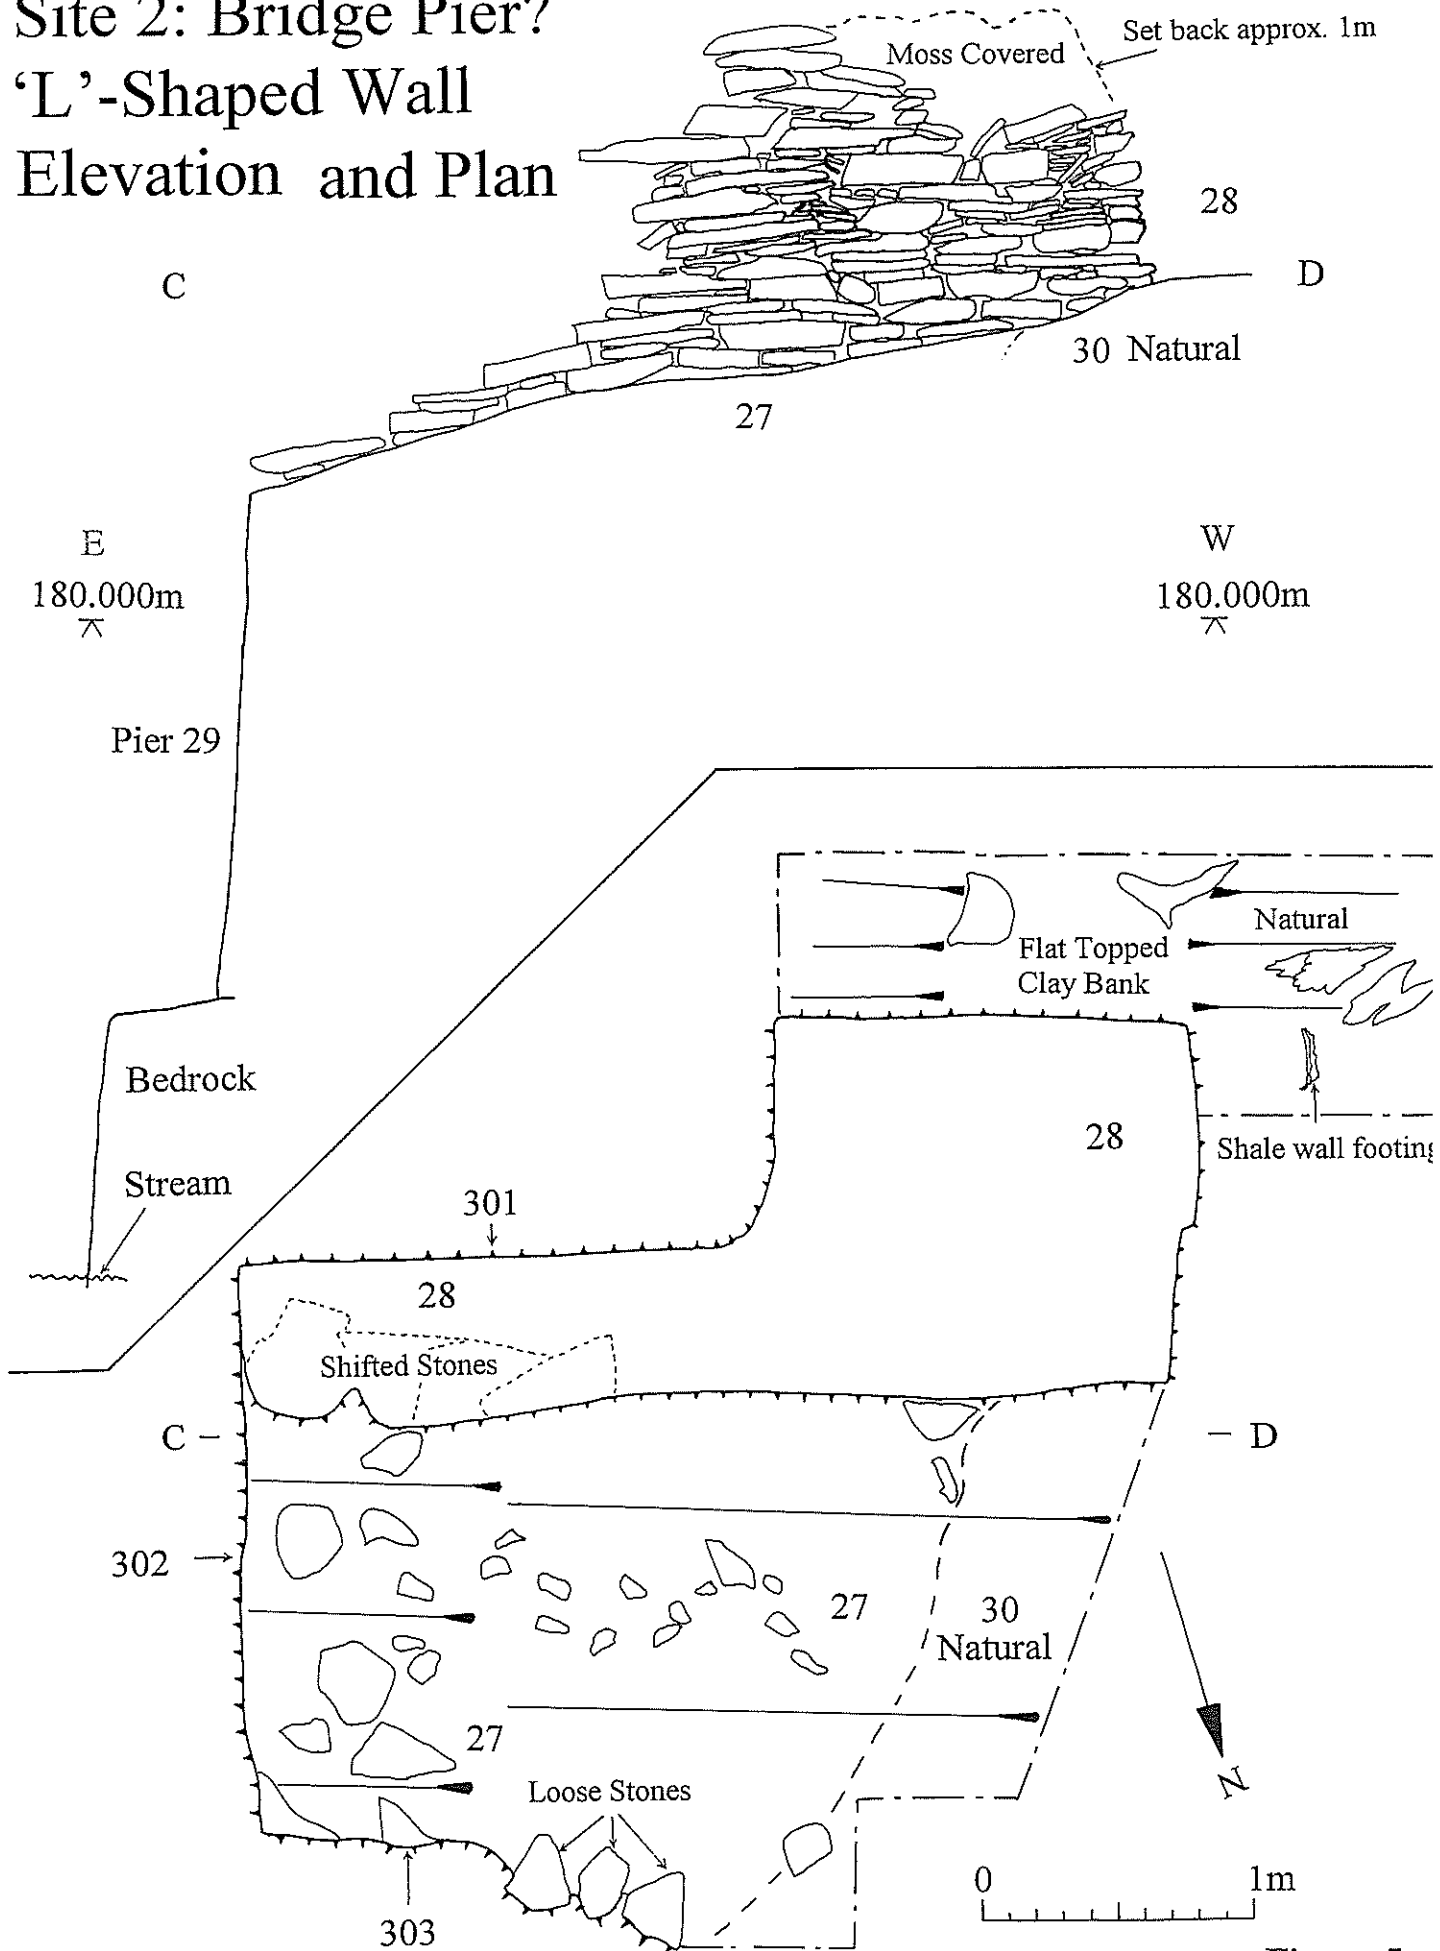
Figure 5

Site 2: Bridge Pier? 'L'-Shaped Wall Elevation and Plan

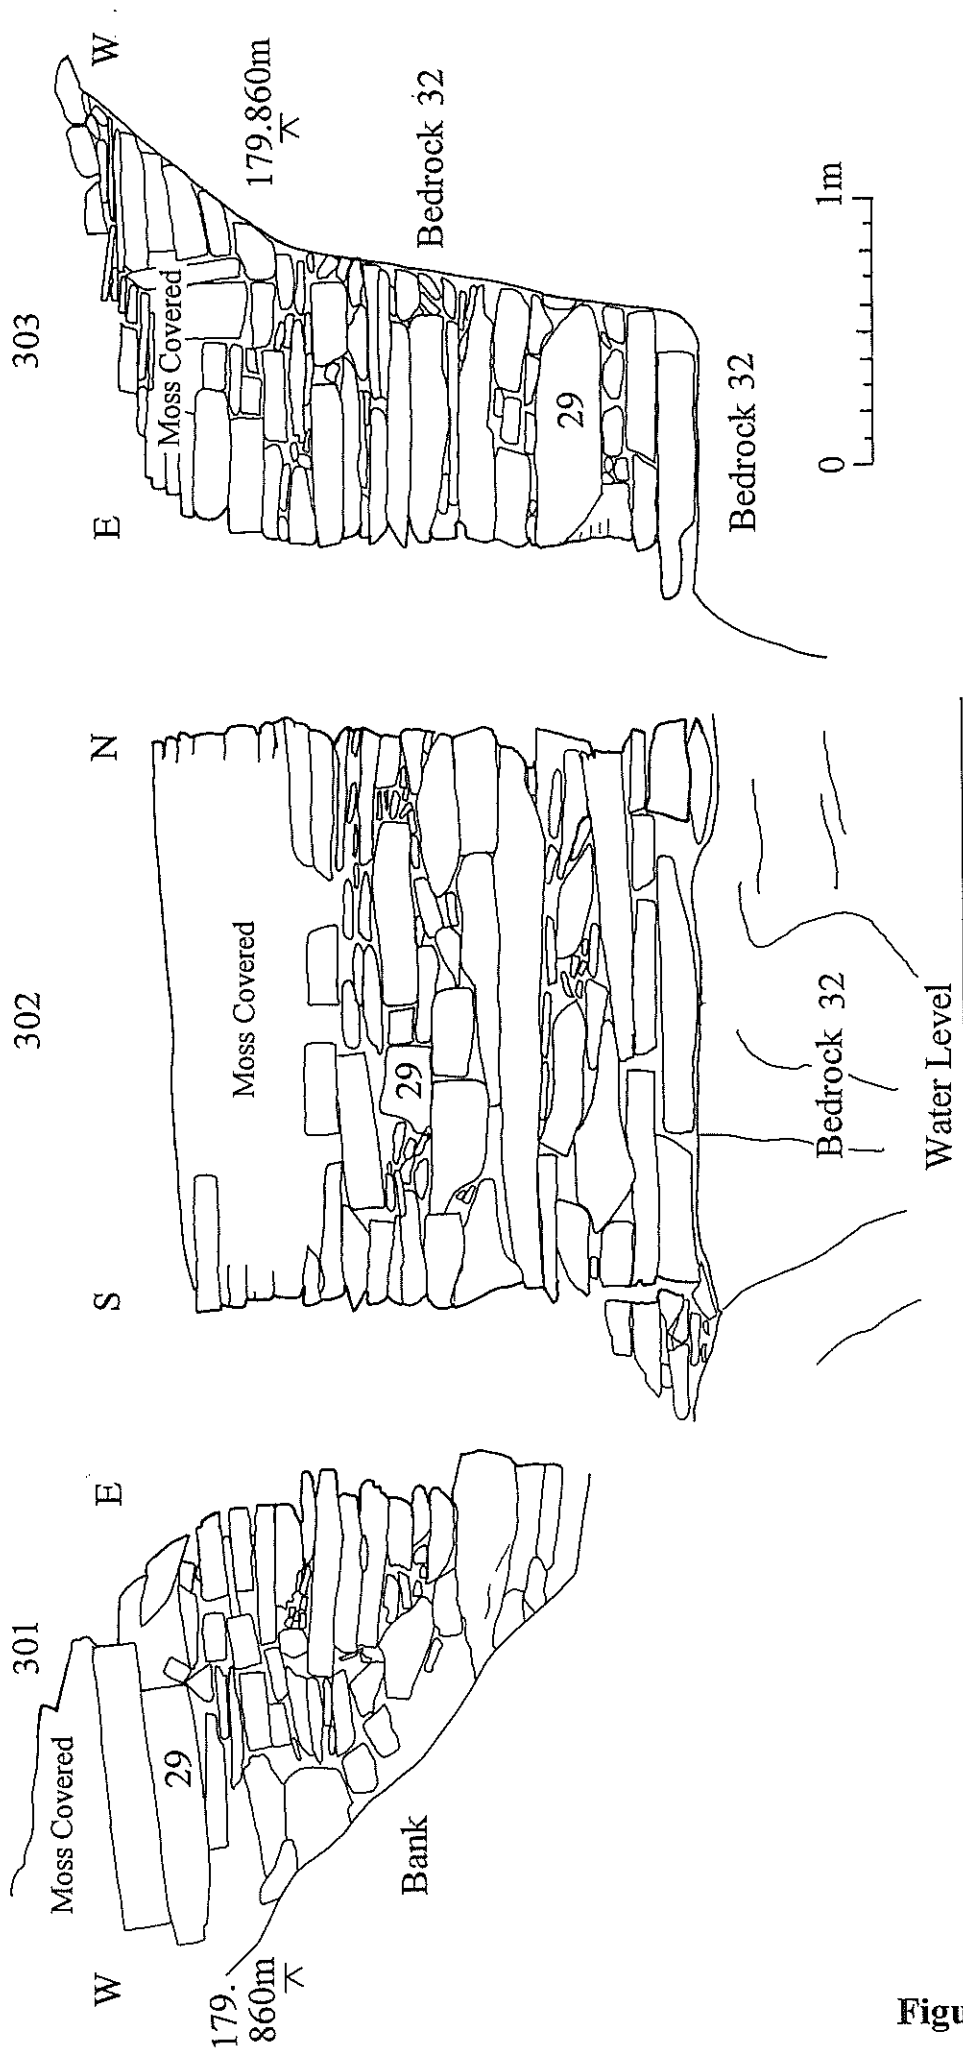
Figure 6

Site 2: Pier Elevations
