A PRELIMINARY SURVEY
OF
HAFOD ICEHOUSE
RECORD NO. 26535

REPORT NO. 35948

June 1998

HAFOD ICEHOUSE (Hafod Archaeological Database No. 26535) A PRELIMINARY SURVEY

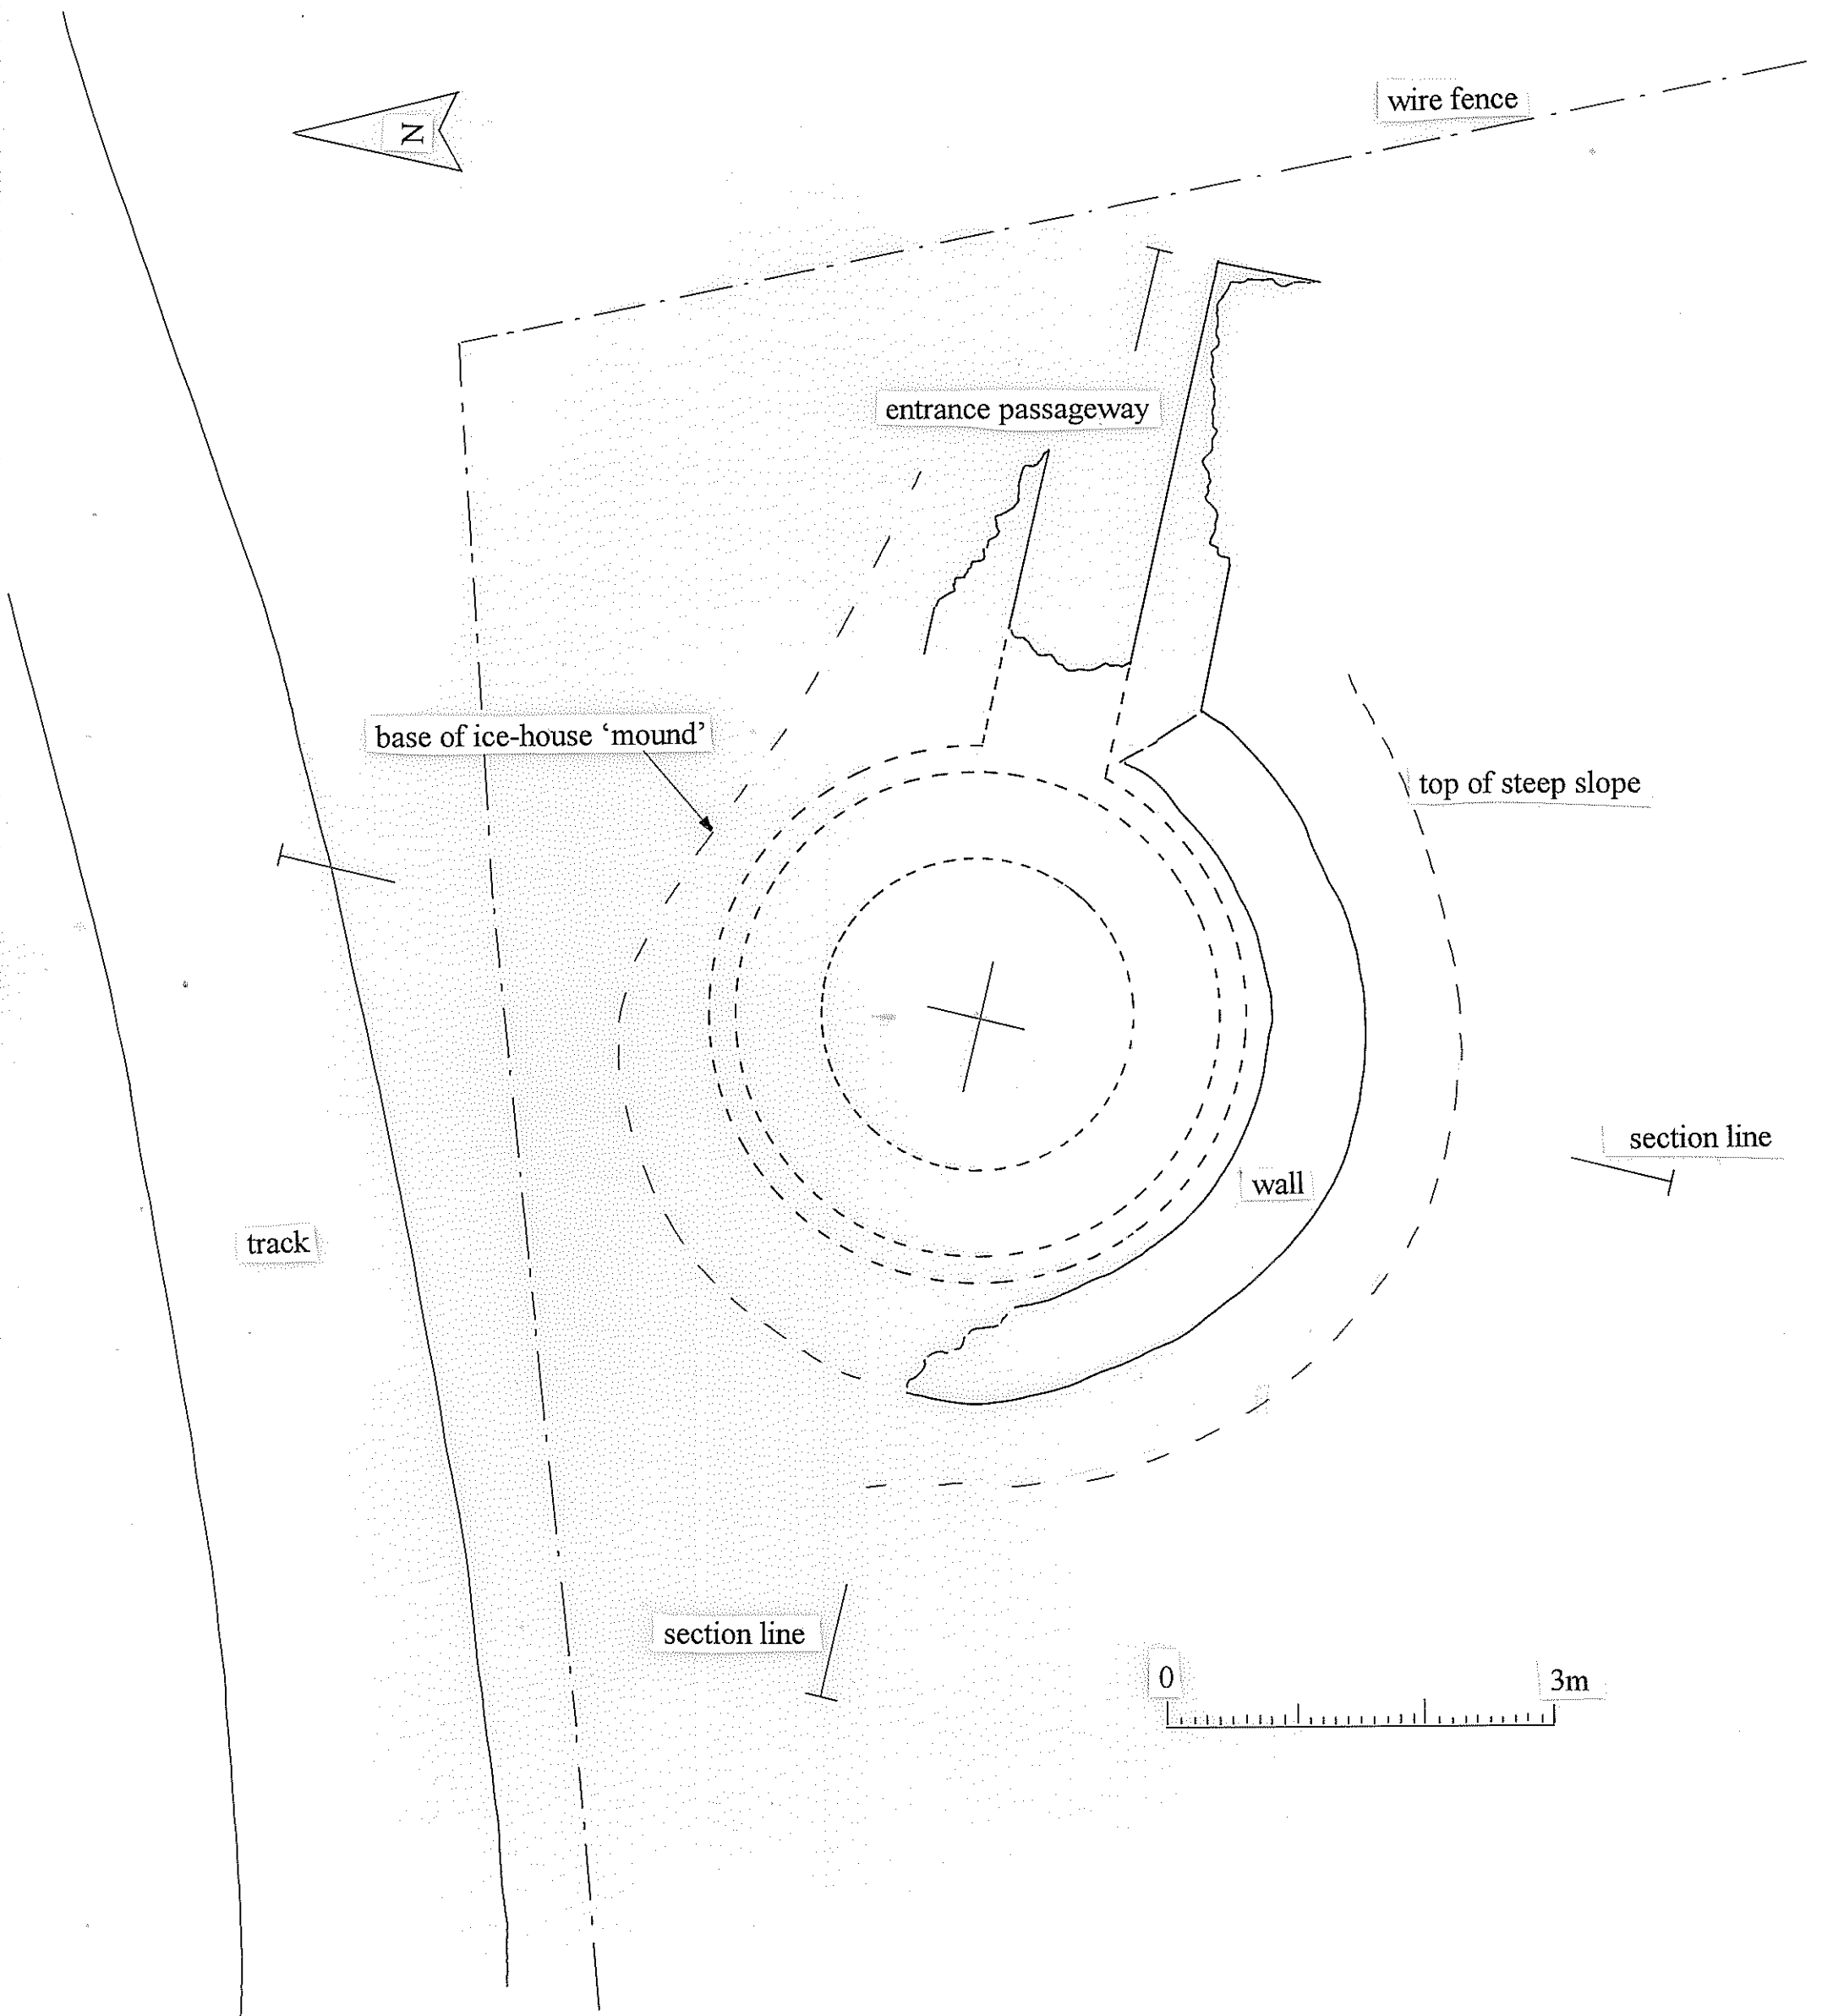
**HAFOD ICE HOUSE
26535
PLAN**

The icehouse entrance passageway is in a very poor state of repair: the stone vaulting has collapsed apart from a c. 1m section adjoining the icehouse's dome, much dilapidation has occurred to the stone-built side walls (the north wall in particular) and rubble has accumulated in the passageway. Nevertheless, it is possible to detect the original plan. The passageway was 3.9m long, 1.1m wide, 1.9m high and built of coursed rubble. A mortar scar of a removed door jamb is visible adjoining the chamber. The walls of the passageway are butt-joined onto the masonry of the chamber, but this is probably a reflection of the building technique employed rather than of chronological significance.

Short term: to prevent further decay to the passageway, repointing of the side walls is required.
